Profile/Photo Observation Report

Date:	03/20/2018	Weather:		Coding:	PACP 6.0
Pipe Length (ft):	212.0	Owner:	NA	Pre Clean:	Not Known
P.O.#:		Surveyor:	JUSTIN GONZALES	PSR:	P-903-052-053
Customer:		Clean Date:	01/01/1900	Shape:	C

Street:	OFF E 38TH PL	Flow Control:	Not Controlled
City:	Hobart, IN	Year Renewed:	
Location:	Other	Tape/Media #:	
Purpose:	Not Known	Dia/Height:	10"
Use:	Sanitary	Material:	PVC
Drain Area:	NA	Lining:	
Category:	NA		
Comment:

Location Details:		Direction of Survey:	Upstream
US MH:	M-903-053	DS MH:	M-903-052
		Total Length Surveyed (ft):	173.8

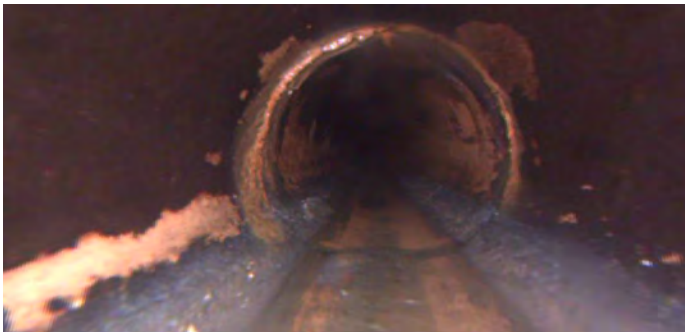
Code:	DAZ
Description:	Deposits Attached Other

Distance (ft):	10.7
Structural Grade:	0
O&M Grade:	2
Clock Start/From:	7
Clock To:	5
1st Value:	
2nd Value:	
Value Percent:	5.000
Continuous Index:	S01
Within 8" of Joint:	YES
Remarks:	WANDER

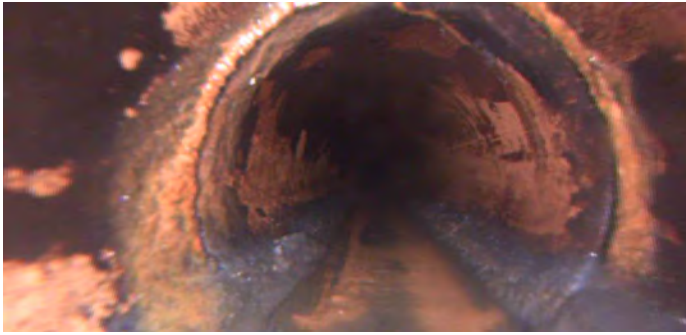
Code: **DAE**
Description: **Deposits Attached Encrustation**

Distance (ft): **11.0**
Structural Grade: **0**
O&M Grade: **2**
Clock Start/From: **7**
Clock To: **5**
1st Value:
2nd Value:
Value Percent: **5.000**
Continuous Index:
Within 8" of Joint: **YES**
Remarks:

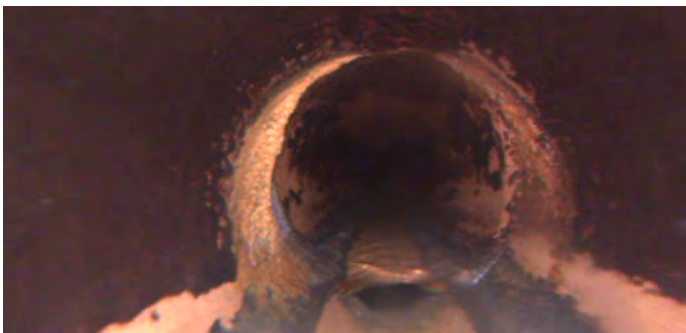
Code: **DAE**
Description: **Deposits Attached Encrustation**

Distance (ft): **21.2**
Structural Grade: **0**
O&M Grade: **2**
Clock Start/From: **7**
Clock To: **12**
1st Value:
2nd Value:
Value Percent: **5.000**
Continuous Index:
Within 8" of Joint: **YES**
Remarks:

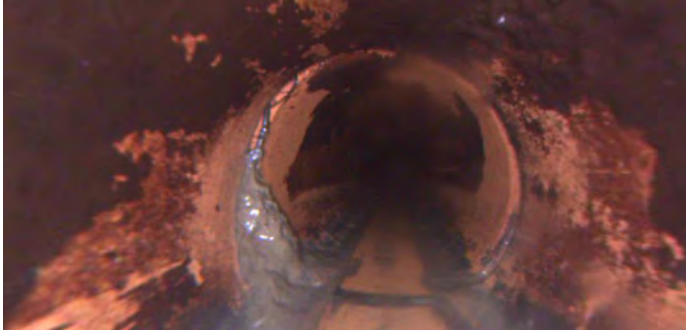
Code: **RFJ**
Description: **Roots Fine Joint**

Distance (ft): **57.6**
Structural Grade: **0**
O&M Grade: **1**
Clock Start/From: **9**
Clock To: **10**
1st Value:
2nd Value:
Value Percent:
Continuous Index:
Within 8" of Joint: **YES**
Remarks:

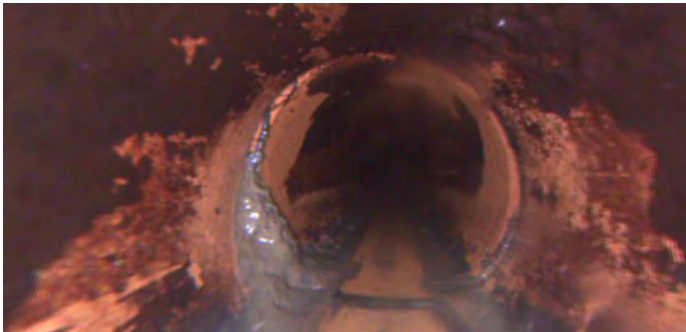
Code: **DAE**
Description: **Deposits Attached Encrustation**

Distance (ft): **57.6**
Structural Grade: **0**
O&M Grade: **2**
Clock Start/From: **7**
Clock To: **10**
1st Value:
2nd Value:
Value Percent: **5.000**
Continuous Index:
Within 8" of Joint: **YES**
Remarks:

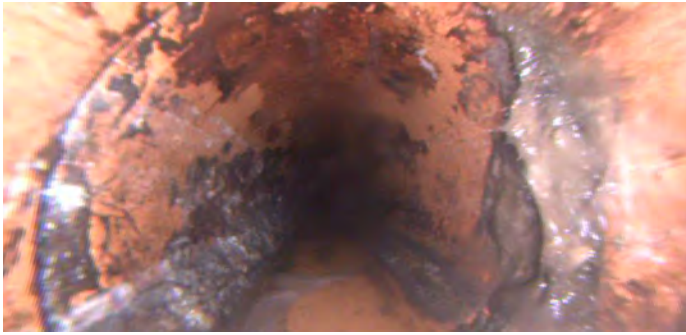
Code: **DAE**
Description: **Deposits Attached Encrustation**

Distance (ft): **84.0**
Structural Grade: **0**
O&M Grade: **2**
Clock Start/From: **1**
Clock To: **5**
1st Value:
2nd Value:
Value Percent: **5.000**
Continuous Index:
Within 8" of Joint: **YES**
Remarks:

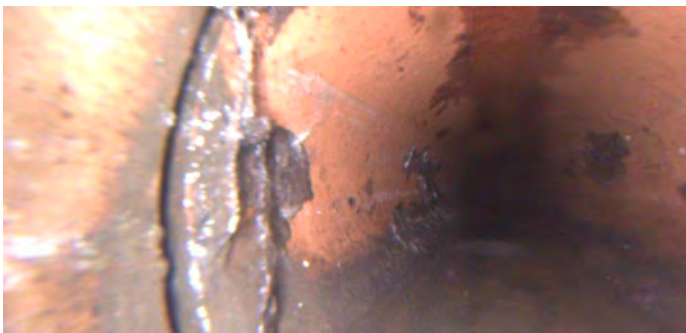
Code: **RFJ**
Description: **Roots Fine Joint**

Distance (ft): **89.4**
Structural Grade: **0**
O&M Grade: **1**
Clock Start/From: **10**
Clock To:
1st Value:
2nd Value:
Value Percent:
Continuous Index:
Within 8" of Joint: **YES**
Remarks:

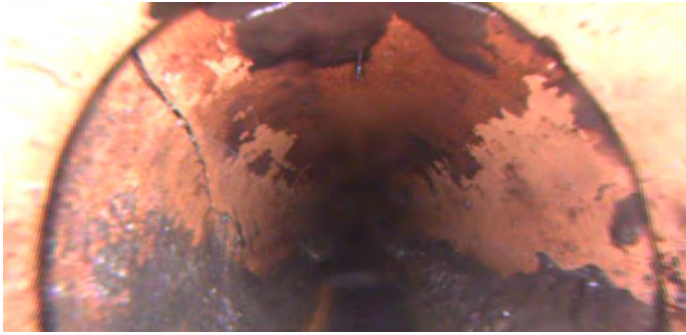
Code: **FS**
Description: **Fracture Spiral**

Distance (ft): **94.4**
Structural Grade: **3**
O&M Grade: **0**
Clock Start/From: **9**
Clock To: **11**
1st Value:
2nd Value:
Value Percent:
Continuous Index:
Within 8" of Joint: **YES**
Remarks:

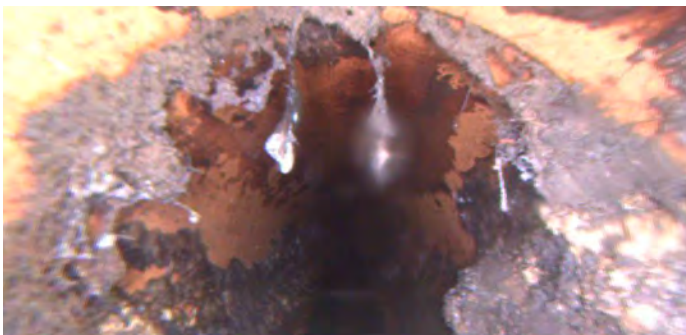
Code: **RFJ**
Description: **Roots Fine Joint**

Distance (ft): **99.7**
Structural Grade: **0**
O&M Grade: **1**
Clock Start/From: **7**
Clock To: **5**
1st Value:
2nd Value:
Value Percent:
Continuous Index:
Within 8" of Joint: **YES**
Remarks:

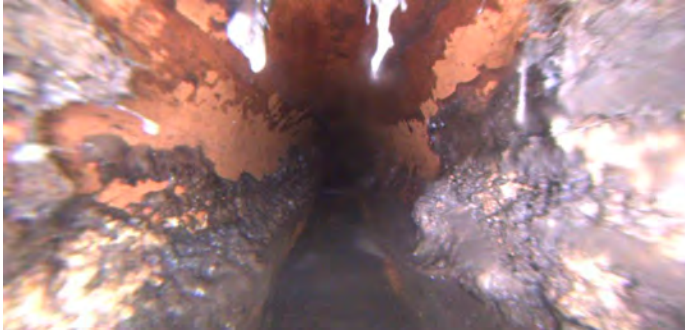
Code: **DAZ**
Description: **Deposits Attached Other**

Distance (ft): **99.9**
Structural Grade: **0**
O&M Grade: **3**
Clock Start/From: **8**
Clock To: **4**
1st Value:
2nd Value:
Value Percent: **15.000**
Continuous Index:
Within 8" of Joint: **YES**
Remarks:

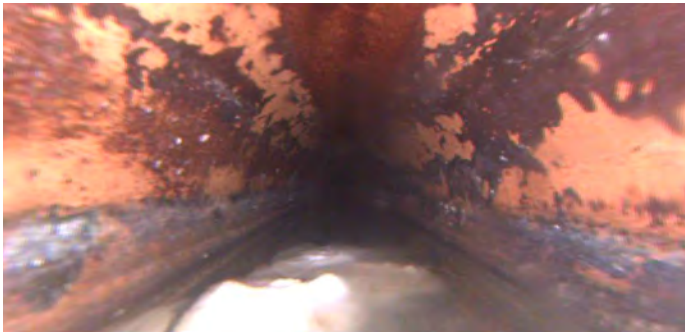
Code: **MGO**
Description: **General Observation**

Distance (ft): **133.8**
Structural Grade: **0**
O&M Grade: **0**
Clock Start/From:
Clock To:
1st Value:
2nd Value:
Value Percent:
Continuous Index:
Within 8" of Joint: **NO**
Remarks: **TOILET TISSUE**

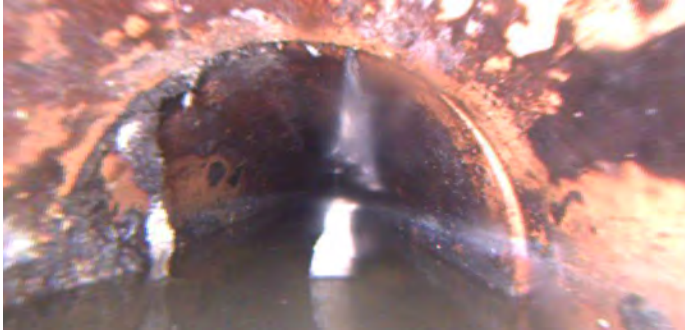
Code: **RFJ**
Description: **Roots Fine Joint**

Distance (ft): **146.5**
Structural Grade: **0**
O&M Grade: **1**
Clock Start/From: **7**
Clock To: **12**
1st Value:
2nd Value:
Value Percent:
Continuous Index:
Within 8" of Joint: **YES**
Remarks:

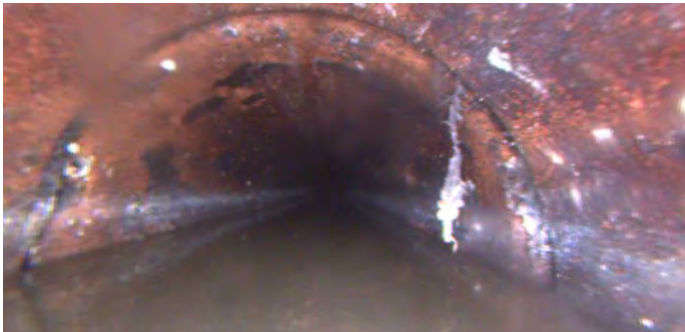
Code: **RFJ**
Description: **Roots Fine Joint**

Distance (ft): **151.8**
Structural Grade: **0**
O&M Grade: **1**
Clock Start/From: **7**
Clock To: **5**
1st Value:
2nd Value:
Value Percent:
Continuous Index:
Within 8" of Joint: **YES**
Remarks:

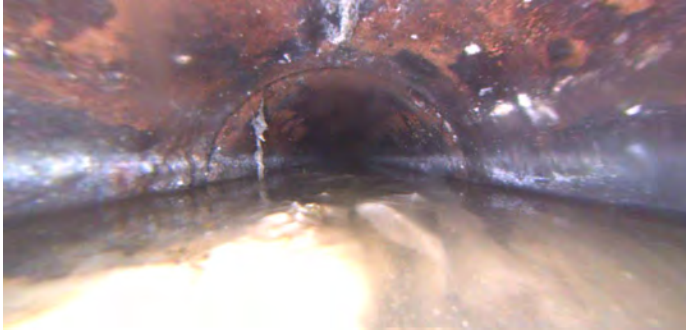
Code: **RFJ**
Description: **Roots Fine Joint**

Distance (ft): **162.3**
Structural Grade: **0**
O&M Grade: **1**
Clock Start/From: **10**
Clock To:
1st Value:
2nd Value:
Value Percent:
Continuous Index:
Within 8" of Joint: **YES**
Remarks:

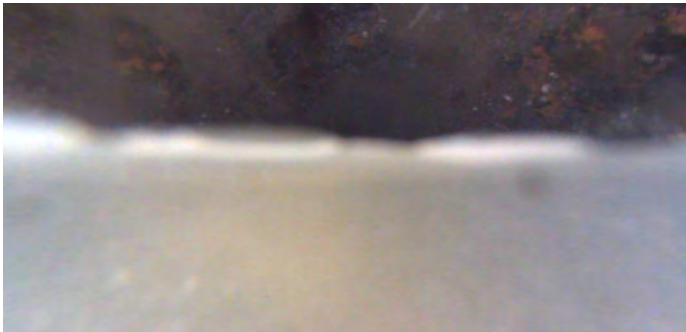
Code: **MWLS**
Description: **Water Level Sag**

Distance (ft): **170.2**
Structural Grade: **3**
O&M Grade: **3**
Clock Start/From:
Clock To:
1st Value:
2nd Value:
Value Percent: **50.000**
Continuous Index:
Within 8" of Joint: **NO**
Remarks:

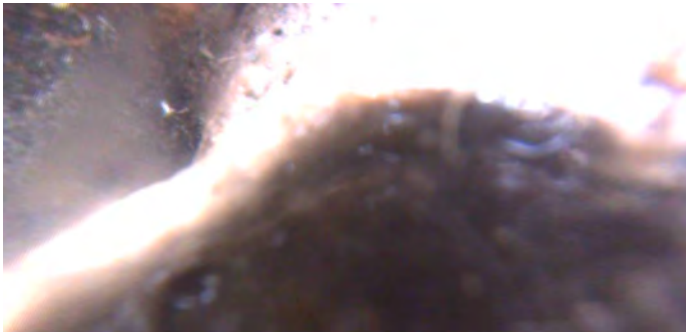
Code: **MSA**
Description: **Abandoned Survey**

Distance (ft): **173.8**
Structural Grade: **0**
O&M Grade: **0**
Clock Start/From:
Clock To:
1st Value:
2nd Value:
Value Percent:
Continuous Index:
Within 8" of Joint: **NO**
Remarks: **debris under water**

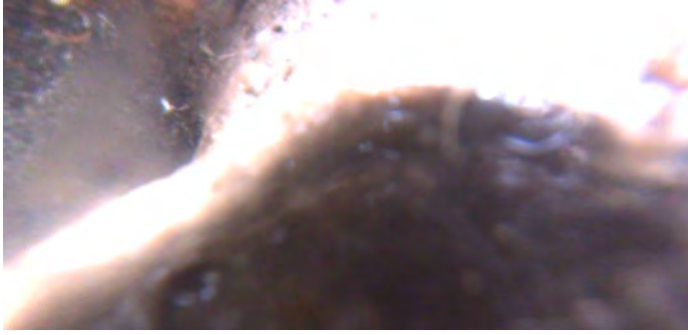
Code:	DAZ
Description:	Deposits Attached Other
Distance (ft):	173.8
Structural Grade:	0
O&M Grade:	2
Clock Start/From:	7
Clock To:	5
1st Value:	
2nd Value:	
Value Percent:	5.000
Continuous Index:	F01
Within 8" of Joint:	YES
Remarks:	WANDER
