## Profile/Photo Observation Report

Street:	<b>37th ave</b>	Flow Control:	<b>Not Controlled</b>
City:	<b>Hobart, IN</b>	Year Renewed:	
Location:	<b>Other</b>	Tape/Media #:	
Purpose:	<b>Not Known</b>	Dia/Height:	<b>10"</b>
Use:	<b>Sanitary</b>	Material:	<b>PVC</b>
Drain Area:	<b>NA</b>	Lining:	
Category:	<b>NA</b>		
Comment:

Location Details:		Direction of Survey:	<b>Upstream</b>
US MH:	<b>M-903-053</b>	DS MH:	<b>M-903-052</b>
		Total Length Surveyed (ft):	<b>173.8</b>

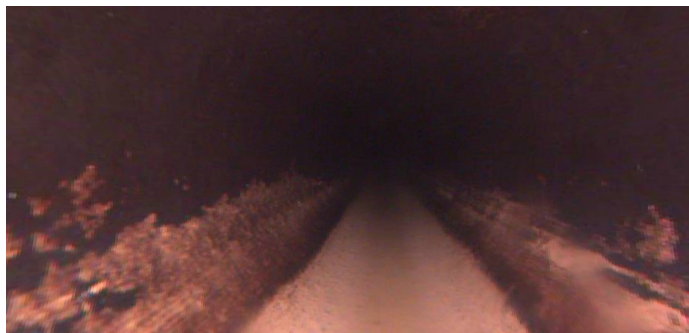
Code: **AMH**  
 Description: **Manhole**  
 Distance (ft): **.0**  
 Structural Grade: **0**  
 O&M Grade: **0**  
 Clock Start/From:  
 Clock To:  
 1st Value:  
 2nd Value:  
 Value Percent:  
 Continuous Index:  
 Within 8" of Joint: **NO**  
 Remarks: **M-903-052**

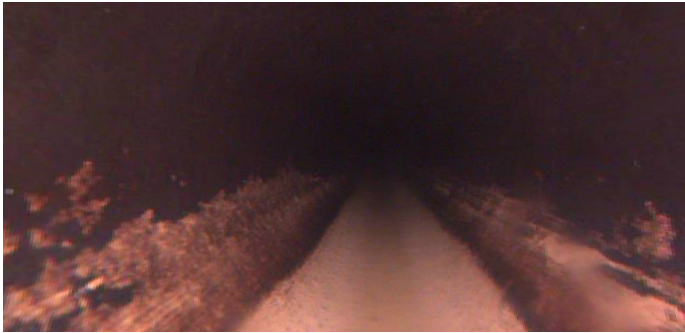
Code:	<b>MWL</b>
Description:	<b>Water Level</b>

Distance (ft):	<b>.0</b>
Structural Grade:	<b>0</b>
O&M Grade:	<b>0</b>
Clock Start/From:	
Clock To:	
1st Value:	
2nd Value:	
Value Percent:	<b>10.000</b>
Continuous Index:	
Within 8" of Joint:	<b>NO</b>
Remarks:

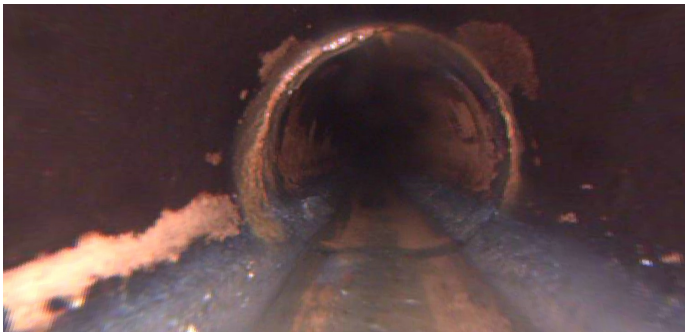
Code:	<b>DAZ</b>
Description:	<b>Deposits Attached Other</b>

Distance (ft):	<b>10.7</b>
Structural Grade:	<b>0</b>
O&M Grade:	<b>2</b>
Clock Start/From:	<b>7</b>
Clock To:	<b>5</b>
1st Value:	
2nd Value:	
Value Percent:	<b>5.000</b>
Continuous Index:	<b>S01</b>
Within 8" of Joint:	<b>YES</b>
Remarks:	<b>WANDER</b>

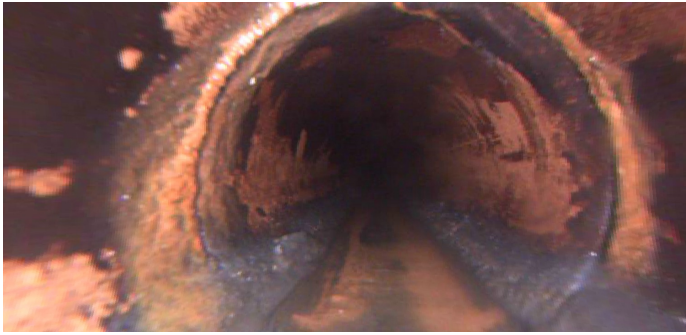
Code: **DAE**  
Description: **Deposits Attached Encrustation**

Distance (ft): **11.0**  
Structural Grade: **0**  
O&M Grade: **2**  
Clock Start/From: **7**  
Clock To: **5**  
1st Value:  
2nd Value:  
Value Percent: **5.000**  
Continuous Index:  
Within 8" of Joint: **YES**  
Remarks:

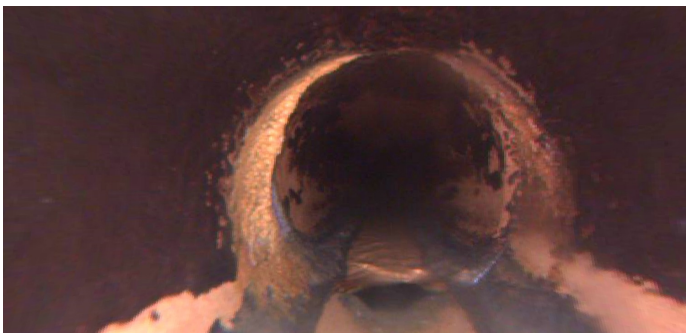
Code: **DAE**  
Description: **Deposits Attached Encrustation**

Distance (ft): **21.2**  
Structural Grade: **0**  
O&M Grade: **2**  
Clock Start/From: **7**  
Clock To: **12**  
1st Value:  
2nd Value:  
Value Percent: **5.000**  
Continuous Index:  
Within 8" of Joint: **YES**  
Remarks:

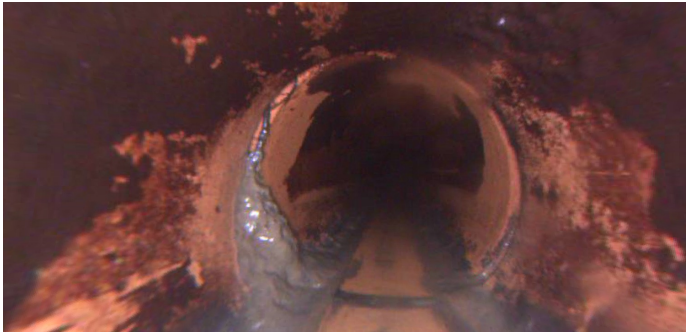
Code: **RFJ**  
Description: **Roots Fine Joint**

Distance (ft): **57.6**  
Structural Grade: **0**  
O&M Grade: **1**  
Clock Start/From: **9**  
Clock To: **10**  
1st Value:  
2nd Value:  
Value Percent:  
Continuous Index:  
Within 8" of Joint: **YES**  
Remarks:

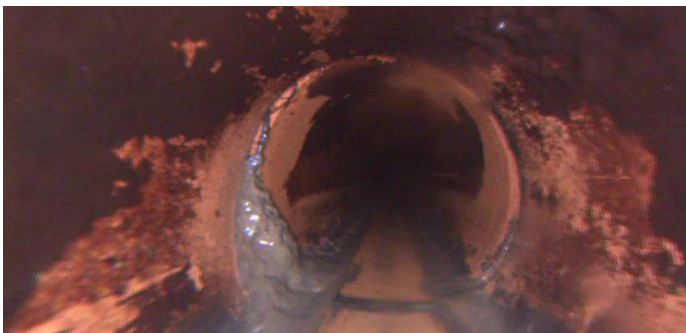
Code: **DAE**  
Description: **Deposits Attached Encrustation**

Distance (ft): **57.6**  
Structural Grade: **0**  
O&M Grade: **2**  
Clock Start/From: **7**  
Clock To: **10**  
1st Value:  
2nd Value:  
Value Percent: **5.000**  
Continuous Index:  
Within 8" of Joint: **YES**  
Remarks:

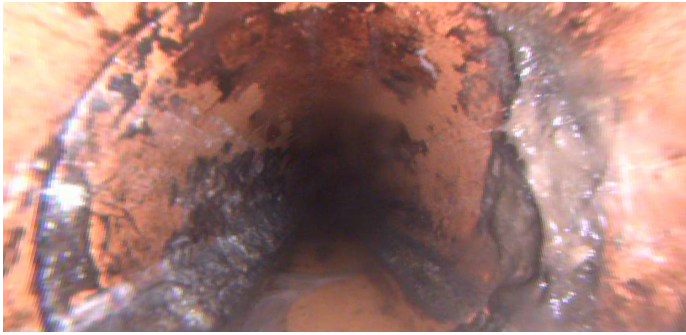
Code: **DAE**  
Description: **Deposits Attached Encrustation**

Distance (ft): **84.0**  
Structural Grade: **0**  
O&M Grade: **2**  
Clock Start/From: **1**  
Clock To: **5**  
1st Value:  
2nd Value:  
Value Percent: **5.000**  
Continuous Index:  
Within 8" of Joint: **YES**  
Remarks:

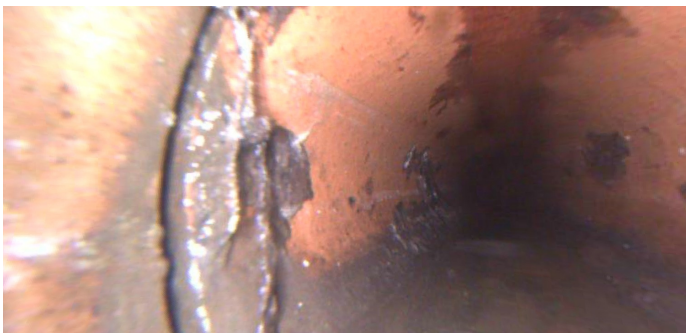
Code: **RFJ**  
Description: **Roots Fine Joint**

Distance (ft): **89.4**  
Structural Grade: **0**  
O&M Grade: **1**  
Clock Start/From: **10**  
Clock To:  
1st Value:  
2nd Value:  
Value Percent:  
Continuous Index:  
Within 8" of Joint: **YES**  
Remarks:

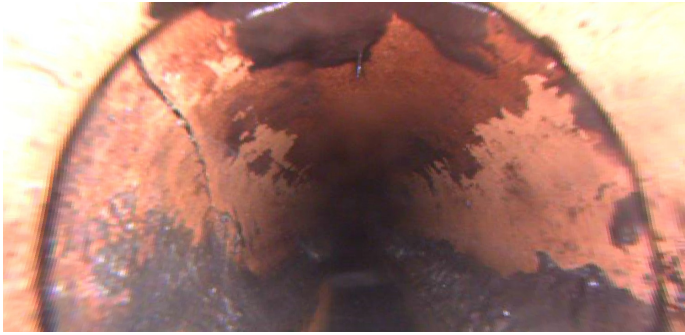
Code: **FS**  
Description: **Fracture Spiral**

Distance (ft): **94.4**  
Structural Grade: **3**  
O&M Grade: **0**  
Clock Start/From: **9**  
Clock To: **11**  
1st Value:  
2nd Value:  
Value Percent:  
Continuous Index:  
Within 8" of Joint: **YES**  
Remarks:

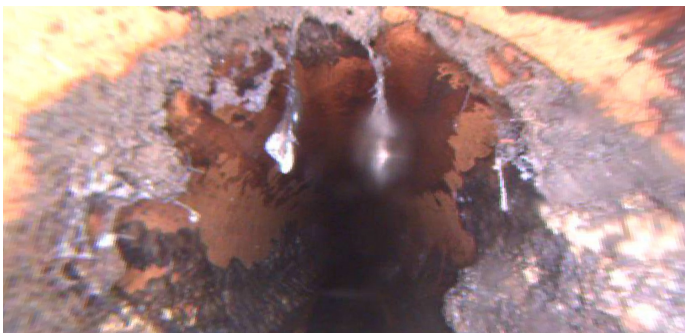
Code: **RFJ**  
Description: **Roots Fine Joint**

Distance (ft): **99.7**  
Structural Grade: **0**  
O&M Grade: **1**  
Clock Start/From: **7**  
Clock To: **5**  
1st Value:  
2nd Value:  
Value Percent:  
Continuous Index:  
Within 8" of Joint: **YES**  
Remarks:

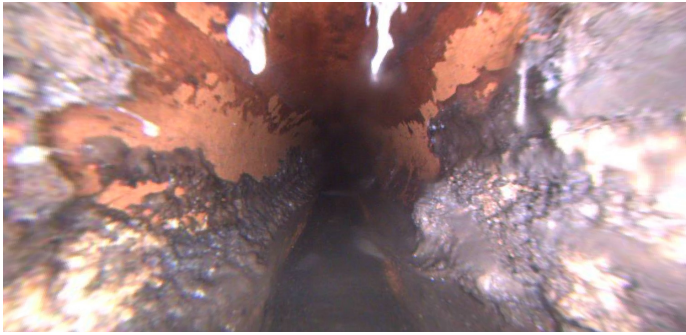
Code: **DAZ**  
Description: **Deposits Attached Other**

Distance (ft): **99.9**  
Structural Grade: **0**  
O&M Grade: **3**  
Clock Start/From: **8**  
Clock To: **4**  
1st Value:  
2nd Value:  
Value Percent: **15.000**  
Continuous Index:  
Within 8" of Joint: **YES**  
Remarks:

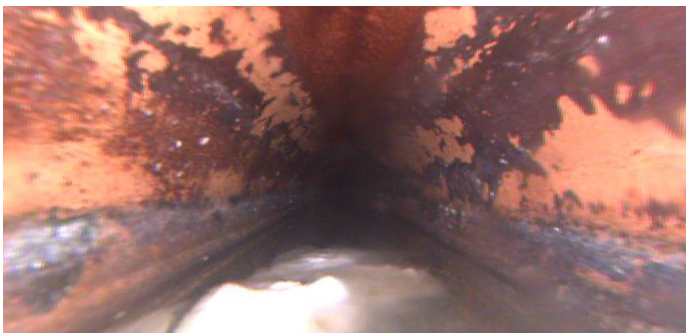
Code: **MGO**  
Description: **General Observation**

Distance (ft): **133.8**  
Structural Grade: **0**  
O&M Grade: **0**  
Clock Start/From:  
Clock To:  
1st Value:  
2nd Value:  
Value Percent:  
Continuous Index:  
Within 8" of Joint: **NO**  
Remarks: **TOILET TISSUE**

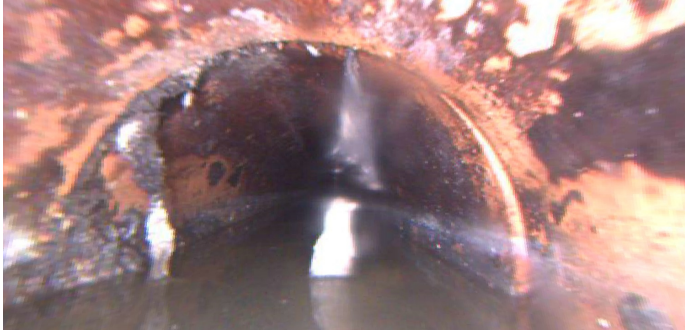
Code: **RFJ**  
Description: **Roots Fine Joint**

Distance (ft): **146.5**  
Structural Grade: **0**  
O&M Grade: **1**  
Clock Start/From: **7**  
Clock To: **12**  
1st Value:  
2nd Value:  
Value Percent:  
Continuous Index:  
Within 8" of Joint: **YES**  
Remarks:

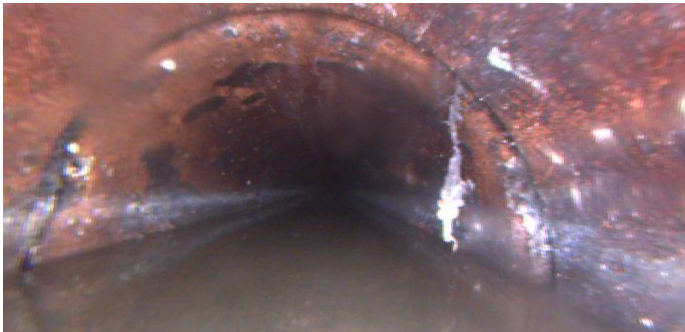
Code: **RFJ**  
Description: **Roots Fine Joint**

Distance (ft): **151.8**  
Structural Grade: **0**  
O&M Grade: **1**  
Clock Start/From: **7**  
Clock To: **5**  
1st Value:  
2nd Value:  
Value Percent:  
Continuous Index:  
Within 8" of Joint: **YES**  
Remarks:

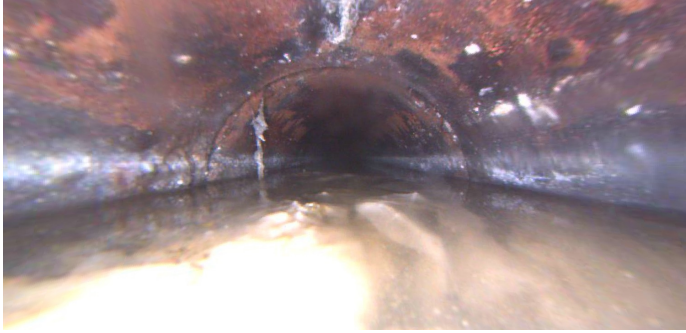
Code: **RFJ**  
Description: **Roots Fine Joint**

Distance (ft): **162.3**  
Structural Grade: **0**  
O&M Grade: **1**  
Clock Start/From: **10**  
Clock To:  
1st Value:  
2nd Value:  
Value Percent:  
Continuous Index:  
Within 8" of Joint: **YES**  
Remarks:

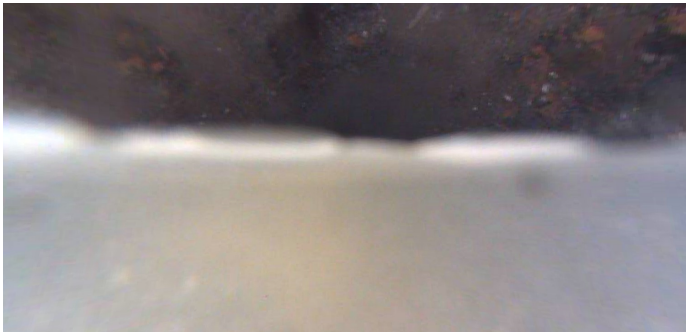
Code: **MWLS**  
Description: **Water Level Sag**

Distance (ft): **170.2**  
Structural Grade: **3**  
O&M Grade: **3**  
Clock Start/From:  
Clock To:  
1st Value:  
2nd Value:  
Value Percent: **50.000**  
Continuous Index:  
Within 8" of Joint: **NO**  
Remarks:

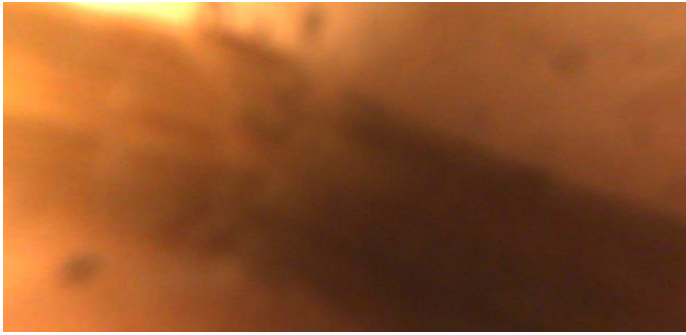
Code: **MCU**  
Description: **Camera Underwater**

Distance (ft): **171.8**  
Structural Grade: **0**  
O&M Grade: **4**  
Clock Start/From:  
Clock To:  
1st Value:  
2nd Value:  
Value Percent:  
Continuous Index:  
Within 8" of Joint: **NO**  
Remarks:

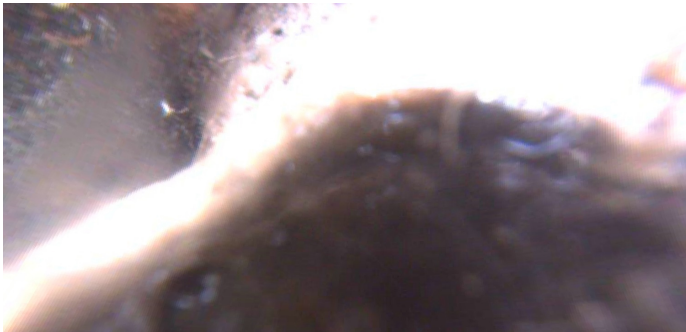
Code: **MSA**  
Description: **Abandoned Survey**

Distance (ft): **173.8**  
Structural Grade: **0**  
O&M Grade: **0**  
Clock Start/From:  
Clock To:  
1st Value:  
2nd Value:  
Value Percent:  
Continuous Index:  
Within 8" of Joint: **NO**  
Remarks: **debris under water**

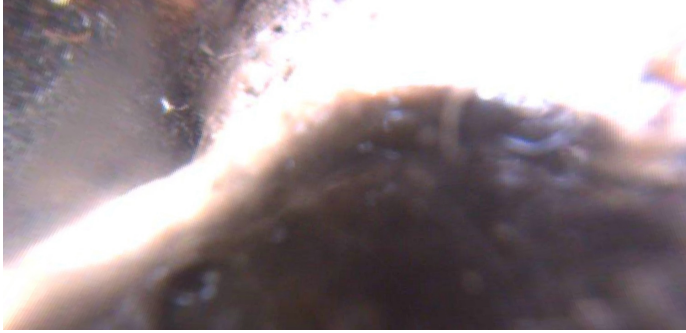
Code:	<b>DAZ</b>
Description:	<b>Deposits Attached Other</b>
Distance (ft):	<b>173.8</b>
Structural Grade:	<b>0</b>
O&M Grade:	<b>2</b>
Clock Start/From:	<b>7</b>
Clock To:	<b>5</b>
1st Value:	
2nd Value:	
Value Percent:	<b>5.000</b>
Continuous Index:	<b>F01</b>
Within 8" of Joint:	<b>YES</b>
Remarks:	<b>WANDER</b>
