Profile/Photo Observation Report

Date:	03/20/2018	Weather:		Coding:	PACP 6.0
Pipe Length (ft):	135.0	Owner:	NA	Pre Clean:	Not Known
P.O.#:		Surveyor:	Justin Gonzales	PSR:	P-903-054-038
Customer:		Clean Date:	01/01/1900	Shape:	C

Street:	OFF E 38TH PL	Flow Control:	Not Controlled
City:	Hobart, IN	Year Renewed:	
Location:	Other	Tape/Media #:	
Purpose:	Not Known	Dia/Height:	10"
Use:	Sanitary	Material:	VCP
Drain Area:	NA	Lining:	
Category:	NA		
Comment:

Location Details:		Direction of Survey:	Upstream
US MH:	M-903-054	DS MH:	M-903-038
		Total Length Surveyed (ft):	130.9

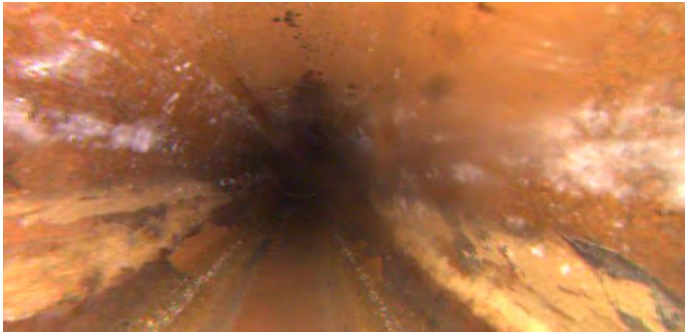
Code:	MWL
Description:	Water Level

Distance (ft):	.0
Structural Grade:	0
O&M Grade:	0
Clock Start/From:	
Clock To:	
1st Value:	
2nd Value:	
Value Percent:	5.000
Continuous Index:	
Within 8" of Joint:	NO
Remarks:

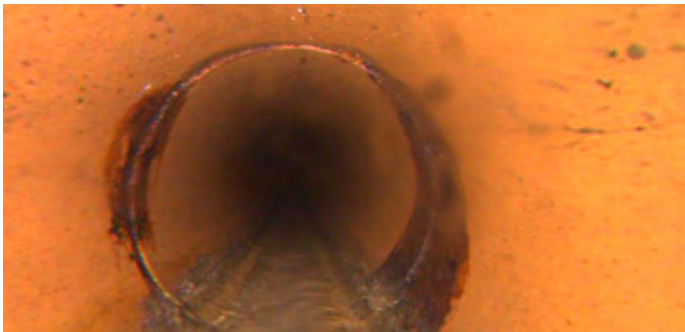
Code:	IS
Description:	Infil Stain

Distance (ft):	28.9
Structural Grade:	0
O&M Grade:	0
Clock Start/From:	9
Clock To:	5
1st Value:	
2nd Value:	
Value Percent:	
Continuous Index:	
Within 8" of Joint:	YES
Remarks:

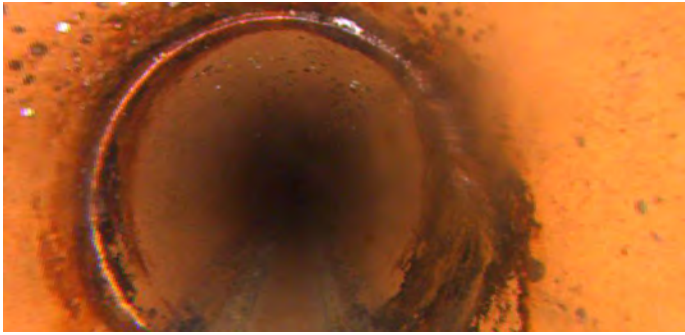
Code: **IS**
Description: **Infil Stain**

Distance (ft): **34.0**
Structural Grade: **0**
O&M Grade: **0**
Clock Start/From: **7**
Clock To: **5**
1st Value:
2nd Value:
Value Percent:
Continuous Index:
Within 8" of Joint: **YES**
Remarks:

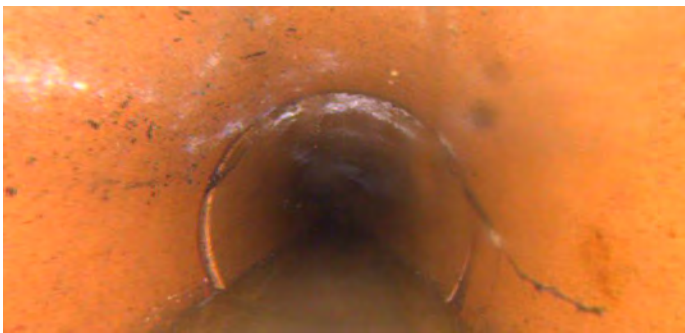
Code: **RFJ**
Description: **Roots Fine Joint**

Distance (ft): **118.6**
Structural Grade: **0**
O&M Grade: **1**
Clock Start/From: **9**
Clock To: **3**
1st Value:
2nd Value:
Value Percent:
Continuous Index:
Within 8" of Joint: **YES**
Remarks:

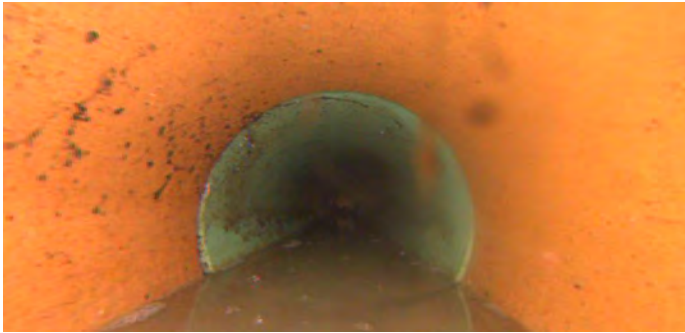
Code: **RPR**
Description: **Repair Point Pipe Replaced**

Distance (ft): **122.8**
Structural Grade: **0**
O&M Grade: **0**
Clock Start/From:
Clock To:
1st Value:
2nd Value:
Value Percent:
Continuous Index:
Within 8" of Joint: **NO**
Remarks: **VCP TO PVC**

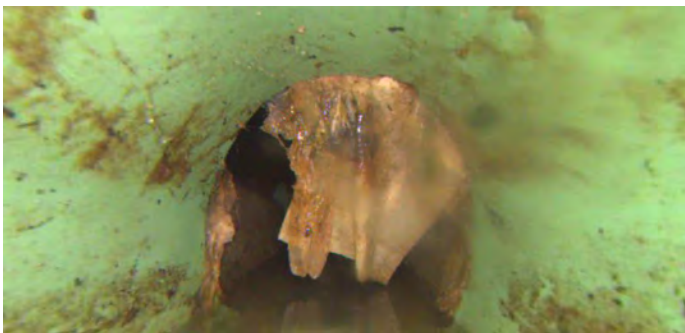
Code: **DAR**
Description: **Deposits Attached Ragging**

Distance (ft): **128.1**
Structural Grade: **0**
O&M Grade: **5**
Clock Start/From: **8**
Clock To: **4**
1st Value:
2nd Value:
Value Percent: **80.000**
Continuous Index:
Within 8" of Joint: **NO**
Remarks: **in MH**

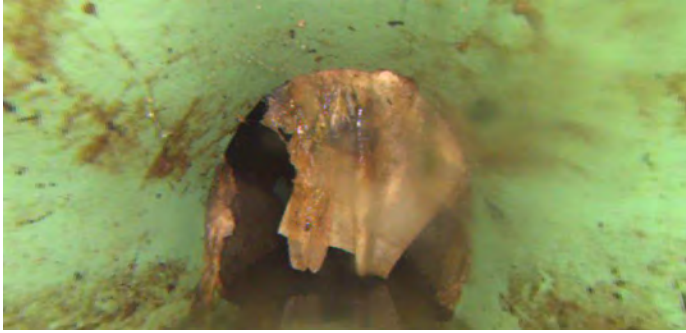
Code: **MGO**
Description: **General Observation**

Distance (ft): **128.1**
Structural Grade: **0**
O&M Grade: **0**
Clock Start/From:
Clock To:
1st Value:
2nd Value:
Value Percent:
Continuous Index:
Within 8" of Joint: **NO**
Remarks: **PAPER/ TOILET TISSUE HANGING
FROM END OF MANHOLE SEGMENT**
