Profile/Photo Observation Report

Street:	37th ave	Flow Control:	Not Controlled
City:	Hobart, IN	Year Renewed:	
Location:	Other	Tape/Media #:	
Purpose:	Not Known	Dia/Height:	10"
Use:	Sanitary	Material:	VCP
Drain Area:	NA	Lining:	
Category:	NA		
Comment:

Location Details:		Direction of Survey:	Upstream
US MH:	M-903-054	DS MH:	M-903-038
		Total Length Surveyed (ft):	130.9

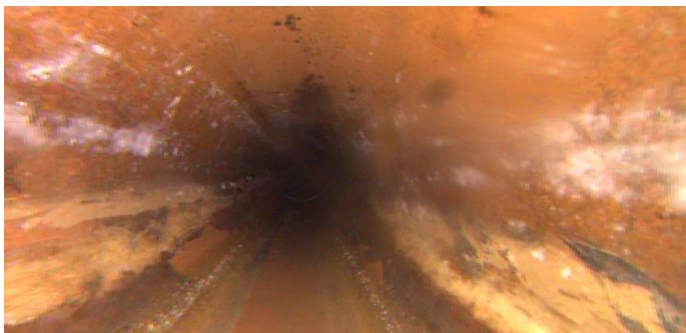
Code: **AMH**
Description: **Manhole**

Distance (ft): **.0**
Structural Grade: **0**
O&M Grade: **0**
Clock Start/From:
Clock To:
1st Value:
2nd Value:
Value Percent:
Continuous Index:
Within 8" of Joint: **NO**
Remarks: **M-903-038**

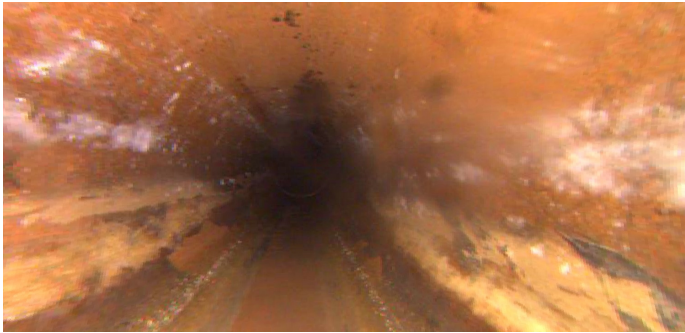
Code:	MWL
Description:	Water Level

Distance (ft):	.0
Structural Grade:	0
O&M Grade:	0
Clock Start/From:	
Clock To:	
1st Value:	
2nd Value:	
Value Percent:	5.000
Continuous Index:	
Within 8" of Joint:	NO
Remarks:

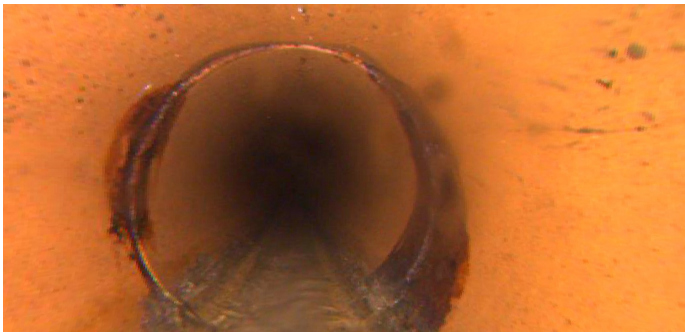
Code:	IS
Description:	Infil Stain

Distance (ft):	28.9
Structural Grade:	0
O&M Grade:	0
Clock Start/From:	9
Clock To:	5
1st Value:	
2nd Value:	
Value Percent:	
Continuous Index:	
Within 8" of Joint:	YES
Remarks:

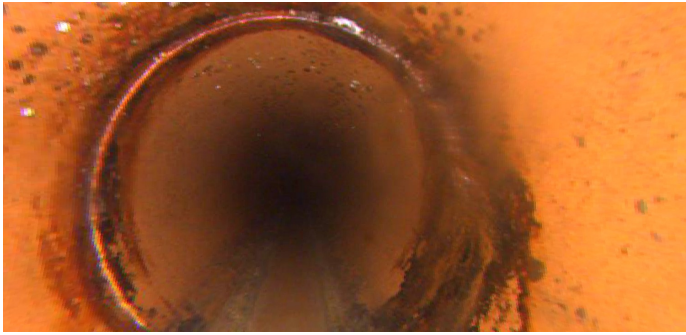
Code: **IS**
Description: **Infil Stain**

Distance (ft): **34.0**
Structural Grade: **0**
O&M Grade: **0**
Clock Start/From: **7**
Clock To: **5**
1st Value:
2nd Value:
Value Percent:
Continuous Index:
Within 8" of Joint: **YES**
Remarks:

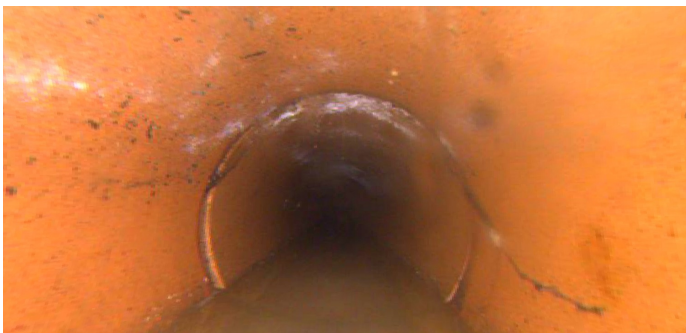
Code: **RFJ**
Description: **Roots Fine Joint**

Distance (ft): **118.6**
Structural Grade: **0**
O&M Grade: **1**
Clock Start/From: **9**
Clock To: **3**
1st Value:
2nd Value:
Value Percent:
Continuous Index:
Within 8" of Joint: **YES**
Remarks:

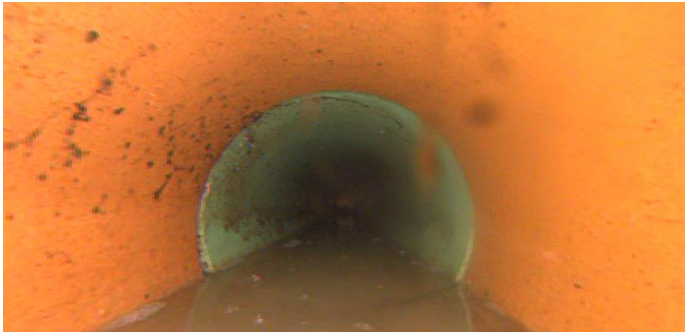
Code: **RPR**
Description: **Repair Point Pipe Replaced**

Distance (ft): **122.8**
Structural Grade: **0**
O&M Grade: **0**
Clock Start/From:
Clock To:
1st Value:
2nd Value:
Value Percent:
Continuous Index:
Within 8" of Joint: **NO**
Remarks: **VCP TO PVC**

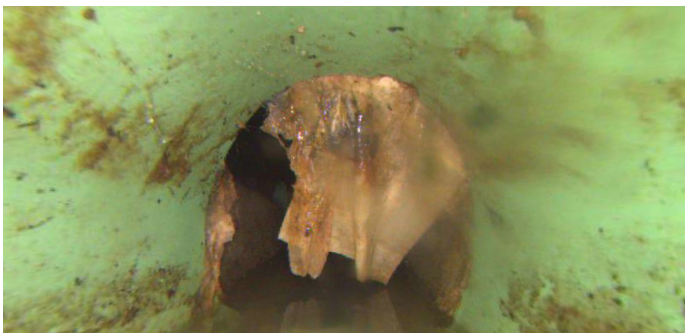
Code: **DAR**
Description: **Deposits Attached Ragging**

Distance (ft): **128.1**
Structural Grade: **0**
O&M Grade: **5**
Clock Start/From: **8**
Clock To: **4**
1st Value:
2nd Value:
Value Percent: **80.000**
Continuous Index:
Within 8" of Joint: **NO**
Remarks: **in MH**

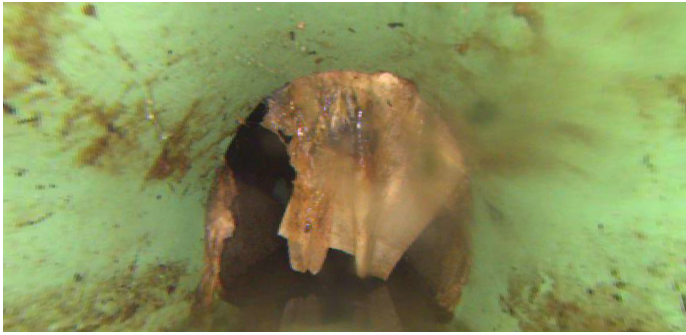
Code: **MGO**
Description: **General Observation**

Distance (ft): **128.1**
Structural Grade: **0**
O&M Grade: **0**
Clock Start/From:
Clock To:
1st Value:
2nd Value:
Value Percent:
Continuous Index:
Within 8" of Joint: **NO**
Remarks: **PAPER/ TOILET TISSUE HANGING
FROM END OF MANHOLE SEGMENT**
