Profile/Photo Observation Report

| Street: | 37th ave | Flow Control: | Not Controlled |
| City: | Hobart, IN | Year Renewed: | |

| US MH: | M-903-055 | DS MH: | M-903-056 |

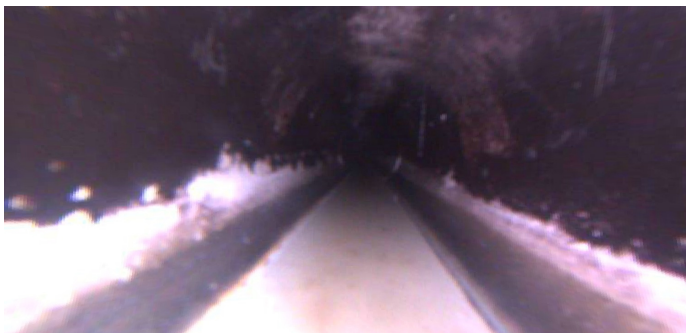
Code: **AMH**
Description: **Manhole**

Distance (ft): **.0**
Structural Grade: **0**
O&M Grade: **0**
Clock Start/From:
Clock To:
1st Value:
2nd Value:
Value Percent:
Continuous Index:
Within 8" of Joint: **NO**
Remarks: **M-903-056**

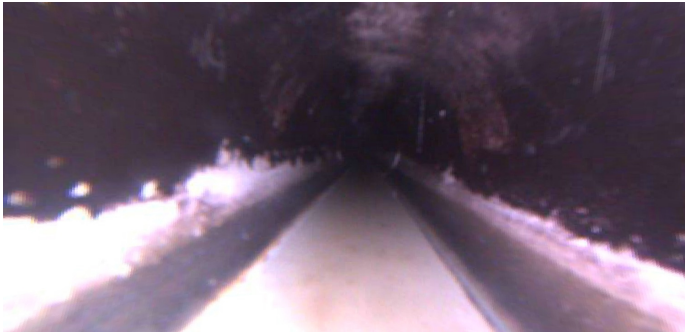
| Code: | MWL |
| Description: | Water Level |

| Value Percent: | 5.000 |

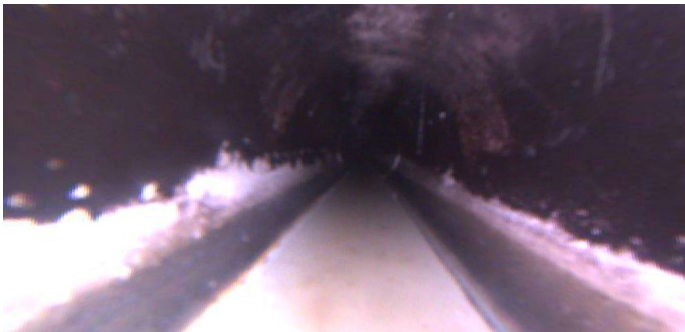
| Code: | DAZ |
| Description: | Deposits Attached Other |

| Distance (ft): | .0 |
| O&M Grade: | 2 |
| Clock Start/From: | 7 |
| Clock To: | 5 |
| Continuous Index: | S01 |
| Within 8" of Joint: | YES |
| Remarks: | WANDER |

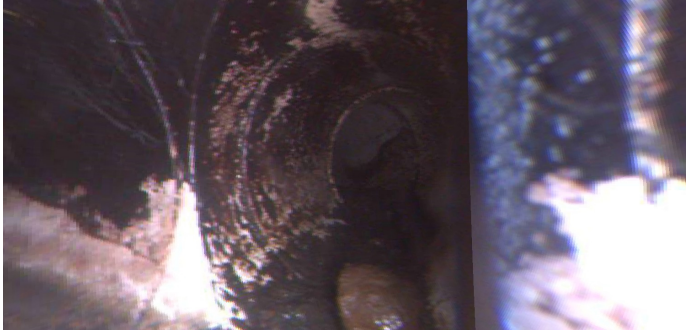
Code: **TF**
Description: **Tap Factory**

Distance (ft): **3.3**
Structural Grade: **0**
O&M Grade: **0**
Clock Start/From: **9**
Clock To:
1st Value: **4.000**
2nd Value:
Value Percent:
Continuous Index:
Within 8" of Joint:
Remarks:

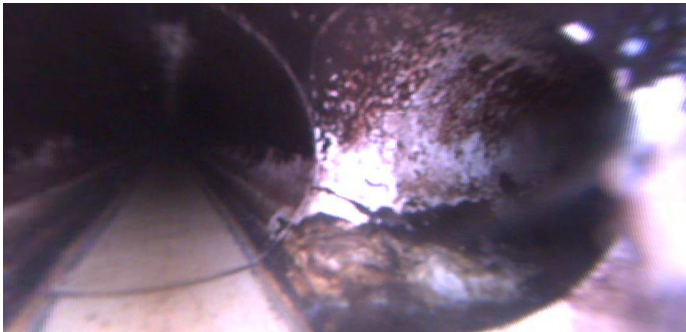
Code: **TF**
Description: **Tap Factory**

Distance (ft): **26.9**
Structural Grade: **0**
O&M Grade: **0**
Clock Start/From: **3**
Clock To:
1st Value: **4.000**
2nd Value:
Value Percent:
Continuous Index:
Within 8" of Joint:
Remarks:

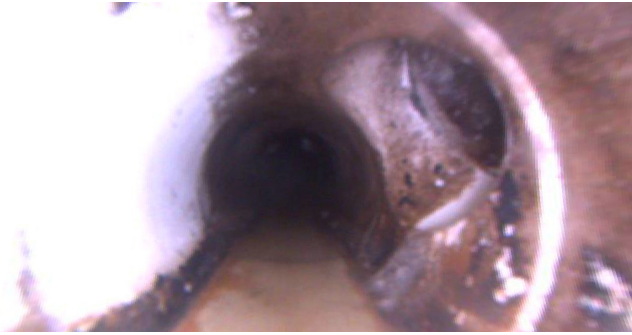
Code: **TF**
Description: **Tap Factory**

Distance (ft): **104.7**
Structural Grade: **0**
O&M Grade: **0**
Clock Start/From: **2**
Clock To:
1st Value: **4.000**
2nd Value:
Value Percent:
Continuous Index:
Within 8" of Joint:
Remarks:

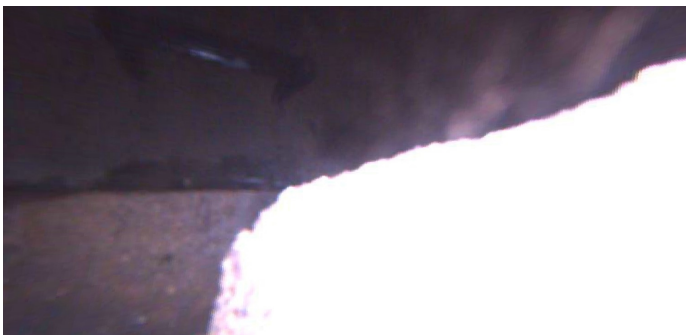
Code: **AMH**
Description: **Manhole**

Distance (ft): **138.6**
Structural Grade: **0**
O&M Grade: **0**
Clock Start/From:
Clock To:
1st Value:
2nd Value:
Value Percent:
Continuous Index:
Within 8" of Joint: **NO**
Remarks: **M-903-055**

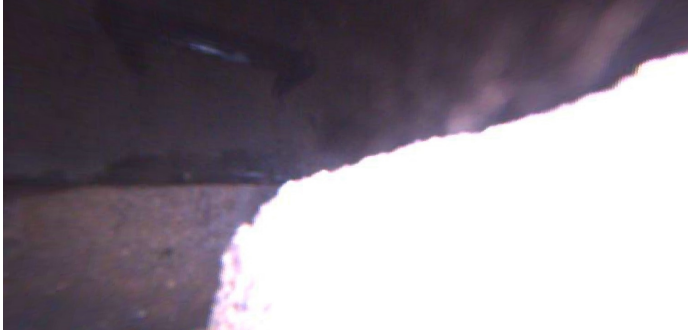
| Code: | DAZ |
| Description: | Deposits Attached Other |
| Distance (ft): | 138.6 |
| O&M Grade: | 2 |
| Clock Start/From: | 7 |
| Clock To: | 5 |
| Continuous Index: | F01 |
| Within 8" of Joint: | YES |
| Remarks: | WANDER |
