Profile/Photo Observation Report

Street:	37th ave	Flow Control:	Not Controlled
City:	Hobart, IN	Year Renewed:	
Location:	Other	Tape/Media #:	
Purpose:	Not Known	Dia/Height:	10"
Use:	Sanitary	Material:	PVC
Drain Area:	NA	Lining:	
Category:	NA		
Comment:

Location Details:		Direction of Survey:	Downstream
US MH:	M-903-056	DS MH:	M-903-057
		Total Length Surveyed (ft):	251.8

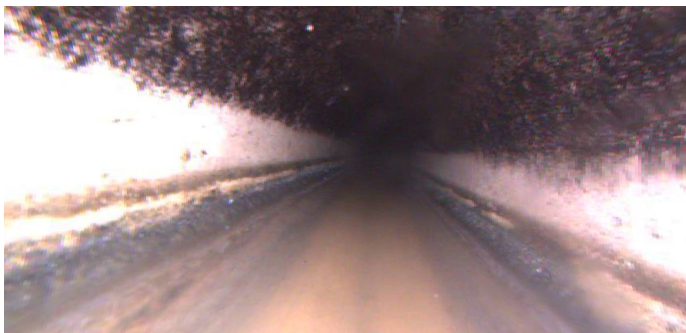
Code: **AMH**
Description: **Manhole**

Distance (ft): **.0**
Structural Grade: **0**
O&M Grade: **0**
Clock Start/From:
Clock To:
1st Value:
2nd Value:
Value Percent:
Continuous Index:
Within 8" of Joint: **NO**
Remarks: **M-903-056**

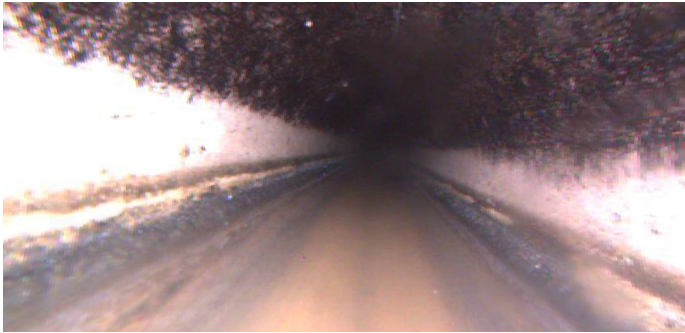
Code:	MWL
Description:	Water Level

Distance (ft):	.0
Structural Grade:	0
O&M Grade:	0
Clock Start/From:	
Clock To:	
1st Value:	
2nd Value:	
Value Percent:	10.000
Continuous Index:	
Within 8" of Joint:	NO
Remarks:

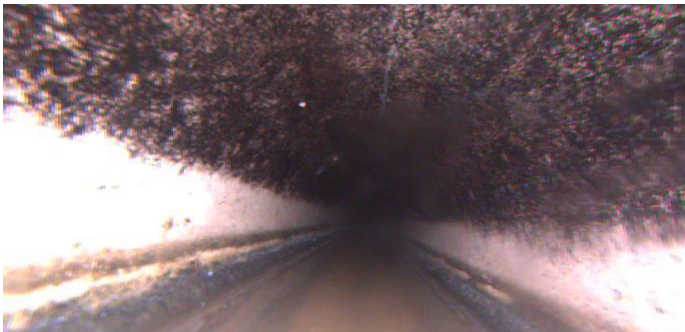
Code:	DAZ
Description:	Deposits Attached Other

Distance (ft):	.0
Structural Grade:	0
O&M Grade:	2
Clock Start/From:	7
Clock To:	5
1st Value:	
2nd Value:	
Value Percent:	5.000
Continuous Index:	S01
Within 8" of Joint:	YES
Remarks:	WANDER

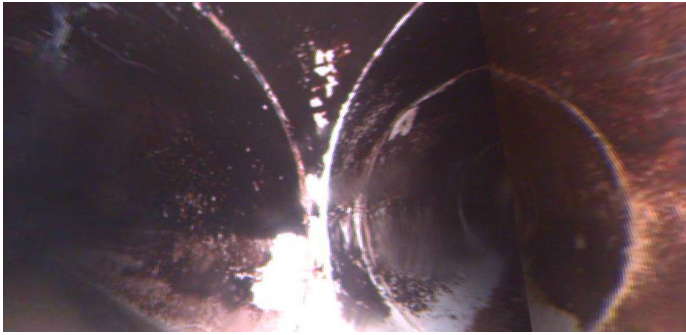
Code: **TF**
Description: **Tap Factory**

Distance (ft): **17.4**
Structural Grade: **0**
O&M Grade: **0**
Clock Start/From: **3**
Clock To:
1st Value: **4.000**
2nd Value:
Value Percent:
Continuous Index:
Within 8" of Joint:
Remarks:

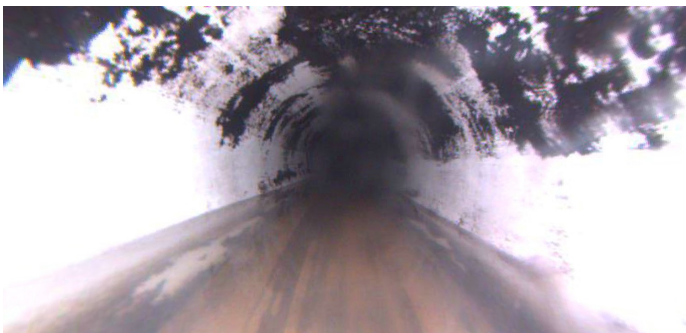
Code: **MWL**
Description: **Water Level**

Distance (ft): **84.5**
Structural Grade: **0**
O&M Grade: **0**
Clock Start/From:
Clock To:
1st Value:
2nd Value:
Value Percent: **20.000**
Continuous Index:
Within 8" of Joint: **NO**
Remarks:

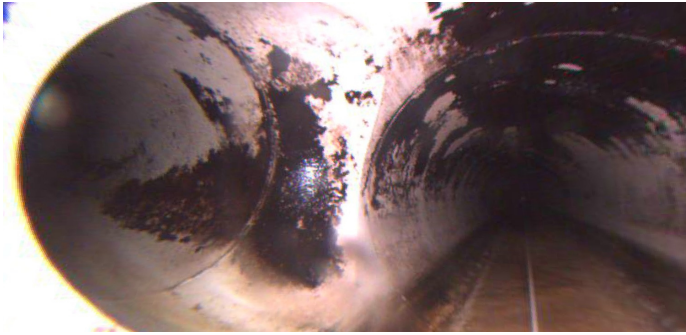
Code: **TF**
Description: **Tap Factory**

Distance (ft): **127.9**
Structural Grade: **0**
O&M Grade: **0**
Clock Start/From: **3**
Clock To:
1st Value: **4.000**
2nd Value:
Value Percent:
Continuous Index:
Within 8" of Joint:
Remarks:

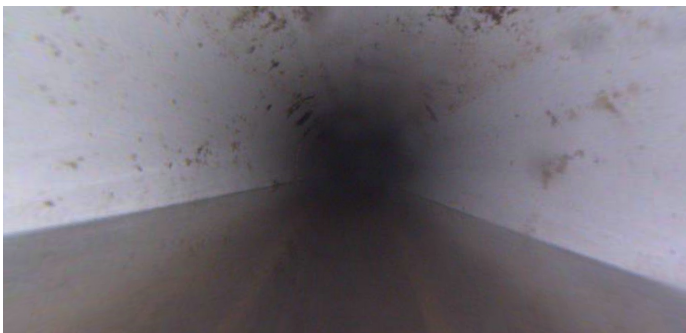
Code: **MWL**
Description: **Water Level**

Distance (ft): **165.5**
Structural Grade: **0**
O&M Grade: **0**
Clock Start/From:
Clock To:
1st Value:
2nd Value:
Value Percent: **30.000**
Continuous Index:
Within 8" of Joint: **NO**
Remarks:

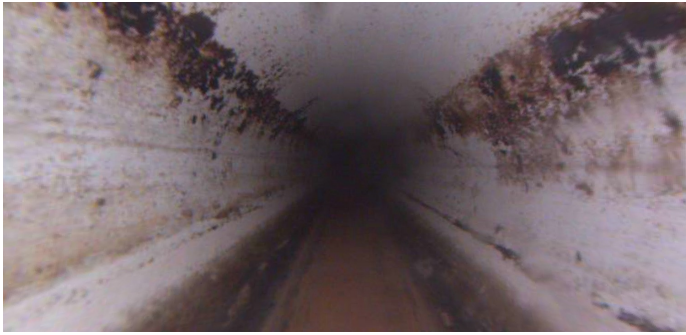
Code: **MWL**
Description: **Water Level**

Distance (ft): **182.8**
Structural Grade: **0**
O&M Grade: **0**
Clock Start/From:
Clock To:
1st Value:
2nd Value:
Value Percent: **5.000**
Continuous Index:
Within 8" of Joint: **NO**
Remarks:

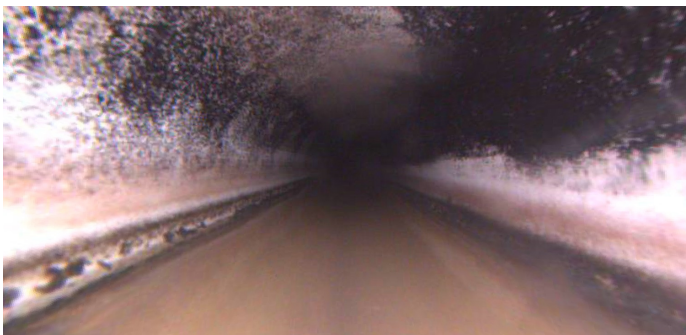
Code: **MWL**
Description: **Water Level**

Distance (ft): **209.5**
Structural Grade: **0**
O&M Grade: **0**
Clock Start/From:
Clock To:
1st Value:
2nd Value:
Value Percent: **30.000**
Continuous Index:
Within 8" of Joint: **NO**
Remarks:

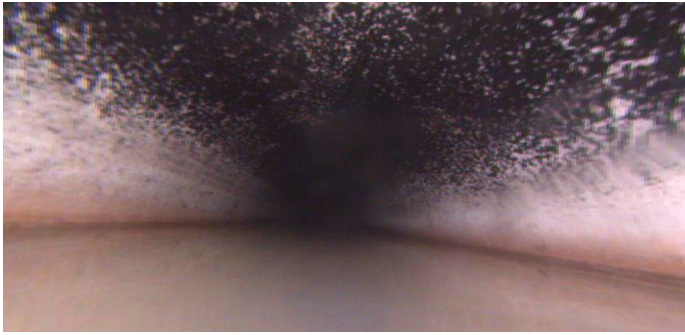
Code: **MWLS**
Description: **Water Level Sag**

Distance (ft): **234.6**
Structural Grade: **2**
O&M Grade: **3**
Clock Start/From:
Clock To:
1st Value:
2nd Value:
Value Percent: **25.000**
Continuous Index:
Within 8" of Joint: **NO**
Remarks:

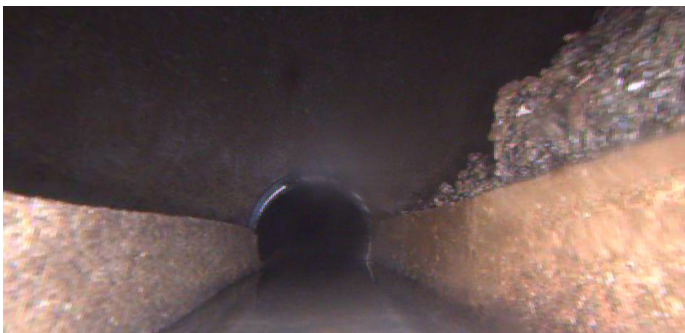
Code: **AMH**
Description: **Manhole**

Distance (ft): **251.8**
Structural Grade: **0**
O&M Grade: **0**
Clock Start/From:
Clock To:
1st Value:
2nd Value:
Value Percent:
Continuous Index:
Within 8" of Joint: **NO**
Remarks: **M-903-057**

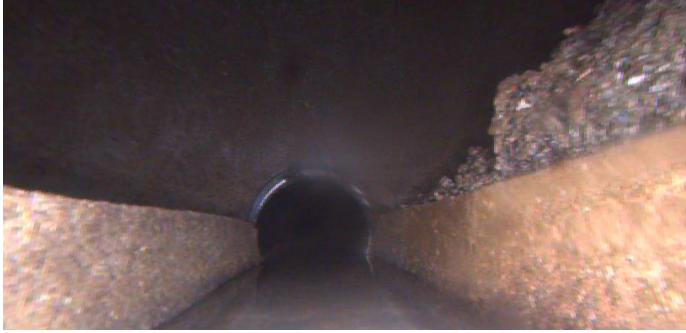
Code:	DAZ
Description:	Deposits Attached Other
Distance (ft):	251.8
Structural Grade:	0
O&M Grade:	2
Clock Start/From:	7
Clock To:	5
1st Value:	
2nd Value:	
Value Percent:	5.000
Continuous Index:	F01
Within 8" of Joint:	YES
Remarks:	WANDER
