Profile/Photo Observation Report

Street:	37th ave	Flow Control:	Not Controlled
City:	Hobart, IN	Year Renewed:	
Location:	Other	Tape/Media #:	
Purpose:	Not Known	Dia/Height:	10"
Use:	Sanitary	Material:	PVC
Drain Area:	NA	Lining:	
Category:	NA		
Comment:	null m-802-002 surcharged highwater

Location Details:		Direction of Survey:	Downstream
US MH:	M-903-059	DS MH:	M-903-039
		Total Length Surveyed (ft):	288.9

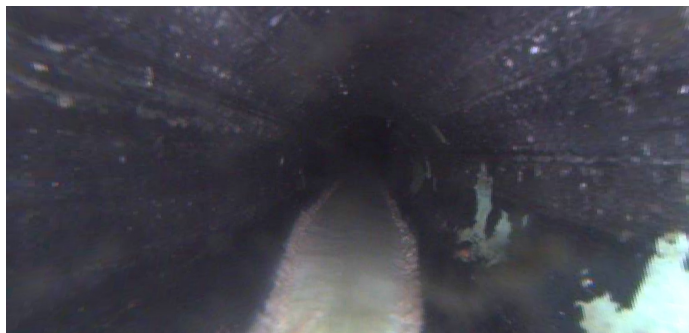
Code: **AMH**
 Description: **Manhole**

Distance (ft): **.0**
 Structural Grade: **0**
 O&M Grade: **0**
 Clock Start/From:
 Clock To:
 1st Value:
 2nd Value:
 Value Percent:
 Continuous Index:
 Within 8" of Joint: **NO**
 Remarks: **M-903-059**

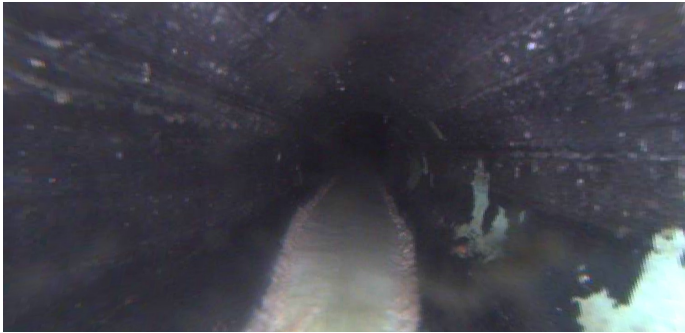
Code:	MWL
Description:	Water Level

Distance (ft):	.0
Structural Grade:	0
O&M Grade:	0
Clock Start/From:	
Clock To:	
1st Value:	
2nd Value:	
Value Percent:	5.000
Continuous Index:	
Within 8" of Joint:	NO
Remarks:

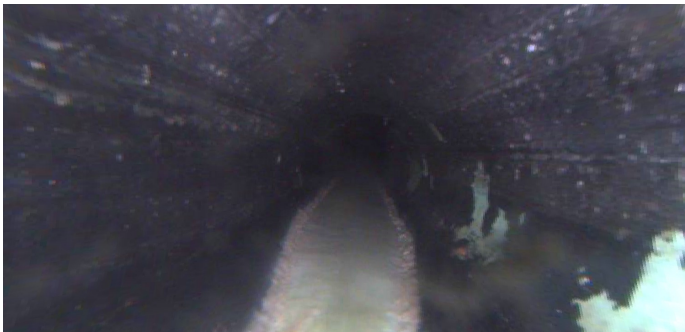
Code:	DAZ
Description:	Deposits Attached Other

Distance (ft):	.0
Structural Grade:	0
O&M Grade:	2
Clock Start/From:	7
Clock To:	5
1st Value:	
2nd Value:	
Value Percent:	5.000
Continuous Index:	S01
Within 8" of Joint:	YES
Remarks:	WANDER

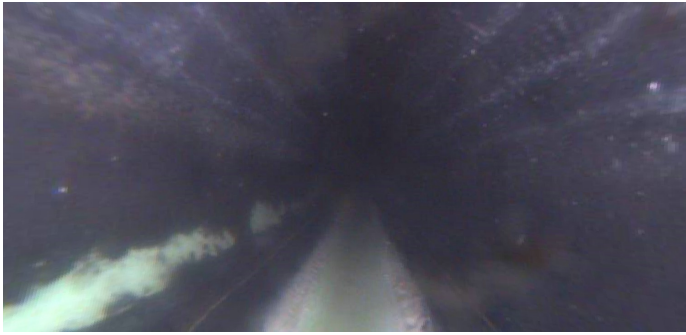
Code: **DAGS**
Description: **Deposits Attached Grease**

Distance (ft): **15.6**
Structural Grade: **0**
O&M Grade: **2**
Clock Start/From: **7**
Clock To: **5**
1st Value:
2nd Value:
Value Percent: **5.000**
Continuous Index: **S02**
Within 8" of Joint: **YES**
Remarks: **WANDER**

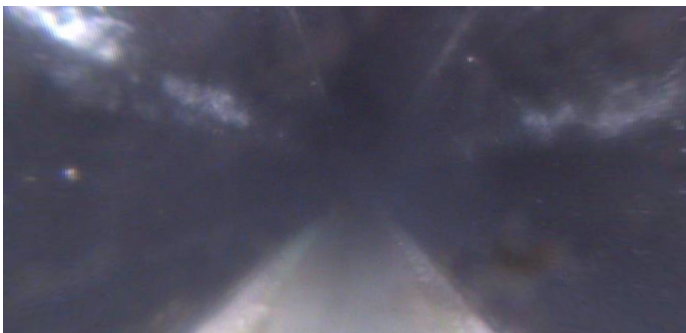
Code: **MGO**
Description: **General Observation**

Distance (ft): **27.5**
Structural Grade: **0**
O&M Grade: **0**
Clock Start/From:
Clock To:
1st Value:
2nd Value:
Value Percent:
Continuous Index:
Within 8" of Joint: **NO**
Remarks: **FOG**

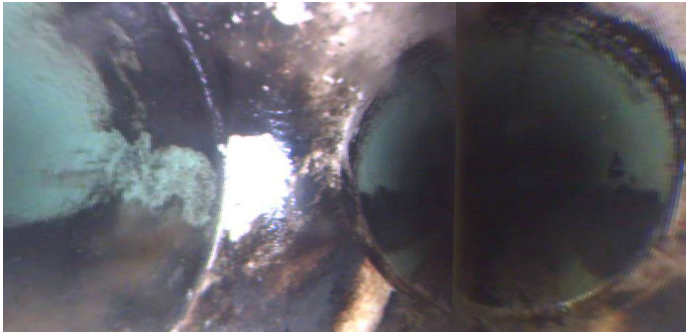
Code: **TF**
Description: **Tap Factory**

Distance (ft): **166.8**
Structural Grade: **0**
O&M Grade: **0**
Clock Start/From: **3**
Clock To:
1st Value: **4.000**
2nd Value:
Value Percent:
Continuous Index:
Within 8" of Joint:
Remarks:

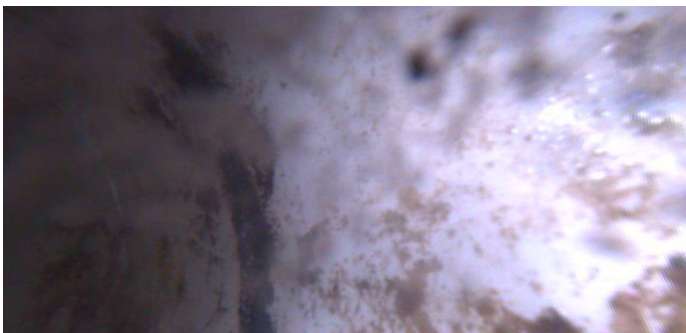
Code: **AMH**
Description: **Manhole**

Distance (ft): **288.9**
Structural Grade: **0**
O&M Grade: **0**
Clock Start/From:
Clock To:
1st Value:
2nd Value:
Value Percent:
Continuous Index:
Within 8" of Joint: **NO**
Remarks: **M-903-039**

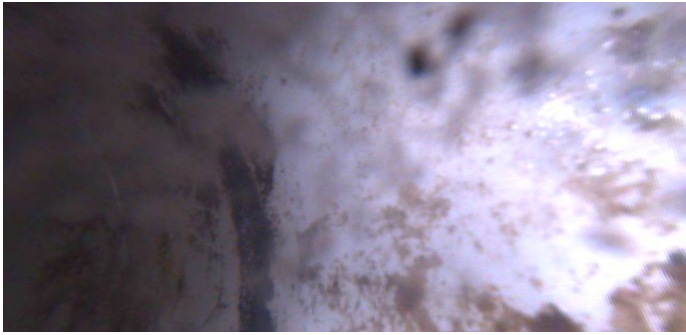
Code: **DAGS**
Description: **Deposits Attached Grease**

Distance (ft): **288.9**
Structural Grade: **0**
O&M Grade: **2**
Clock Start/From: **7**
Clock To: **5**
1st Value:
2nd Value:
Value Percent: **5.000**
Continuous Index: **F02**
Within 8" of Joint: **YES**
Remarks: **WANDER**

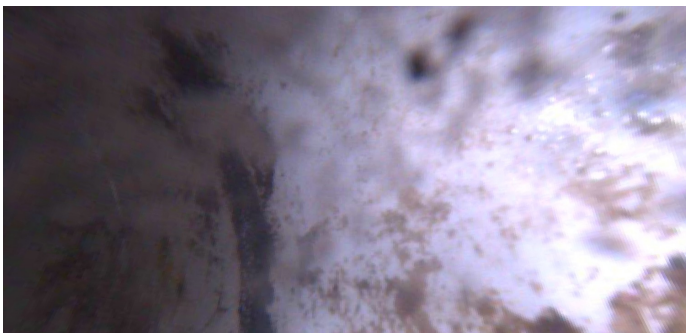
Code: **DAZ**
Description: **Deposits Attached Other**

Distance (ft): **288.9**
Structural Grade: **0**
O&M Grade: **2**
Clock Start/From: **7**
Clock To: **5**
1st Value:
2nd Value:
Value Percent: **5.000**
Continuous Index: **F01**
Within 8" of Joint: **YES**
Remarks: **WANDER**
