Profile/Photo Observation Report

Date:	03/20/2018	Weather:		Coding:	PACP 6.0
Pipe Length (ft):	320.7	Owner:	NA	Pre Clean:	Not Known
P.O.#:		Surveyor:	JUSTIN GONZALES	PSR:	P-903-060-059
Customer:		Clean Date:	01/01/1900	Shape:	C

Street:	OFF E 37TH AVE	Flow Control:	Not Controlled
City:	Hobart, IN	Year Renewed:	
Location:	Other	Tape/Media #:	
Purpose:	Not Known	Dia/Height:	10"
Use:	Sanitary	Material:	PVC
Drain Area:	NA	Lining:	
Category:	NA		
Comment:			
Location Details:		Direction of Survey:	Upstream
US MH:	M-903-060	DS MH:	M-903-059
		Total Length Surveyed (ft):	312.9

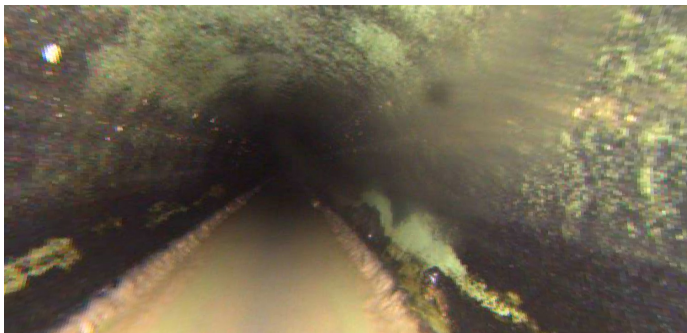
Code:	MWL
Description:	Water Level

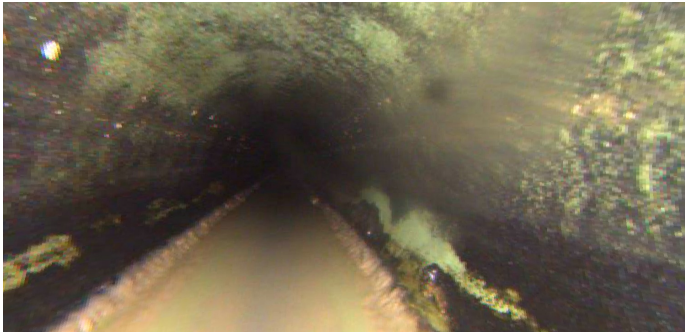
Distance (ft):	.0
Structural Grade:	0
O&M Grade:	0
Clock Start/From:	
Clock To:	
1st Value:	
2nd Value:	
Value Percent:	10.000
Continuous Index:	
Within 8" of Joint:	NO
Remarks:

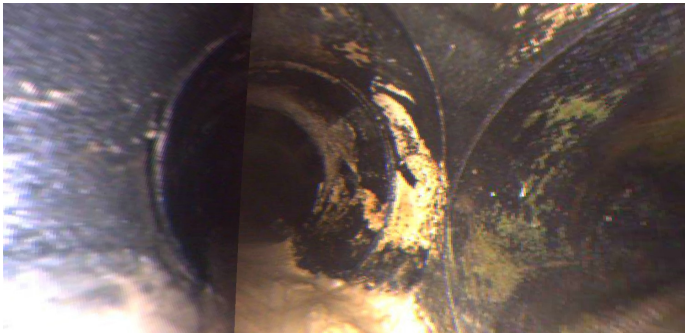
Code:	TF
Description:	Tap Factory

Distance (ft):	12.4
Structural Grade:	0
O&M Grade:	0
Clock Start/From:	9
Clock To:	
1st Value:	4.000
2nd Value:	
Value Percent:	
Continuous Index:	
Within 8" of Joint:	
Remarks:

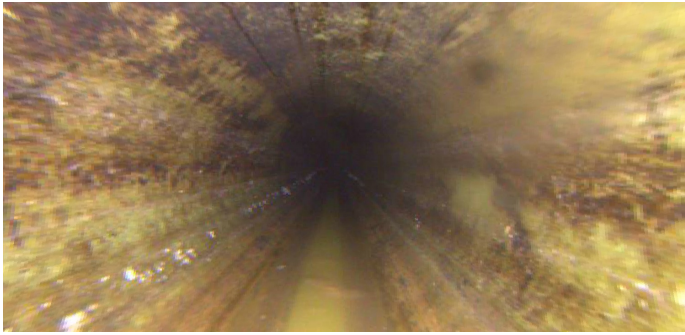
Code: **DAGS**
Description: **Deposits Attached Grease**

Distance (ft): **31.1**
Structural Grade: **0**
O&M Grade: **2**
Clock Start/From: **7**
Clock To: **5**
1st Value:
2nd Value:
Value Percent: **5.000**
Continuous Index: **S01**
Within 8" of Joint: **YES**
Remarks: **WANDER**

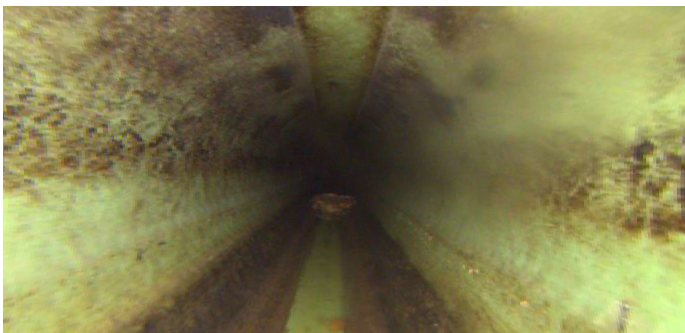
Code: **DAGS**
Description: **Deposits Attached Grease**

Distance (ft): **45.9**
Structural Grade: **0**
O&M Grade: **2**
Clock Start/From: **7**
Clock To: **5**
1st Value:
2nd Value:
Value Percent: **5.000**
Continuous Index: **F01**
Within 8" of Joint: **YES**
Remarks: **WANDER**

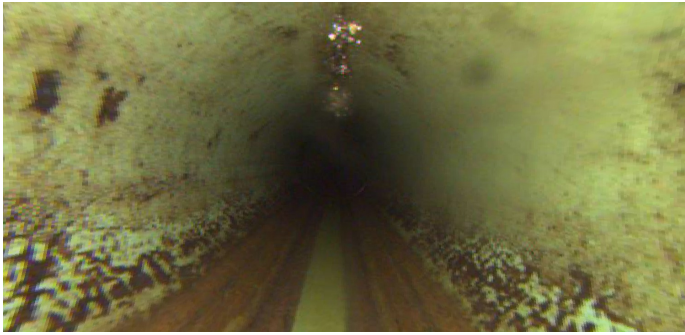
Code: **DAGS**
Description: **Deposits Attached Grease**

Distance (ft): **236.1**
Structural Grade: **0**
O&M Grade: **2**
Clock Start/From: **12**
Clock To: **5**
1st Value:
2nd Value:
Value Percent: **0.000**
Continuous Index:
Within 8" of Joint: **NO**
Remarks: **LESS THAN 5%**

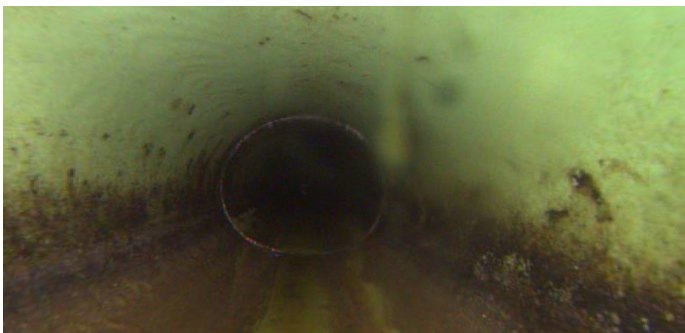
Code: **D**
Description: **Deformed**

Distance (ft): **300.6**
Structural Grade: **4**
O&M Grade: **0**
Clock Start/From:
Clock To:
1st Value:
2nd Value:
Value Percent: **5.000**
Continuous Index:
Within 8" of Joint: **NO**
Remarks:

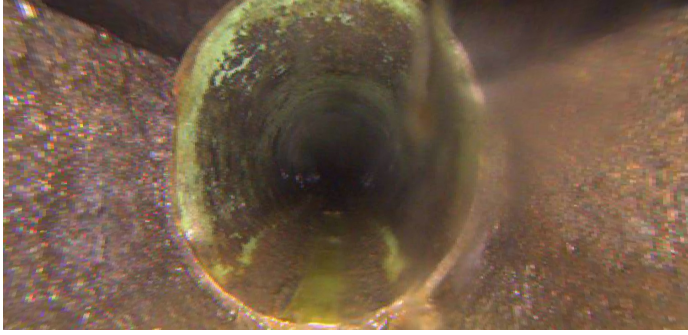
Code:	AMH
Description:	Manhole
Distance (ft):	312.9
Structural Grade:	0
O&M Grade:	0
Clock Start/From:	
Clock To:	
1st Value:	
2nd Value:	
Value Percent:	
Continuous Index:	
Within 8" of Joint:	NO
Remarks:	M-903-060
