## Profile/Photo Observation Report

Street:	<b>37th ave</b>	Flow Control:	<b>Not Controlled</b>
City:	<b>Hobart, IN</b>	Year Renewed:	
Location:	<b>Other</b>	Tape/Media #:	
Purpose:	<b>Not Known</b>	Dia/Height:	<b>10"</b>
Use:	<b>Sanitary</b>	Material:	<b>PVC</b>
Drain Area:	<b>NA</b>	Lining:	
Category:	<b>NA</b>		
Comment:

Location Details:		Direction of Survey:	<b>Upstream</b>
US MH:	<b>M-903-060</b>	DS MH:	<b>M-903-059</b>
		Total Length Surveyed (ft):	<b>312.9</b>

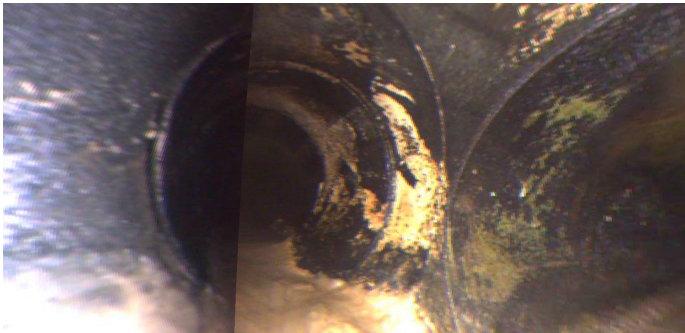
Code:	<b>TF</b>
Description:	<b>Tap Factory</b>

Distance (ft):	<b>12.4</b>
Structural Grade:	<b>0</b>
O&M Grade:	<b>0</b>
Clock Start/From:	<b>9</b>
Clock To:	
1st Value:	<b>4.000</b>
2nd Value:	
Value Percent:	
Continuous Index:	
Within 8" of Joint:	
Remarks:

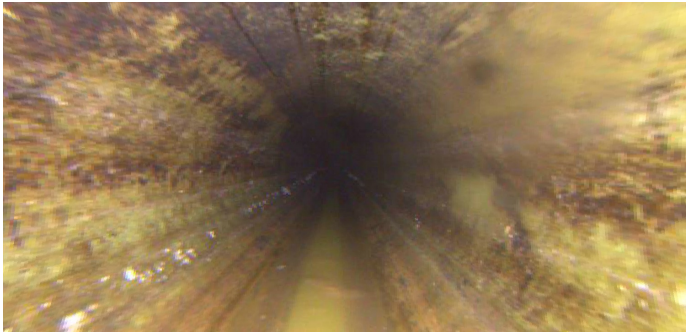
Code: **DAGS**  
Description: **Deposits Attached Grease**

Distance (ft): **31.1**  
Structural Grade: **0**  
O&M Grade: **2**  
Clock Start/From: **7**  
Clock To: **5**  
1st Value:  
2nd Value:  
Value Percent: **5.000**  
Continuous Index: **S01**  
Within 8" of Joint: **YES**  
Remarks: **WANDER**

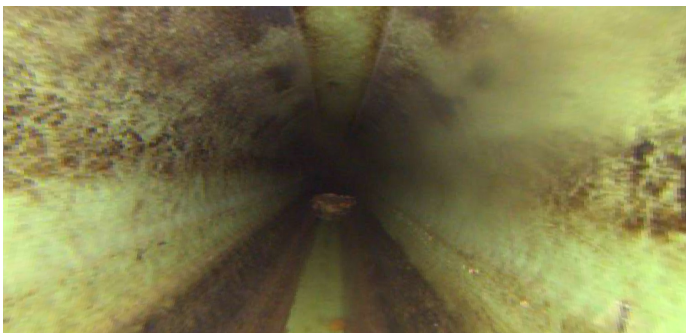
Code: **DAGS**  
Description: **Deposits Attached Grease**

Distance (ft): **45.9**  
Structural Grade: **0**  
O&M Grade: **2**  
Clock Start/From: **7**  
Clock To: **5**  
1st Value:  
2nd Value:  
Value Percent: **5.000**  
Continuous Index: **F01**  
Within 8" of Joint: **YES**  
Remarks: **WANDER**

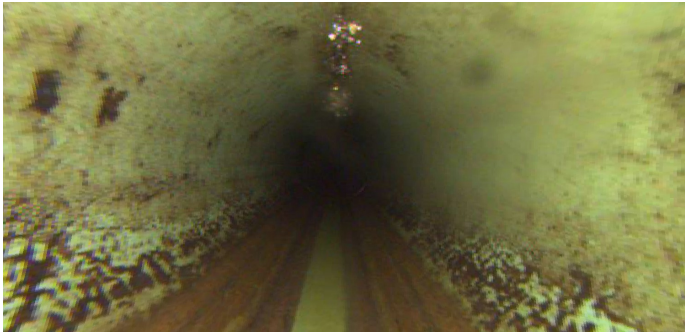
Code: **DAGS**  
Description: **Deposits Attached Grease**

Distance (ft): **236.1**  
Structural Grade: **0**  
O&M Grade: **2**  
Clock Start/From: **12**  
Clock To: **5**  
1st Value:  
2nd Value:  
Value Percent: **0.000**  
Continuous Index:  
Within 8" of Joint: **NO**  
Remarks: **LESS THAN 5%**

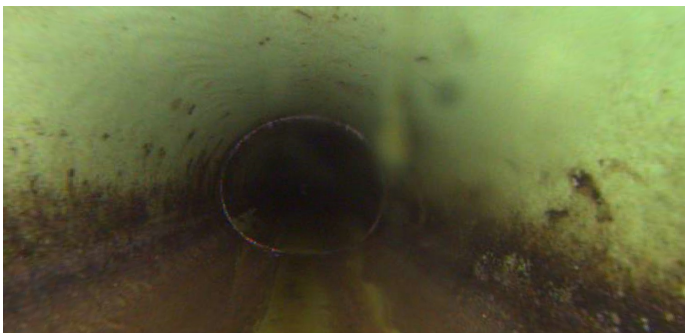
Code: **D**  
Description: **Deformed**

Distance (ft): **300.6**  
Structural Grade: **4**  
O&M Grade: **0**  
Clock Start/From:  
Clock To:  
1st Value:  
2nd Value:  
Value Percent: **5.000**  
Continuous Index:  
Within 8" of Joint: **NO**  
Remarks:
