Date:	03/23/2018	Weather:		Coding:	PACP 6.0
Pipe Length (ft):	98.7	Owner:	NA	Pre Clean:	Not Known
P.O.#:		Surveyor:	Jen Costello	PSR:	P-903-066-067
Customer:		Clean Date:	01/01/1900	Shape:	С
Street:	N UNION ST		Flow Control:	Not Controlled	l
City:	Hobart, IN		Year Renewed:		
Location:	Other		Tape/Media #:		
Purpose:	Not Known		Dia/Height:	10"	
Use:	Sanitary		Material:	PVC	
Drain Area:	NA		Lining:		
Category:	NA				
Comment:					
Location Details	:		Direction of Surve	y: Downstream	
US MH:	M-903-067	DS MH:	M-903-066	Total Length Surveyed (ft): 102.0
D&M Index:	0.00	O&M Quick:	0000	O&M Rating:	0.00
Structural Index:	0.00	Structural Qu	uick: 0000		0.00
Overall Index:	0.00	Overall Quic			0.00

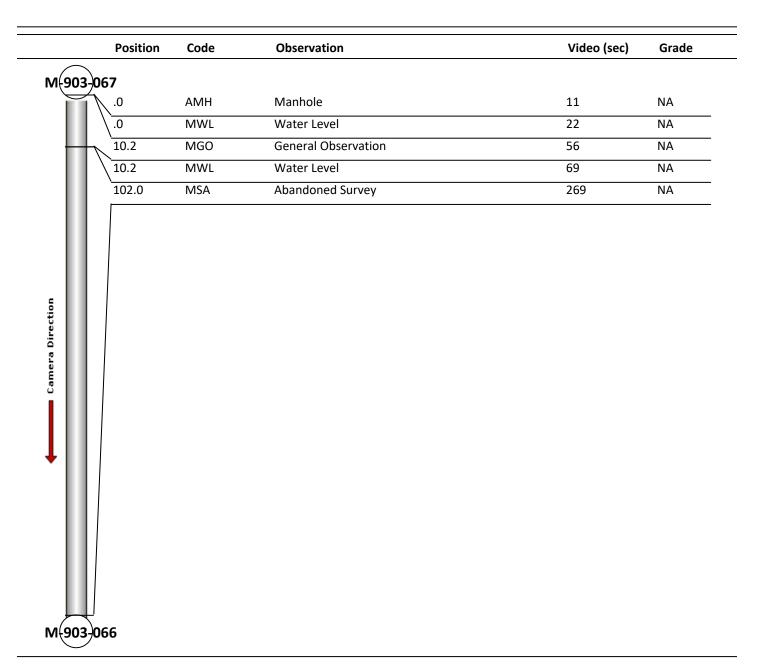
Code: Description:	AMH Manhole
Distance (ft):	.0
Structural Grade:	0
O&M Grade:	0
Clock Start/From:	
Clock To:	
1st Value:	
2nd Value:	
Value Percent:	
Continuous Index:	
Within 8" of Joint:	NO
Remarks:	M-903-067

Code: MWL Description: Water Level

Distance (ft):	.0
Structural Grade:	0
O&M Grade:	0
Clock Start/From:	
Clock To:	
1st Value:	
2nd Value:	
Value Percent:	30.000
Continuous Index:	
Within 8" of Joint:	NO
Remarks:
