## Profile/Photo Observation Report

Street:	<b>BRANDT ST &amp; COOKE ST</b>	Flow Control:	<b>Not Controlled</b>
City:	<b>Hobart, IN</b>	Year Renewed:	
Location:	<b>Other</b>	Tape/Media #:	
Purpose:	<b>Not Known</b>	Dia/Height:	<b>10"</b>
Use:	<b>Sanitary</b>	Material:	<b>PVC</b>
Drain Area:	<b>NA</b>	Lining:	
Category:	<b>NA</b>		
Comment:

Location Details:		Direction of Survey:	<b>Upstream</b>
US MH:	<b>M-903-068</b>	DS MH:	<b>M-903-049</b>
		Total Length Surveyed (ft):	<b>177.2</b>

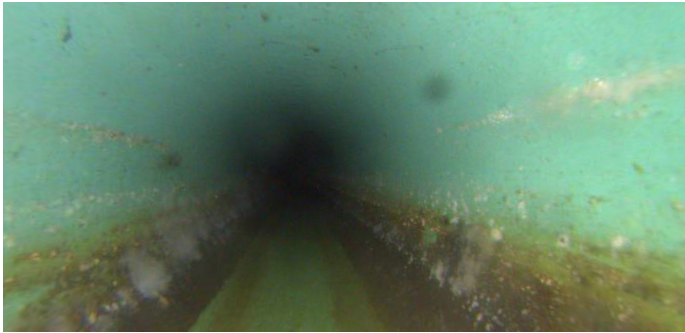
Code:	<b>MWL</b>
Description:	<b>Water Level</b>

Distance (ft):	<b>.0</b>
Structural Grade:	<b>0</b>
O&M Grade:	<b>0</b>
Clock Start/From:	
Clock To:	
1st Value:	
2nd Value:	
Value Percent:	<b>5.000</b>
Continuous Index:	
Within 8" of Joint:	<b>NO</b>
Remarks:

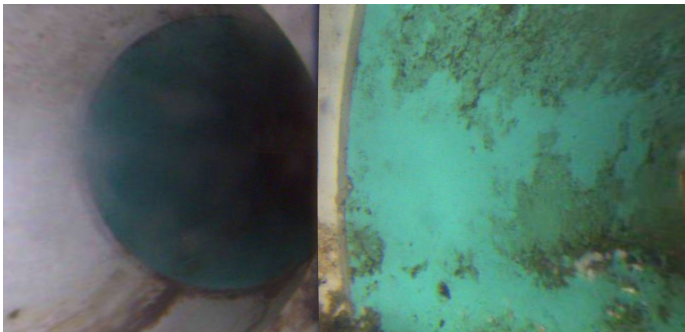
Code:	<b>TF</b>
Description:	<b>Tap Factory</b>

Distance (ft):	<b>40.9</b>
Structural Grade:	<b>0</b>
O&M Grade:	<b>0</b>
Clock Start/From:	<b>9</b>
Clock To:	
1st Value:	<b>4.000</b>
2nd Value:	
Value Percent:	
Continuous Index:	
Within 8" of Joint:	
Remarks:

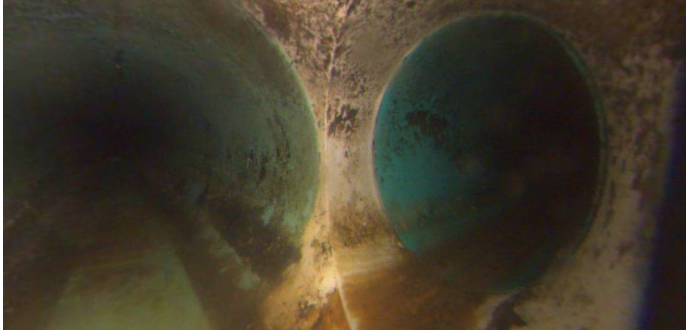
Code: **TFA**  
Description: **Tap Factory Active**

Distance (ft): **41.9**  
Structural Grade: **0**  
O&M Grade: **0**  
Clock Start/From: **3**  
Clock To:  
1st Value: **4.000**  
2nd Value:  
Value Percent:  
Continuous Index:  
Within 8" of Joint:  
Remarks:

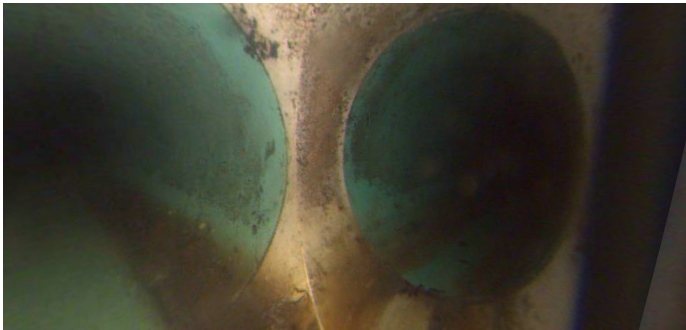
Code: **TF**  
Description: **Tap Factory**

Distance (ft): **124.4**  
Structural Grade: **0**  
O&M Grade: **0**  
Clock Start/From: **3**  
Clock To:  
1st Value: **4.000**  
2nd Value:  
Value Percent:  
Continuous Index:  
Within 8" of Joint:  
Remarks:

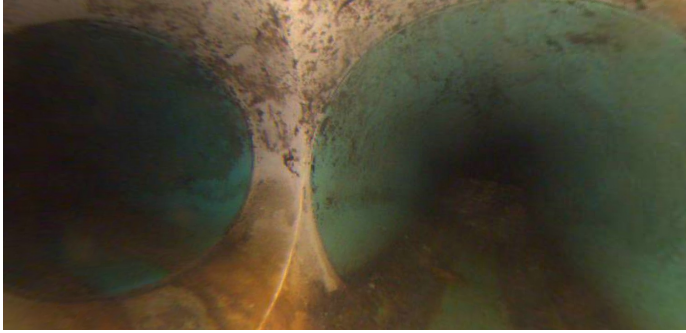
Code: **TFA**  
Description: **Tap Factory Active**

Distance (ft): **138.5**  
Structural Grade: **0**  
O&M Grade: **0**  
Clock Start/From: **9**  
Clock To:  
1st Value: **4.000**  
2nd Value:  
Value Percent:  
Continuous Index:  
Within 8" of Joint:  
Remarks:

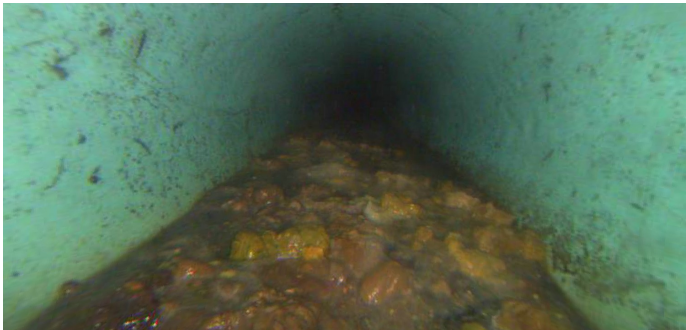
Code: **DSZ**  
Description: **Deposits Settled Other**

Distance (ft): **141.0**  
Structural Grade: **0**  
O&M Grade: **4**  
Clock Start/From: **4**  
Clock To: **8**  
1st Value:  
2nd Value:  
Value Percent: **30.000**  
Continuous Index:  
Within 8" of Joint: **NO**  
Remarks: **MISC**

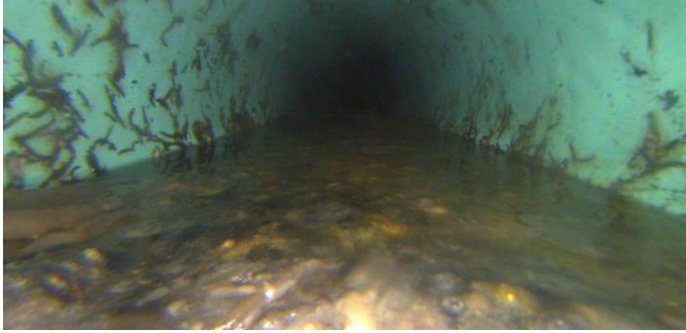
Code: **MWL**  
Description: **Water Level**

Distance (ft): **146.6**  
Structural Grade: **0**  
O&M Grade: **0**  
Clock Start/From:  
Clock To:  
1st Value:  
2nd Value:  
Value Percent: **40.000**  
Continuous Index:  
Within 8" of Joint: **NO**  
Remarks:

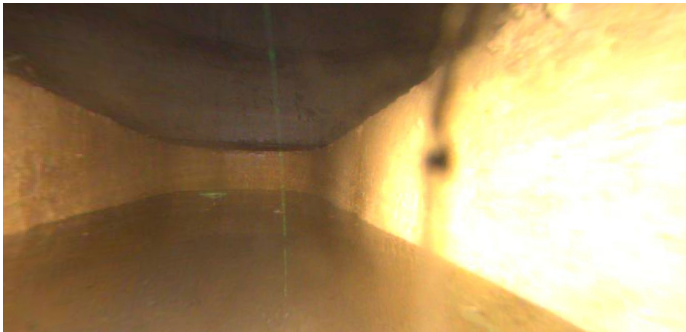
Code: **AMH**  
Description: **Manhole**

Distance (ft): **177.1**  
Structural Grade: **0**  
O&M Grade: **0**  
Clock Start/From:  
Clock To:  
1st Value:  
2nd Value:  
Value Percent:  
Continuous Index:  
Within 8" of Joint: **NO**  
Remarks: **M-903-068**
