Profile/Photo Observation Report

Date:	03/29/2018	Weather:		Coding:	PACP 6.0
Pipe Length (ft):	185.1	Owner:	NA	Pre Clean:	Not Known
P.O.#:		Surveyor:	Jen Costello	PSR:	P-903-068-049
Customer:		Clean Date:	01/01/1900	Shape:	C

Street:	brandit st	Flow Control:	Not Controlled
City:	Hobart, IN	Year Renewed:	
Location:	Other	Tape/Media #:	
Purpose:	Not Known	Dia/Height:	10"
Use:	Sanitary	Material:	PVC
Drain Area:	NA	Lining:	
Category:	NA		
Comment:

Location Details:		Direction of Survey:	Upstream
US MH:	M-903-068	DS MH:	M-903-049
		Total Length Surveyed (ft):	177.2

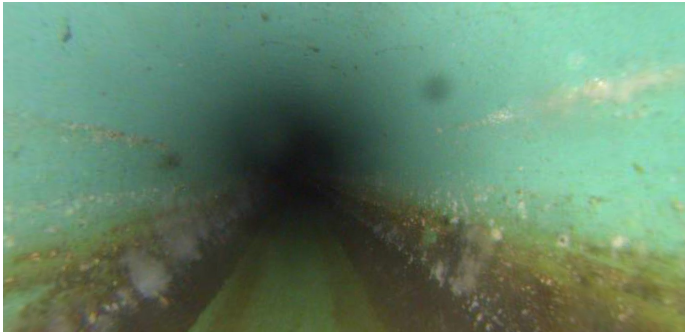
Code:	MWL
Description:	Water Level

Distance (ft):	.0
Structural Grade:	0
O&M Grade:	0
Clock Start/From:	
Clock To:	
1st Value:	
2nd Value:	
Value Percent:	5.000
Continuous Index:	
Within 8" of Joint:	NO
Remarks:

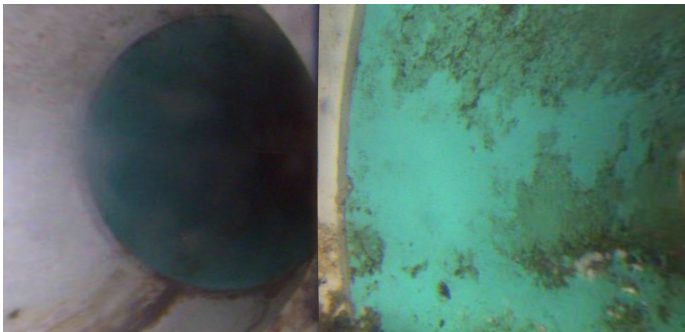
Code:	TF
Description:	Tap Factory

Distance (ft):	40.9
Structural Grade:	0
O&M Grade:	0
Clock Start/From:	9
Clock To:	
1st Value:	4.000
2nd Value:	
Value Percent:	
Continuous Index:	
Within 8" of Joint:	
Remarks:

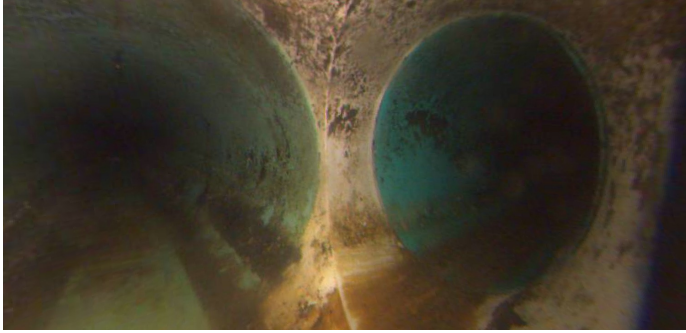
Code: **TFA**
Description: **Tap Factory Active**

Distance (ft): **41.9**
Structural Grade: **0**
O&M Grade: **0**
Clock Start/From: **3**
Clock To:
1st Value: **4.000**
2nd Value:
Value Percent:
Continuous Index:
Within 8" of Joint:
Remarks:

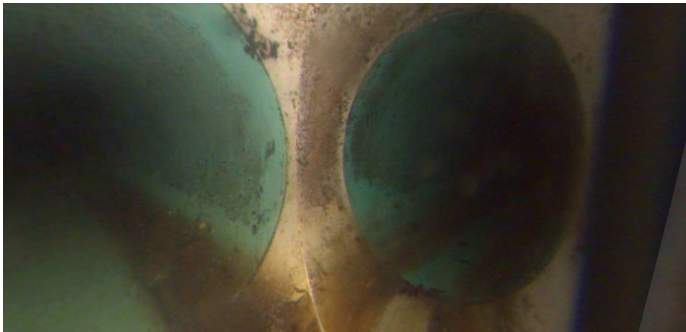
Code: **TF**
Description: **Tap Factory**

Distance (ft): **124.4**
Structural Grade: **0**
O&M Grade: **0**
Clock Start/From: **3**
Clock To:
1st Value: **4.000**
2nd Value:
Value Percent:
Continuous Index:
Within 8" of Joint:
Remarks:

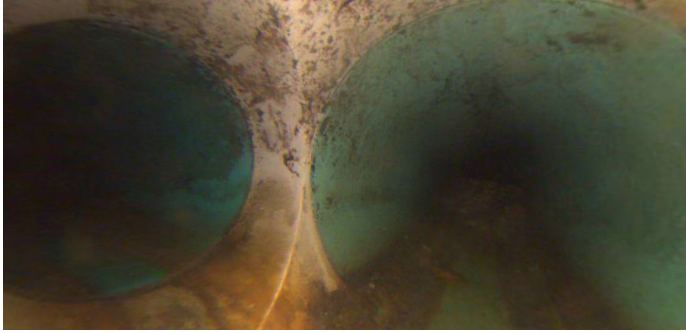
Code: **TFA**
Description: **Tap Factory Active**

Distance (ft): **138.5**
Structural Grade: **0**
O&M Grade: **0**
Clock Start/From: **9**
Clock To:
1st Value: **4.000**
2nd Value:
Value Percent:
Continuous Index:
Within 8" of Joint:
Remarks:

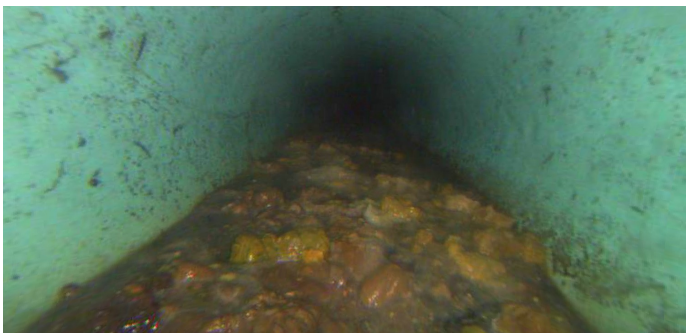
Code: **DSZ**
Description: **Deposits Settled Other**

Distance (ft): **141.0**
Structural Grade: **0**
O&M Grade: **4**
Clock Start/From: **4**
Clock To: **8**
1st Value:
2nd Value:
Value Percent: **30.000**
Continuous Index:
Within 8" of Joint: **NO**
Remarks: **MISC**

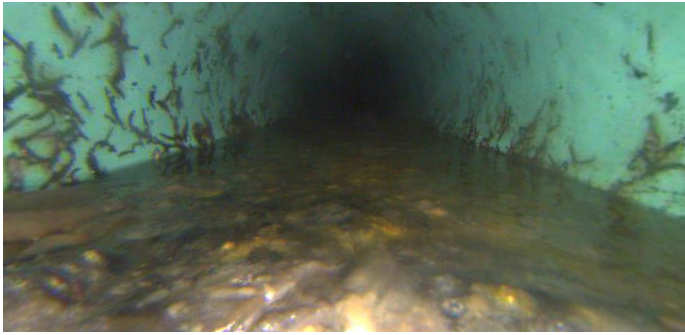
Code: **MWL**
Description: **Water Level**

Distance (ft): **146.6**
Structural Grade: **0**
O&M Grade: **0**
Clock Start/From:
Clock To:
1st Value:
2nd Value:
Value Percent: **40.000**
Continuous Index:
Within 8" of Joint: **NO**
Remarks:

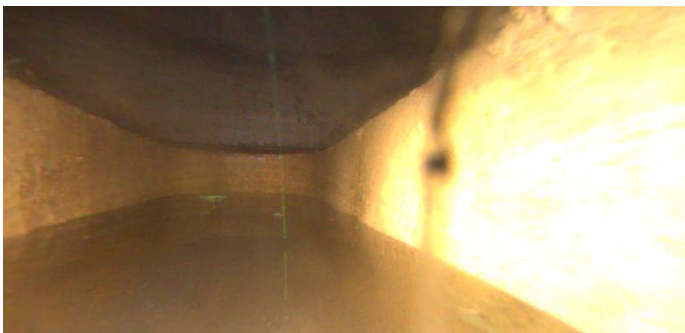
Code: **AMH**
Description: **Manhole**

Distance (ft): **177.1**
Structural Grade: **0**
O&M Grade: **0**
Clock Start/From:
Clock To:
1st Value:
2nd Value:
Value Percent:
Continuous Index:
Within 8" of Joint: **NO**
Remarks: **M-903-068**
