## Profile/Photo Observation Report

Date:	<b>04/20/2018</b>	Weather:		Coding:	<b>PACP 4.2</b>
Pipe Length (ft):	<b>349.2</b>	Owner:	<b>City of Hobart</b>	Pre Clean:	<b>No Pre-Cleaning</b>
P.O.#:	<b>2004</b>	Surveyor:	<b>SAN</b>	PSR:	<b>P-1004-037-005</b>
Customer:	<b>Red Zone</b>	Clean Date:		Shape:	<b>C</b>

Street:	<b>203 Hillcrest Ave</b>	Flow Control:	<b>Not Controlled</b>
City:	<b>Hobart In</b>	Year Renewed:	
Location:	<b>Light Highway</b>	Tape/Media #:	<b>Deliverable 1</b>
Purpose:	<b>Routine Assessment</b>	Dia/Height:	<b>18"</b>
Use:	<b>Sanitary</b>	Material:	<b>PVC</b>
Drain Area:	<b>Northeast</b>	Lining:	
Category:	<b>NA</b>		
Comment:	<b>422-1</b>		
Location Details:	<b>Center of street</b>	Direction of Survey:	<b>Downstream</b>
US MH:	<b>M-1004-037</b>	DS MH:	<b>M-904-005</b>
		Total Length Surveyed (ft):	<b>349.2</b>

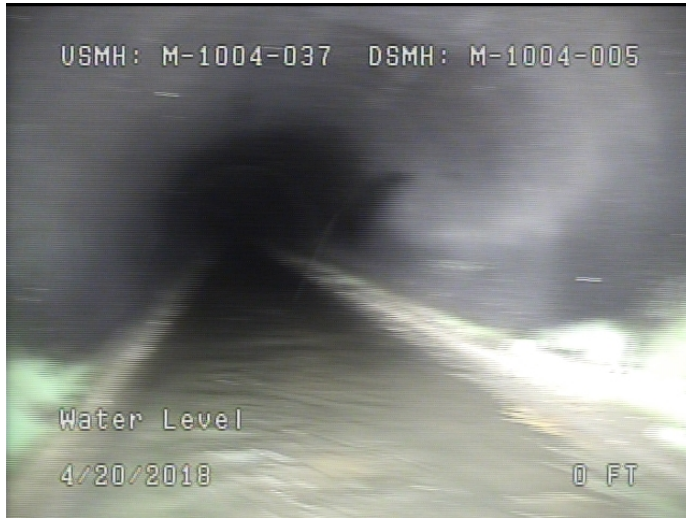
Code:	<b>MWL</b>
Description:	<b>Water Level</b>
Distance (ft):	<b>.0</b>
Structural Grade:	<b>0</b>
O&M Grade:	<b>0</b>
Clock Start/From:	
Clock To:	
1st Value:	
2nd Value:	
Value Percent:	<b>15.000</b>
Continuous Index:	
Within 8" of Joint:	<b>NO</b>
Remarks:

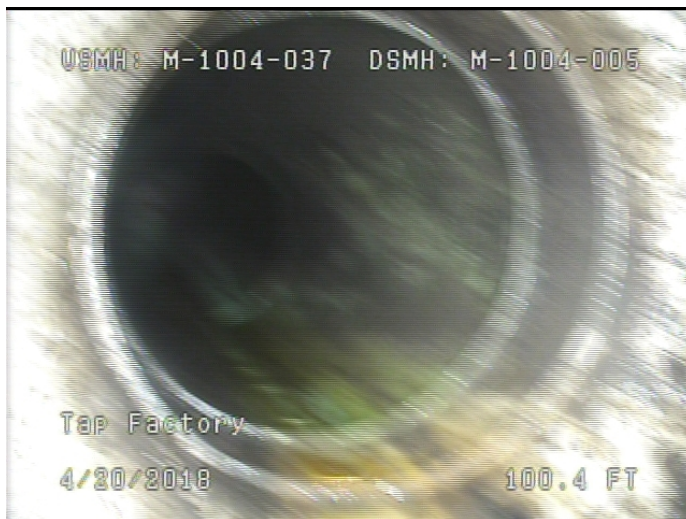
Code:	<b>TF</b>
Description:	<b>Tap Factory</b>
Distance (ft):	<b>100.4</b>
Structural Grade:	<b>0</b>
O&M Grade:	<b>0</b>
Clock Start/From:	<b>10</b>
Clock To:	
1st Value:	<b>4.000</b>
2nd Value:	
Value Percent:	
Continuous Index:	
Within 8" of Joint:	<b>NO</b>
Remarks:

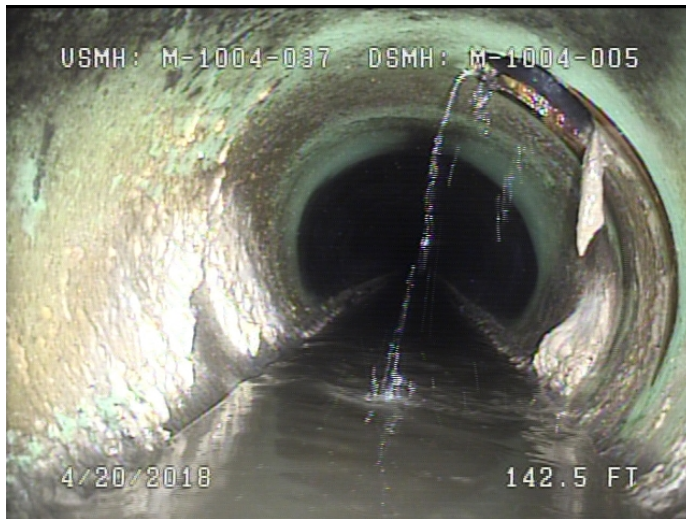
Code:	<b>TBD</b>
Description:	<b>Tap Break-in Defective</b>
Distance (ft):	<b>142.5</b>
Structural Grade:	<b>0</b>
O&M Grade:	<b>3</b>
Clock Start/From:	<b>1</b>
Clock To:	
1st Value:	<b>4.000</b>
2nd Value:	
Value Percent:	
Continuous Index:	
Within 8" of Joint:	<b>NO</b>
Remarks:	<b>infil @ tap</b>

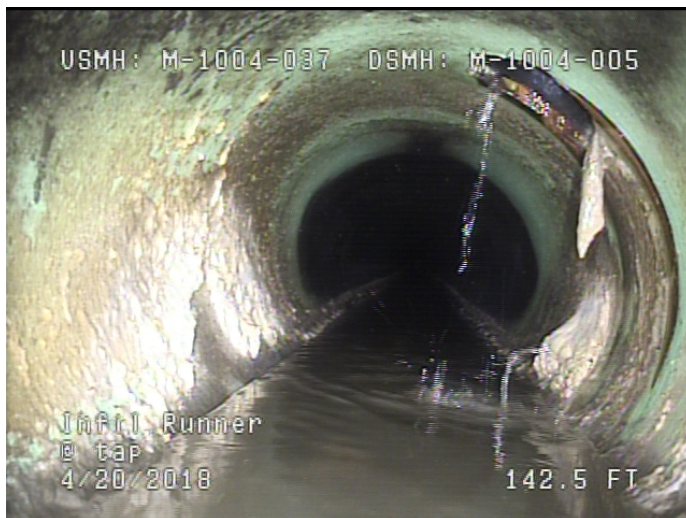
Code:	<b>IR</b>
Description:	<b>Infil Runner</b>
Distance (ft):	<b>142.5</b>
Structural Grade:	<b>0</b>
O&M Grade:	<b>4</b>
Clock Start/From:	<b>1</b>
Clock To:	
1st Value:	
2nd Value:	
Value Percent:	
Continuous Index:	
Within 8" of Joint:	<b>NO</b>
Remarks:	<b>@ tap</b>

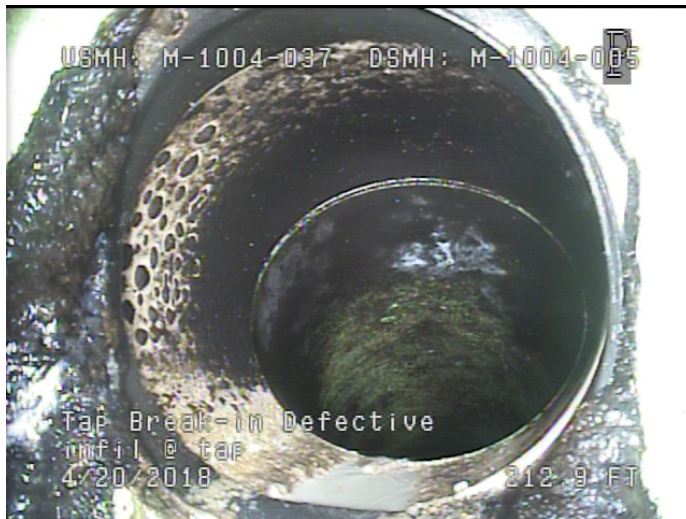
Code:	<b>TBD</b>
Description:	<b>Tap Break-in Defective</b>
Distance (ft):	<b>212.9</b>
Structural Grade:	<b>0</b>
O&M Grade:	<b>3</b>
Clock Start/From:	<b>1</b>
Clock To:	
1st Value:	<b>4.000</b>
2nd Value:	
Value Percent:	
Continuous Index:	
Within 8" of Joint:	<b>NO</b>
Remarks:	<b>infil @ tap</b>

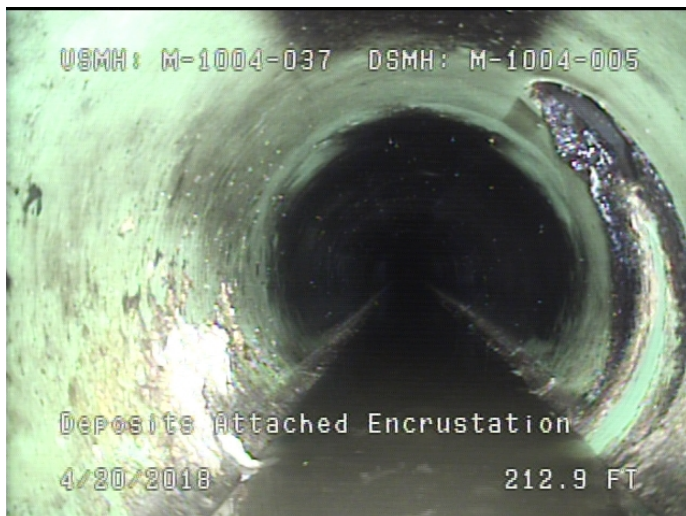
Code:	<b>DAE</b>
Description:	<b>Deposits Attached Encrustation</b>
Distance (ft):	<b>212.9</b>
Structural Grade:	<b>0</b>
O&M Grade:	<b>3</b>
Clock Start/From:	<b>1</b>
Clock To:	<b>5</b>
1st Value:	
2nd Value:	
Value Percent:	<b>15.000</b>
Continuous Index:	
Within 8" of Joint:	<b>NO</b>
Remarks:

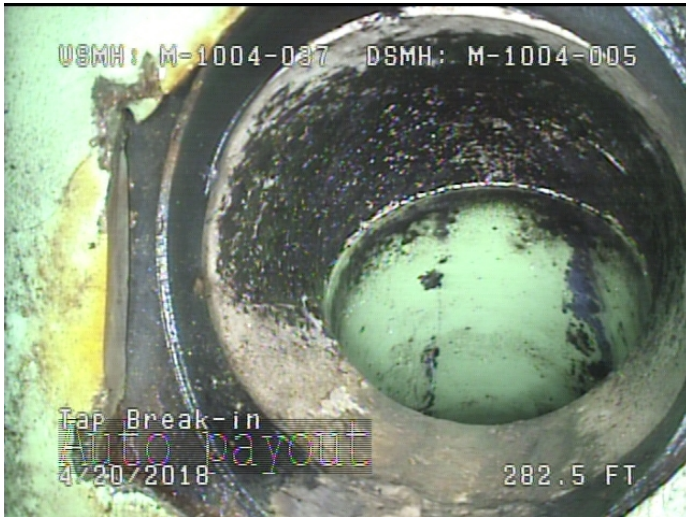
Code:	<b>TB</b>
Description:	<b>Tap Break-in</b>
Distance (ft):	<b>282.5</b>
Structural Grade:	<b>0</b>
O&M Grade:	<b>0</b>
Clock Start/From:	<b>1</b>
Clock To:	
1st Value:	<b>4.000</b>
2nd Value:	
Value Percent:	
Continuous Index:	
Within 8" of Joint:	<b>NO</b>
Remarks:

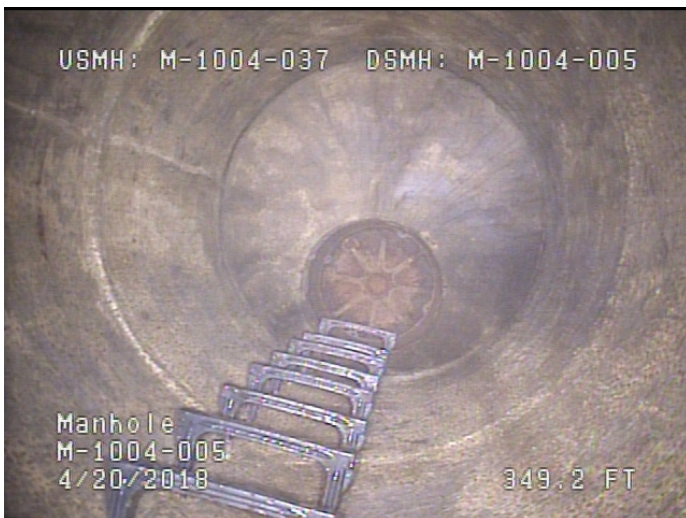
Code:	<b>AMH</b>
Description:	<b>Manhole</b>
Distance (ft):	<b>349.2</b>
Structural Grade:	<b>0</b>
O&M Grade:	<b>0</b>
Clock Start/From:	
Clock To:	
1st Value:	
2nd Value:	
Value Percent:	
Continuous Index:	
Within 8" of Joint:	<b>NO</b>
Remarks:	<b>M-1004-005</b>
