Profile/Photo Observation Report

Date: 05/04/2018 Weather: **PACP 4.2** Coding: Pipe Length (ft): 385.0 Owner: **City of Hobart** Pre Clean: No Pre-Cleaning P.O.#: 2004 PSR: P-904-008-009 Surveyor: SAN **Red Zone** Clean Date: Customer: Shape: 166 Fraser Ln Flow Control: **Not Controlled** Street: City: **Hobart In** Year Renewed: Easement/Right of Way Tape/Media #: Deliverable 1 Location: Purpose: **Routine Assessment** Dia/Height: 18" **PVC** Use: Sanitary Material: Northeast Drain Area: Lining: NA Category: Comment: 448-1 **Location Details:** Edge of field Direction of Survey: Upstream M-904-008 US MH: DS MH: M-904-009 Total Length Surveyed (ft): 385.0 0.00 0000 0.00 O&M Index: O&M Quick: O&M Rating: 0.00 0000 0.00 Structural Index: Structural Quick: Structural Rating:

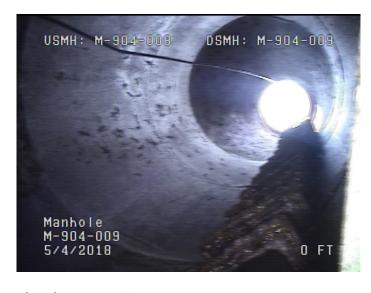
AMH

Description:	Manhole
Distance (ft): Structural Grade:	.0 0
O&M Grade: Clock Start/From:	0
Clock To: 1st Value:	
2nd Value: Value Percent:	
Continuous Index: Within 8" of Joint: Remarks:	NO M-904-009

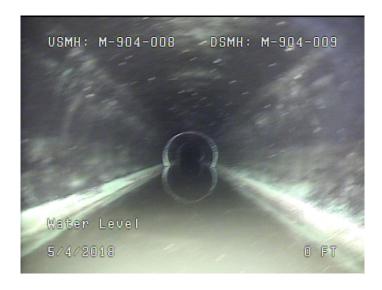
Code: MWL

Description: Water Level

Distance (ft): .0
Structural Grade: 0
O&M Grade: 0

Value Percent: 15.000

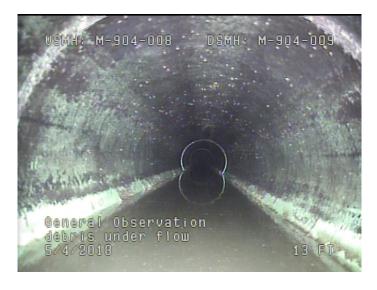
Code: MGO

Description: General Observation

Distance (ft): 13.0
Structural Grade: 0
O&M Grade: 0
Clock Start/From:

Remarks: debris under flow

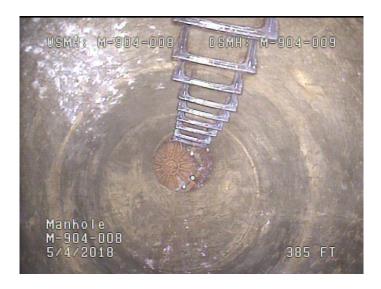
Code: AMH
Description: Manhole

Distance (ft): 385.0
Structural Grade: 0
O&M Grade: 0

Remarks: M-904-008
