Profile/Photo Observation Report

Date:	05/04/2018	Weather:		Coding:	PACP 4.2
Pipe Length (ft):	151.0	Owner:	City of Hobart	Pre Clean:	No Pre-Cleaning
P.O.#:	2004	Surveyor:	SAN	PSR:	P-904-009-010
Customer:	Red Zone	Clean Date:		Shape:	C

Street:	Fraser Ln	Flow Control:	Not Controlled
City:	Hobart In	Year Renewed:	
Location:	Easement/Right of Way	Tape/Media #:	Deliverable 1
Purpose:	Routine Assessment	Dia/Height:	18"
Use:	Sanitary	Material:	VCP
Drain Area:	Northeast	Lining:	
Category:	NA		
Comment:	447-1		
Location Details:	Edge of field	Direction of Survey:	Downstream
US MH:	M-904-009	DS MH:	M-804-010
		Total Length Surveyed (ft):	100.0

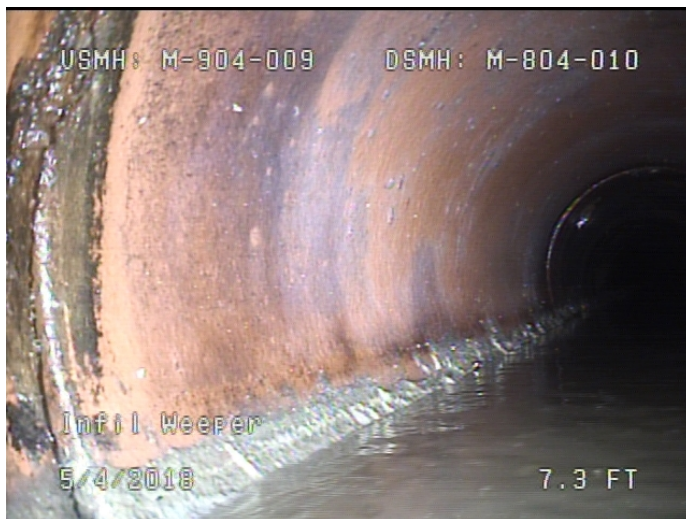
Code:	IW
Description:	Infil Weeper
Distance (ft):	7.3
Structural Grade:	0
O&M Grade:	2
Clock Start/From:	7
Clock To:	12
1st Value:	
2nd Value:	
Value Percent:	
Continuous Index:	S01
Within 8" of Joint:	YES
Remarks:

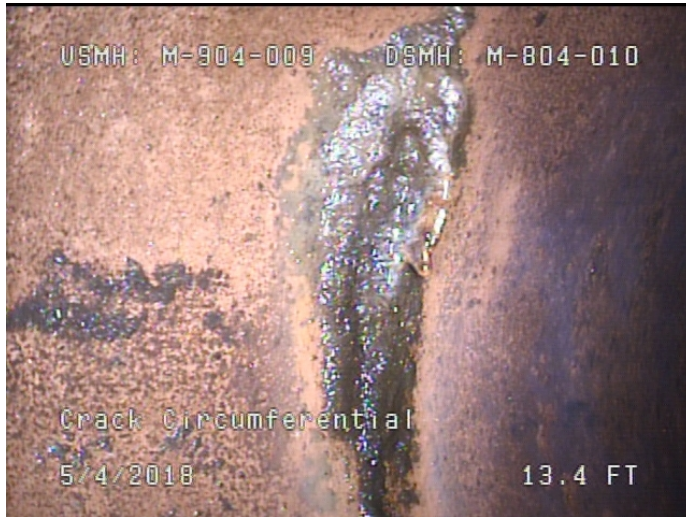
Code:	CC
Description:	Crack Circumferential
Distance (ft):	13.4
Structural Grade:	1
O&M Grade:	0
Clock Start/From:	10
Clock To:	11
1st Value:	
2nd Value:	
Value Percent:	
Continuous Index:	
Within 8" of Joint:	NO
Remarks:

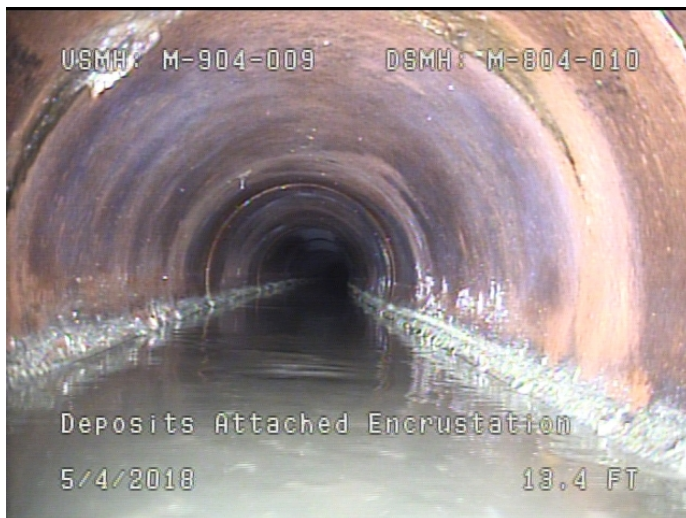
Code:	DAE
Description:	Deposits Attached Encrustation
Distance (ft):	13.4
Structural Grade:	0
O&M Grade:	2
Clock Start/From:	9
Clock To:	2
1st Value:	
2nd Value:	
Value Percent:	10.000
Continuous Index:	
Within 8" of Joint:	NO
Remarks:

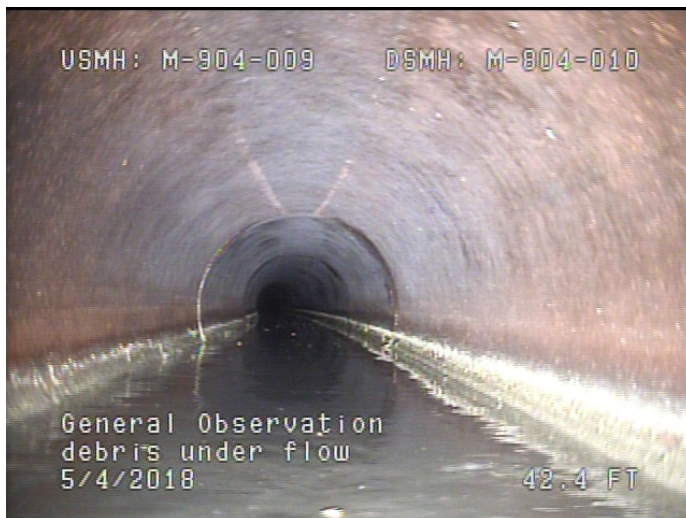
Code: **MGO**
 Description: **General Observation**

Distance (ft): **42.4**
 Structural Grade: **0**
 O&M Grade: **0**
 Clock Start/From:
 Clock To:
 1st Value:
 2nd Value:
 Value Percent:
 Continuous Index:
 Within 8" of Joint: **NO**
 Remarks: **debris under flow**

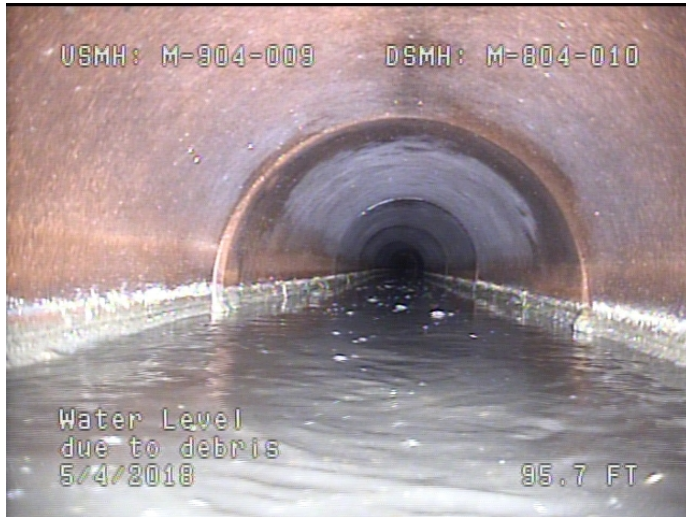
Code:	MWL
Description:	Water Level
Distance (ft):	95.7
Structural Grade:	0
O&M Grade:	0
Clock Start/From:	
Clock To:	
1st Value:	
2nd Value:	
Value Percent:	35.000
Continuous Index:	
Within 8" of Joint:	NO
Remarks:	due to debris

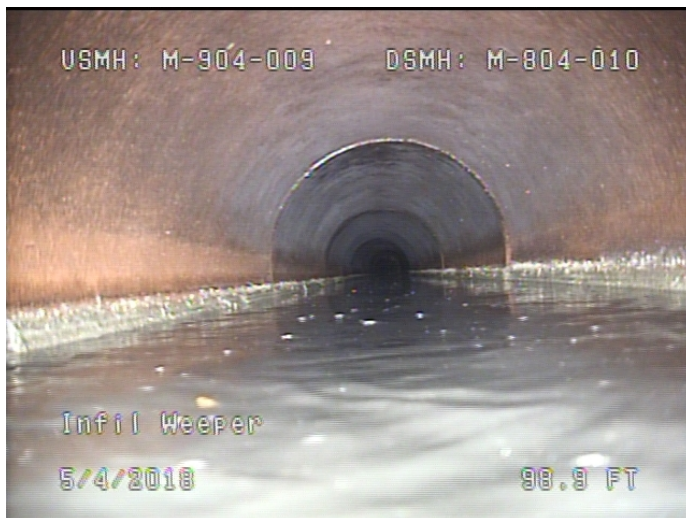
Code:	IW
Description:	Infil Weeper
Distance (ft):	98.9
Structural Grade:	0
O&M Grade:	2
Clock Start/From:	7
Clock To:	12
1st Value:	
2nd Value:	
Value Percent:	
Continuous Index:	F01
Within 8" of Joint:	YES
Remarks:

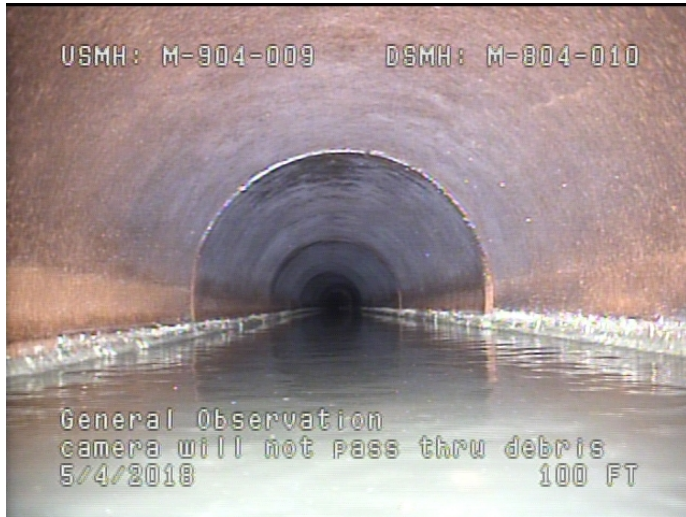
Code:	MGO
Description:	General Observation
Distance (ft):	100.0
Structural Grade:	0
O&M Grade:	0
Clock Start/From:	
Clock To:	
1st Value:	
2nd Value:	
Value Percent:	
Continuous Index:	
Within 8" of Joint:	NO
Remarks:	camera will not pass thru debris

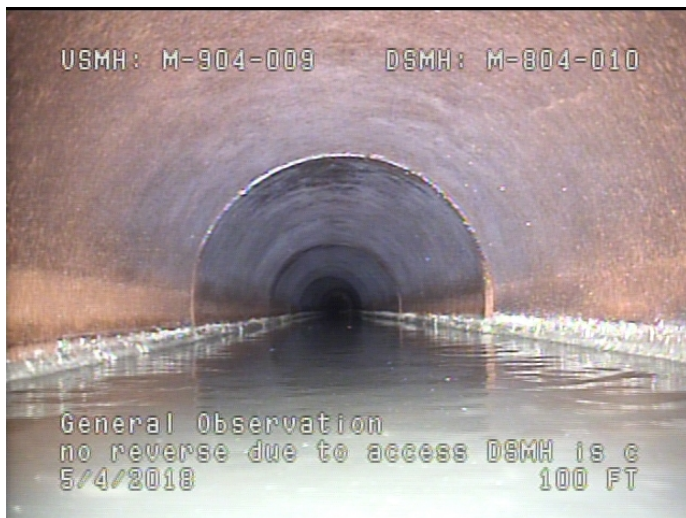
Code:	MGO
Description:	General Observation
Distance (ft):	100.0
Structural Grade:	0
O&M Grade:	0
Clock Start/From:	
Clock To:	
1st Value:	
2nd Value:	
Value Percent:	
Continuous Index:	
Within 8" of Joint:	NO
Remarks:	no reverse due to access DSMH is covered

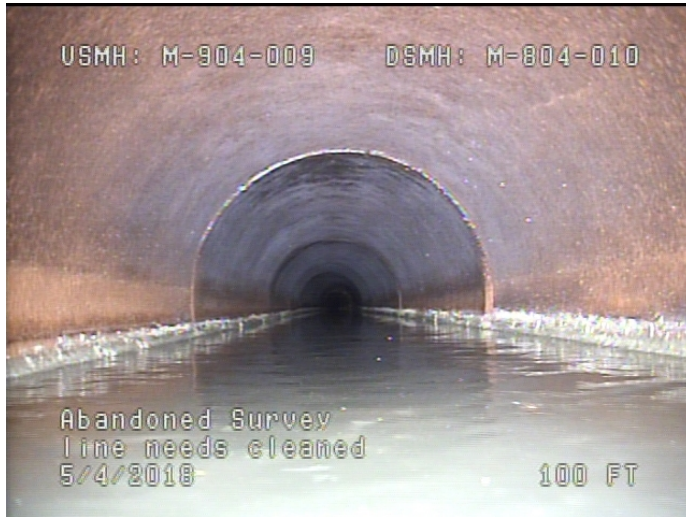
Code:	MSA
Description:	Abandoned Survey
Distance (ft):	100.0
Structural Grade:	0
O&M Grade:	0
Clock Start/From:	
Clock To:	
1st Value:	
2nd Value:	
Value Percent:	
Continuous Index:	
Within 8" of Joint:	NO
Remarks:	line needs cleaned
