Profile/Photo Observation Report

Date:	04/16/2018	Weather:		Coding:	PACP 6.0
Pipe Length (ft):	172.9	Owner:	NA	Pre Clean:	Not Known
P.O.#:		Surveyor:	Selasie Honu	PSR:	P-904-012-009
Customer:		Clean Date:	01/01/1900	Shape:	C

Street:	FRASER LN	Flow Control:	Not Controlled
City:	Hobart, IN	Year Renewed:	
Location:	Other	Tape/Media #:	
Purpose:	Not Known	Dia/Height:	10"
Use:	Sanitary	Material:	VCP
Drain Area:	NA	Lining:	
Category:	NA		
Comment:

Location Details:		Direction of Survey:	Downstream
US MH:	M-904-009	DS MH:	M-904-012
		Total Length Surveyed (ft):	125.1

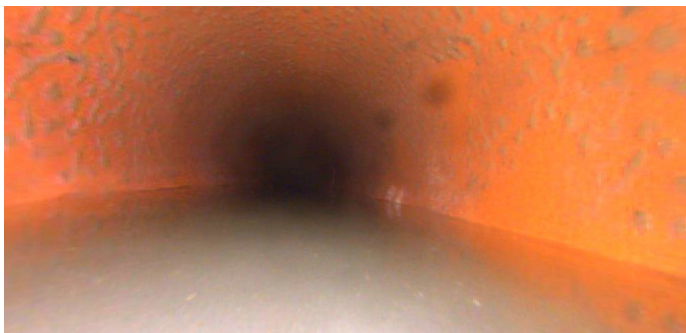
Code: **AMH**
Description: **Manhole**

Distance (ft): **.0**
Structural Grade: **0**
O&M Grade: **0**
Clock Start/From:
Clock To:
1st Value:
2nd Value:
Value Percent:
Continuous Index:
Within 8" of Joint: **NO**
Remarks: **M-904-009**

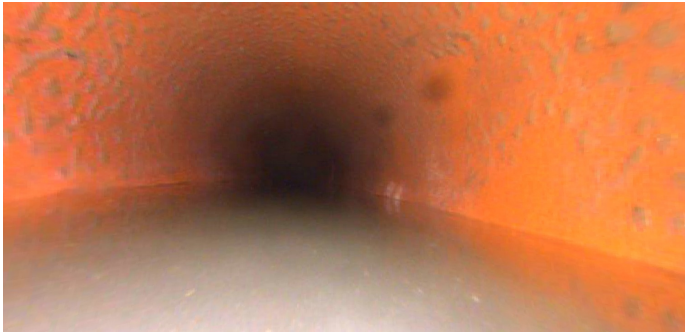
Code:	MWL
Description:	Water Level

Distance (ft):	.0
Structural Grade:	0
O&M Grade:	0
Clock Start/From:	
Clock To:	
1st Value:	
2nd Value:	
Value Percent:	5.000
Continuous Index:	
Within 8" of Joint:	NO
Remarks:

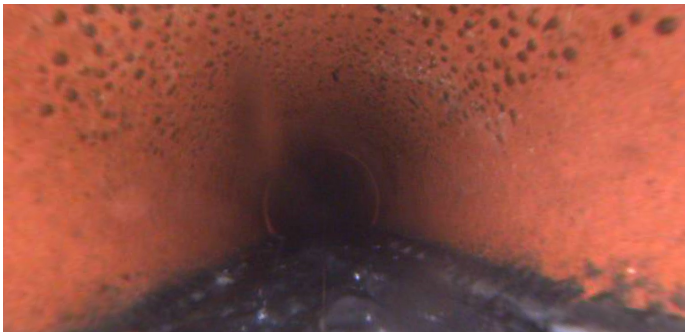
Code:	MGO
Description:	General Observation

Distance (ft):	46.4
Structural Grade:	0
O&M Grade:	0
Clock Start/From:	
Clock To:	
1st Value:	
2nd Value:	
Value Percent:	
Continuous Index:	
Within 8" of Joint:	NO
Remarks:	rear camera

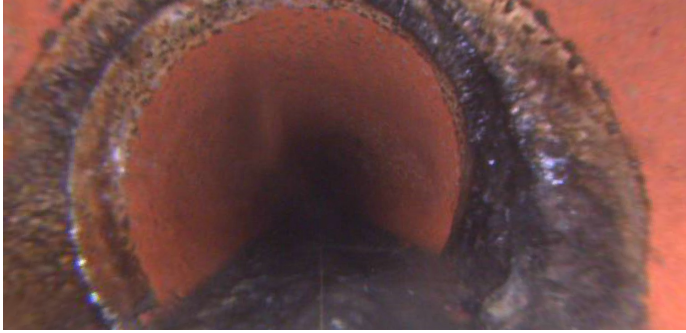
Code: **DAE**
Description: **Deposits Attached Encrustation**

Distance (ft): **54.8**
Structural Grade: **0**
O&M Grade: **2**
Clock Start/From: **8**
Clock To: **4**
1st Value:
2nd Value:
Value Percent: **5.000**
Continuous Index:
Within 8" of Joint: **YES**
Remarks:

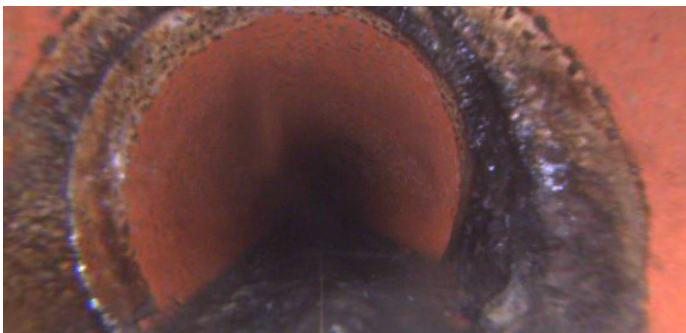
Code: **IW**
Description: **Infil Weeper**

Distance (ft): **54.8**
Structural Grade: **0**
O&M Grade: **2**
Clock Start/From: **8**
Clock To: **4**
1st Value:
2nd Value:
Value Percent:
Continuous Index:
Within 8" of Joint: **YES**
Remarks:

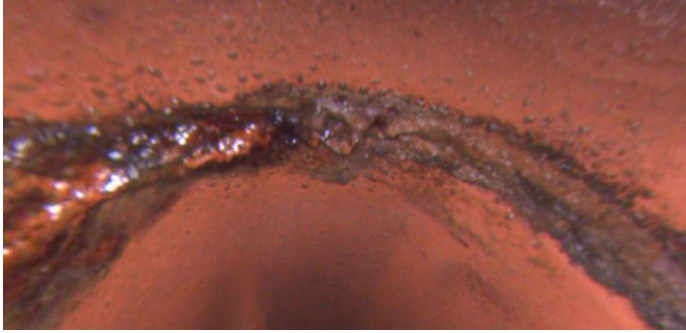
Code: ID
Description: Infil Dripper

Distance (ft): 90.8
Structural Grade: 0
O&M Grade: 3
Clock Start/From: 12
Clock To:
1st Value:
2nd Value:
Value Percent:
Continuous Index:
Within 8" of Joint: YES
Remarks:

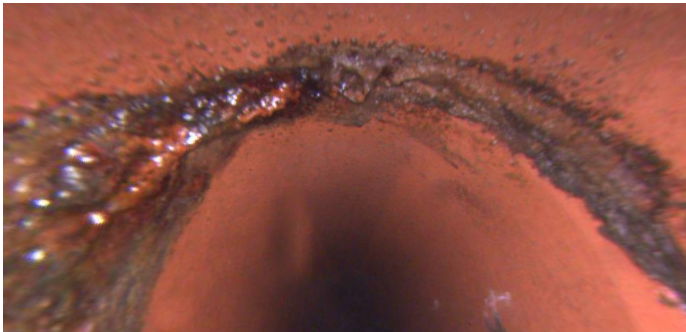
Code: DAE
Description: Deposits Attached Encrustation

Distance (ft): 90.8
Structural Grade: 0
O&M Grade: 2
Clock Start/From: 8
Clock To: 4
1st Value:
2nd Value:
Value Percent: 10.000
Continuous Index:
Within 8" of Joint: YES
Remarks:

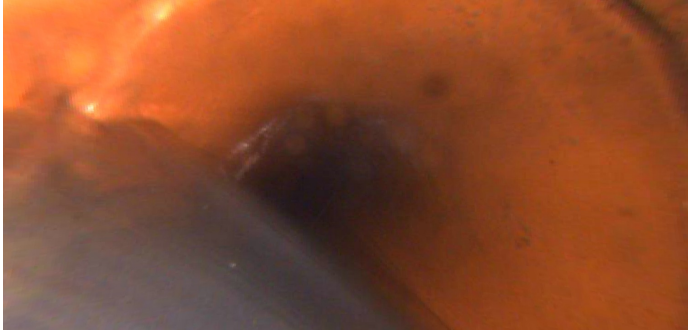
Code:	MSA
Description:	Abandoned Survey
Distance (ft):	125.1
Structural Grade:	0
O&M Grade:	0
Clock Start/From:	
Clock To:	
1st Value:	
2nd Value:	
Value Percent:	
Continuous Index:	
Within 8" of Joint:	NO
Remarks:	camera stopped
