Profile/Photo Observation Report

| Street: | Fraser Ln. | Flow Control: | Not Controlled |
| City: | Hobart, IN | Year Renewed: | |

| US MH: | M-904-009 | DS MH: | M-904-012 |

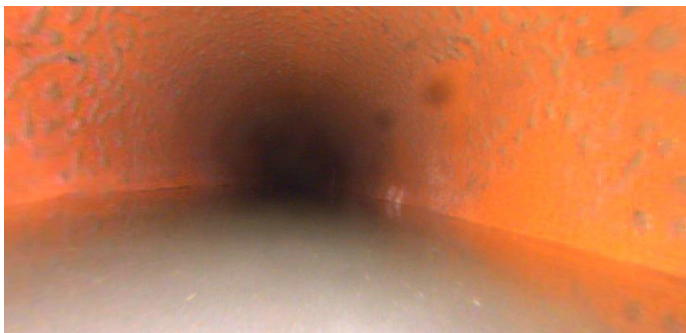
Code: **AMH**
Description: **Manhole**

Distance (ft): **.0**
Structural Grade: **0**
O&M Grade: **0**
Clock Start/From:
Clock To:
1st Value:
2nd Value:
Value Percent:
Continuous Index:
Within 8" of Joint: **NO**
Remarks: **M-904-009**

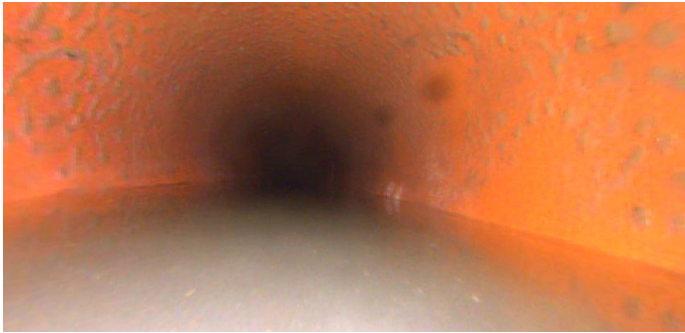
| Code: | MWL |
| Description: | Water Level |

| Value Percent: | 5.000 |

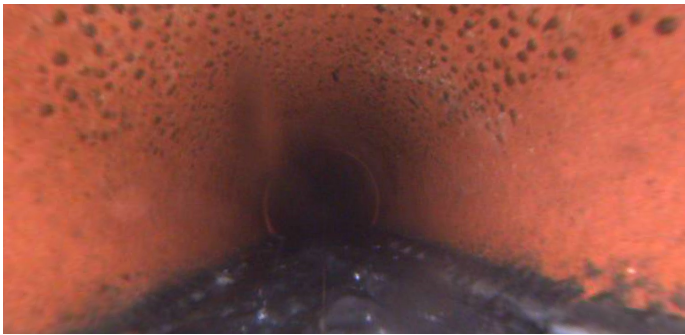
| Code: | MGO |
| Description: | General Observation |

| Remarks: | rear camera |

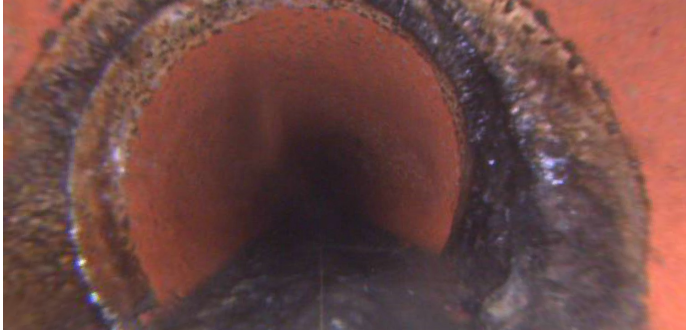
| | Position | Code | Observation | Video (sec) | Grade |
|--|---|---|---|---|---|
| | 54.8 | DAE | Deposits Attached Encrustation | 156 | M 2 |

Code: **DAE**
Description: **Deposits Attached Encrustation**

Distance (ft): **54.8**
Structural Grade: **0**
O&M Grade: **2**
Clock Start/From: **8**
Clock To: **4**
1st Value:
2nd Value:
Value Percent: **5.000**
Continuous Index:
Within 8" of Joint: **YES**
Remarks:

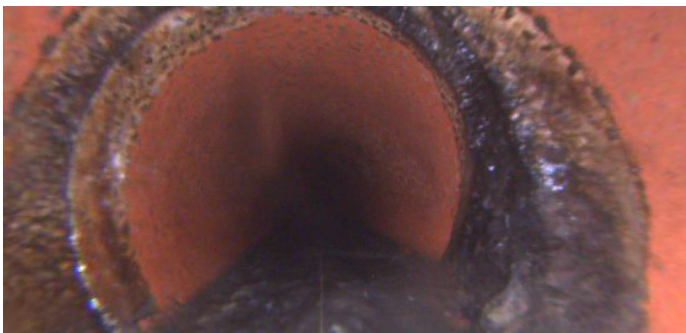
| | Position | Code | Observation | Video (sec) | Grade |
|--|---|---|---|---|---|
| | 54.8 | IW | Infil Weeper | 167 | M 2 |

Code: **IW**
Description: **Infil Weeper**

Distance (ft): **54.8**
Structural Grade: **0**
O&M Grade: **2**
Clock Start/From: **8**
Clock To: **4**
1st Value:
2nd Value:
Value Percent:
Continuous Index:
Within 8" of Joint: **YES**
Remarks:

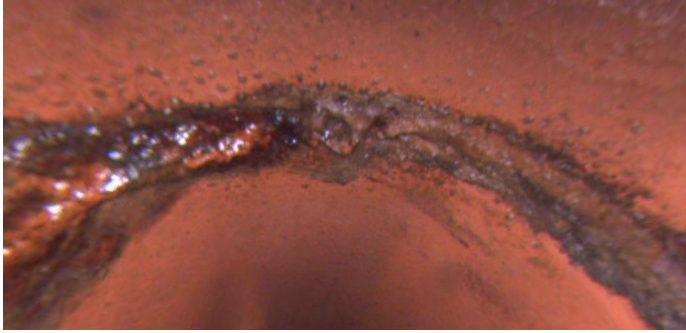
| | Position | Code | Observation | Video (sec) | Grade |
|--|---|---|---|---|---|
| | 90.8 | ID | Infil Dripper | 251 | M 3 |

Code: ID
Description: Infil Dripper

Distance (ft): 90.8
Structural Grade: 0
O&M Grade: 3
Clock Start/From: 12
Clock To:
1st Value:
2nd Value:
Value Percent:
Continuous Index:
Within 8" of Joint: YES
Remarks:

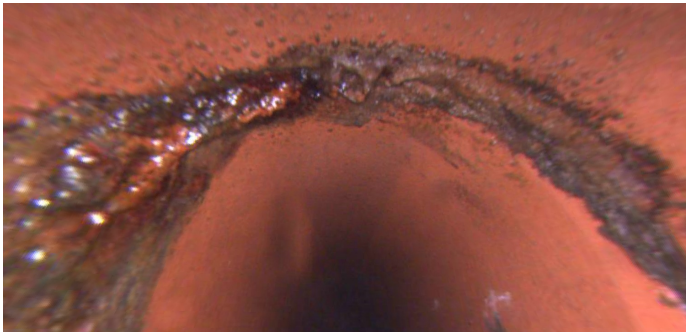
| | Position | Code | Observation | Video (sec) | Grade |
|--|---|---|---|---|---|
| | 90.8 | DAE | Deposits Attached Encrustation | 262 | M 2 |

Code: DAE
Description: Deposits Attached Encrustation

Distance (ft): 90.8
Structural Grade: 0
O&M Grade: 2
Clock Start/From: 8
Clock To: 4
1st Value:
2nd Value:
Value Percent: 10.000
Continuous Index:
Within 8" of Joint: YES
Remarks:

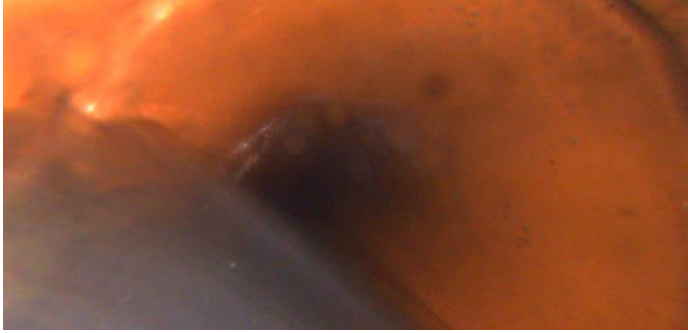
| Code: | MSA |
| Description: | Abandoned Survey |
| Distance (ft): | 125.1 |
| Remarks: | camera stopped |
