Profile/Photo Observation Report

Street:	FRASER LN	Flow Control:	Not Controlled
City:	Hobart, IN	Year Renewed:	
Location:	Other	Tape/Media #:	
Purpose:	Not Known	Dia/Height:	10"
Use:	Sanitary	Material:	VCP
Drain Area:	NA	Lining:	
Category:	NA		
Comment:

Location Details:		Direction of Survey:	Upstream
US MH:	M-904-009	DS MH:	M-904-012
		Total Length Surveyed (ft):	37.4

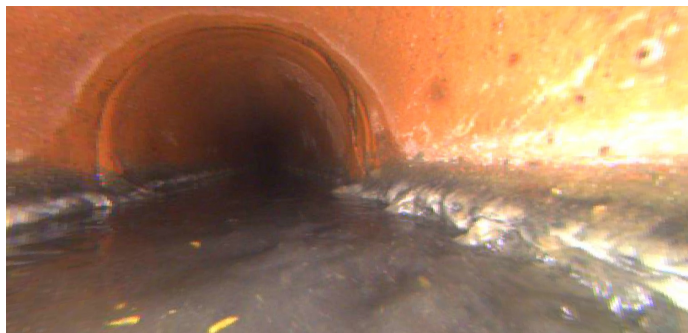
Code: **AMH**
Description: **Manhole**

Distance (ft): **.0**
Structural Grade: **0**
O&M Grade: **0**
Clock Start/From:
Clock To:
1st Value:
2nd Value:
Value Percent:
Continuous Index:
Within 8" of Joint: **NO**
Remarks: **M-904-012**

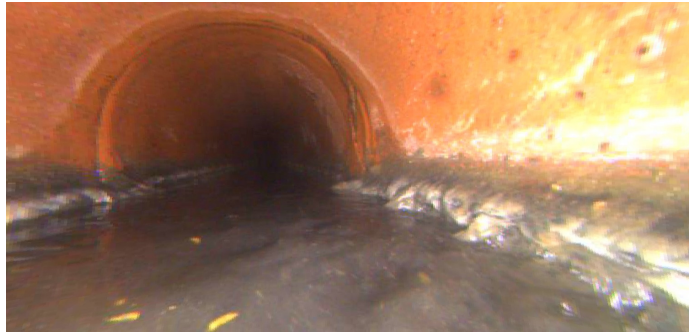
Code: **MWL**
Description: **Water Level**

Distance (ft): **.0**
Structural Grade: **0**
O&M Grade: **0**
Clock Start/From:
Clock To:
1st Value:
2nd Value:
Value Percent: **5.000**
Continuous Index:
Within 8" of Joint: **NO**
Remarks:

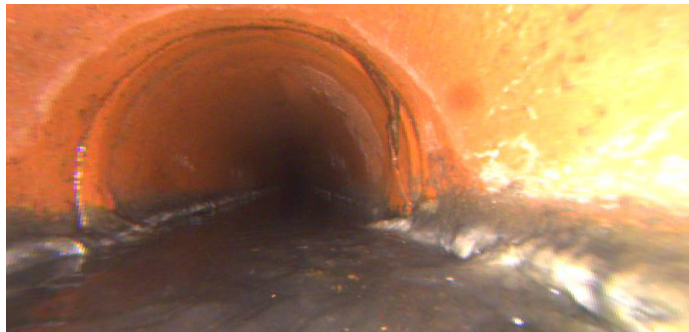
Code: **RFJ**
Description: **Roots Fine Joint**

Distance (ft): **.6**
Structural Grade: **0**
O&M Grade: **1**
Clock Start/From: **2**
Clock To: **5**
1st Value:
2nd Value:
Value Percent:
Continuous Index:
Within 8" of Joint: **YES**
Remarks:

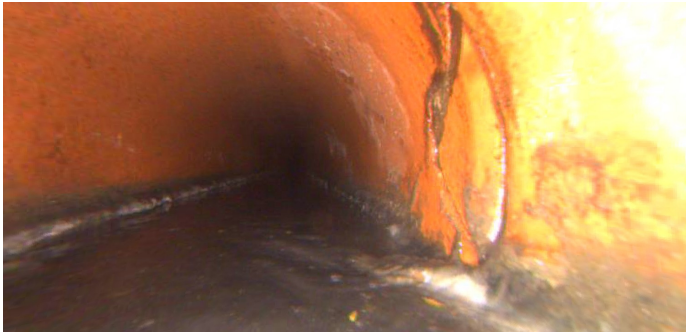
Code: **FS**
Description: **Fracture Spiral**

Distance (ft): **1.8**
Structural Grade: **3**
O&M Grade: **0**
Clock Start/From: **2**
Clock To: **4**
1st Value:
2nd Value:
Value Percent:
Continuous Index:
Within 8" of Joint: **YES**
Remarks:

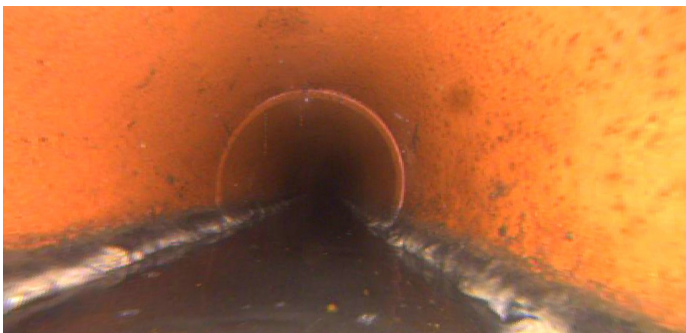
Code: **RFJ**
Description: **Roots Fine Joint**

Distance (ft): **5.8**
Structural Grade: **0**
O&M Grade: **1**
Clock Start/From: **11**
Clock To: **12**
1st Value:
2nd Value:
Value Percent:
Continuous Index:
Within 8" of Joint: **YES**
Remarks:

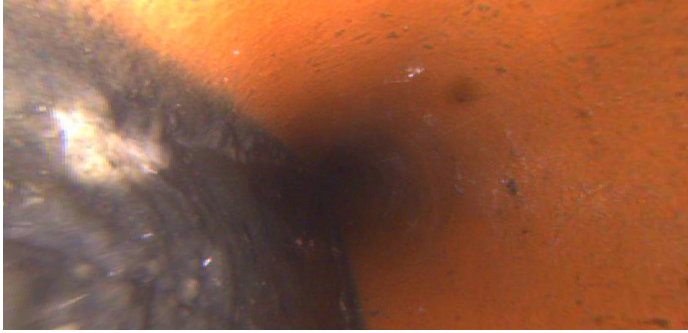
Code:	MSA
Description:	Abandoned Survey
Distance (ft):	37.4
Structural Grade:	0
O&M Grade:	0
Clock Start/From:	
Clock To:	
1st Value:	
2nd Value:	
Value Percent:	
Continuous Index:	
Within 8" of Joint:	NO
Remarks:	camera stopped
