Profile/Photo Observation Report

Date:	05/07/2018	Weather:		Coding:	PACP 4.2
Pipe Length (ft):	150.0	Owner:	City of Hobart	Pre Clean:	No Pre-Cleaning
P.O.#:	2004	Surveyor:	SAN	PSR:	P-904-010-041
Customer:	Red Zone	Clean Date:		Shape:	C

Street:	144 Fraser Ln	Flow Control:	Not Controlled
City:	Hobart In	Year Renewed:	
Location:	Easement/Right of Way	Tape/Media #:	Deliverable 1
Purpose:	Routine Assessment	Dia/Height:	18"
Use:	Sanitary	Material:	VCP
Drain Area:	Northeast	Lining:	
Category:	NA		
Comment:	455-1/Incomplete due to debris/No reverse due to covered manhole 010.		
Location Details:	Backyards	Direction of Survey:	Upstream
US MH:	M-904-010	DS MH:	M-904-041
		Total Length Surveyed (ft):	127.2

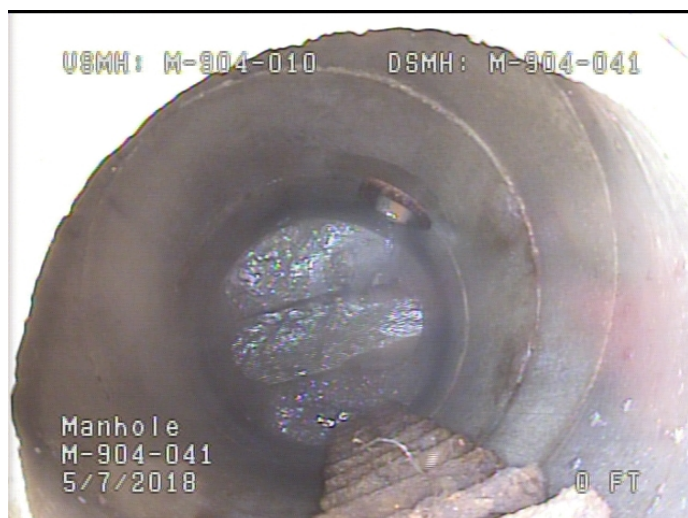
Code:	AMH
Description:	Manhole
Distance (ft):	.0
Structural Grade:	0
O&M Grade:	0
Clock Start/From:	
Clock To:	
1st Value:	
2nd Value:	
Value Percent:	
Continuous Index:	
Within 8" of Joint:	NO
Remarks:	M-904-041

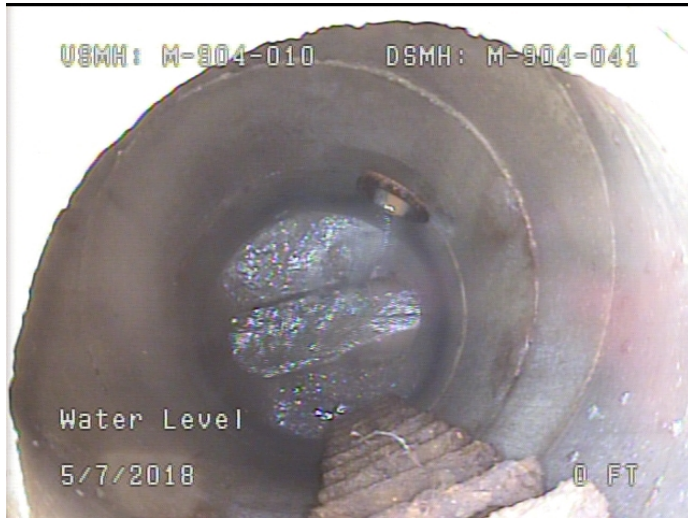
Code: **MWL**
Description: **Water Level**

Distance (ft): **.0**
Structural Grade: **0**
O&M Grade: **0**
Clock Start/From:
Clock To:
1st Value:
2nd Value:
Value Percent: **10.000**
Continuous Index:
Within 8" of Joint: **NO**
Remarks:

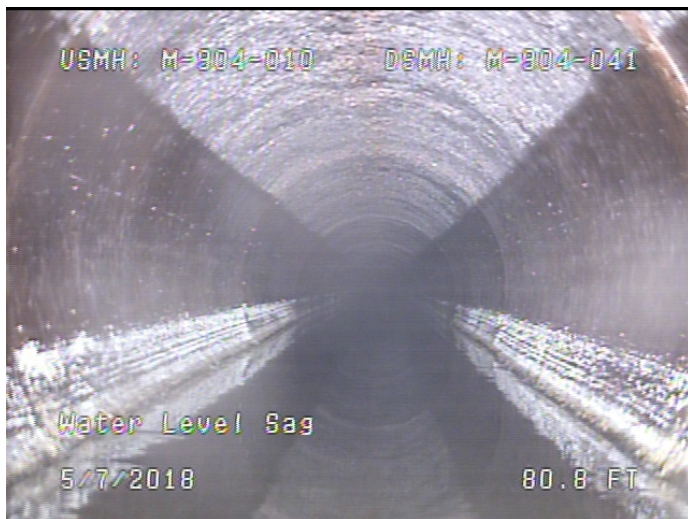
Code: **MWLS**
Description: **Water Level Sag**

Distance (ft): **80.8**
Structural Grade: **2**
O&M Grade: **3**
Clock Start/From:
Clock To:
1st Value:
2nd Value:
Value Percent: **20.000**
Continuous Index: **S01**
Within 8" of Joint: **NO**
Remarks:

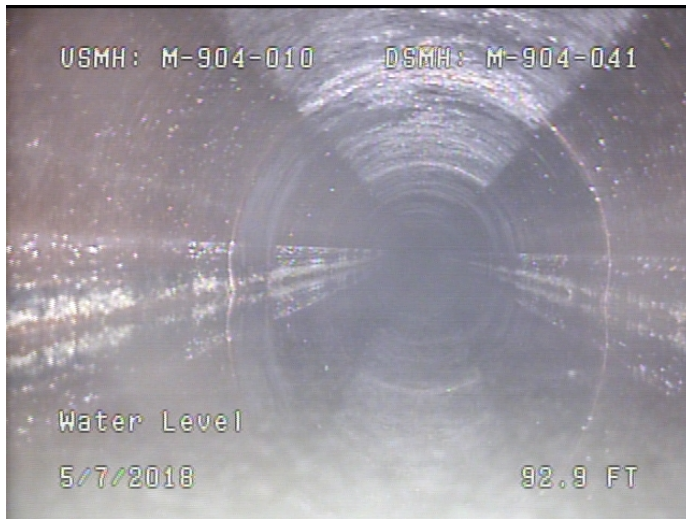
Code:	MWL
Description:	Water Level
Distance (ft):	92.9
Structural Grade:	0
O&M Grade:	0
Clock Start/From:	
Clock To:	
1st Value:	
2nd Value:	
Value Percent:	35.000
Continuous Index:	
Within 8" of Joint:	NO
Remarks:

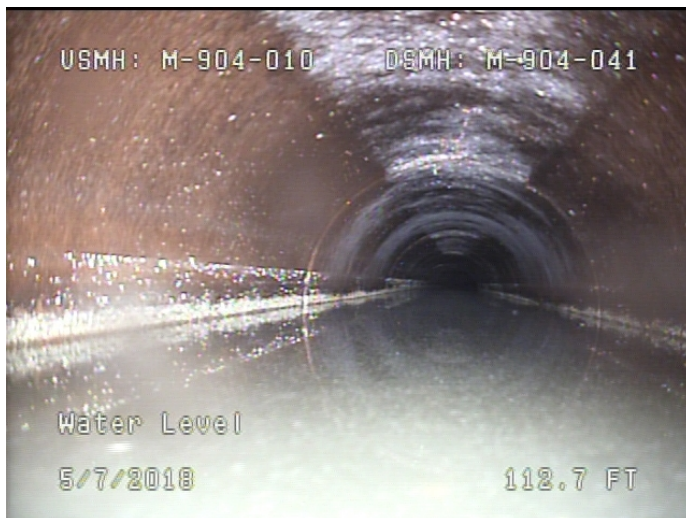
Code:	MWL
Description:	Water Level
Distance (ft):	112.7
Structural Grade:	0
O&M Grade:	0
Clock Start/From:	
Clock To:	
1st Value:	
2nd Value:	
Value Percent:	40.000
Continuous Index:	
Within 8" of Joint:	NO
Remarks:

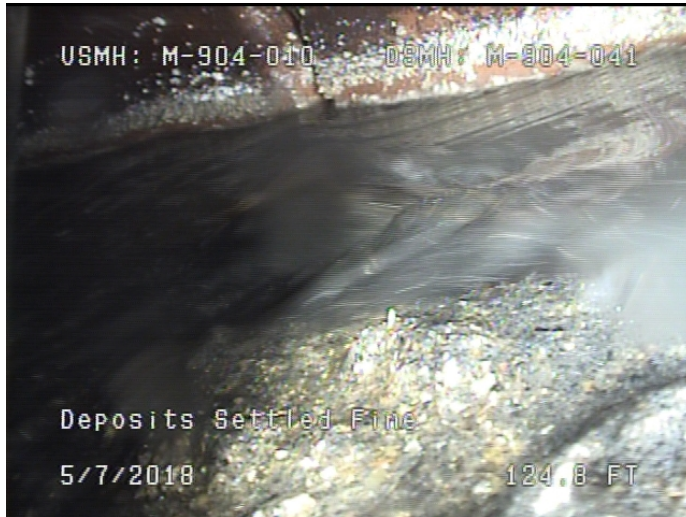
Code: **DSF**
Description: **Deposits Settled Fine**

Distance (ft): **124.8**
Structural Grade: **0**
O&M Grade: **4**
Clock Start/From: **5**
Clock To: **7**
1st Value:
2nd Value:
Value Percent: **30.000**
Continuous Index:
Within 8" of Joint: **NO**
Remarks:

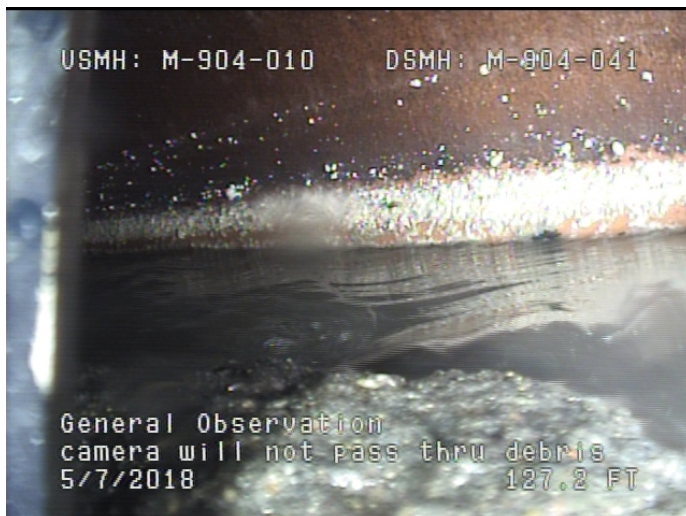
Code: **MGO**
Description: **General Observation**

Distance (ft): **127.2**
Structural Grade: **0**
O&M Grade: **0**
Clock Start/From:
Clock To:
1st Value:
2nd Value:
Value Percent:
Continuous Index:
Within 8" of Joint: **NO**
Remarks: **camera will not pass thru debris**

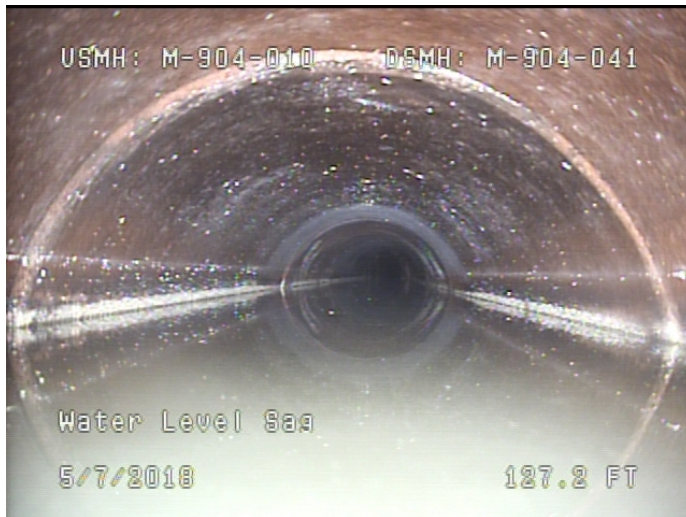
Code: **MWLS**
 Description: **Water Level Sag**

Distance (ft): **127.2**
 Structural Grade: **2**
 O&M Grade: **3**
 Clock Start/From:
 Clock To:
 1st Value:
 2nd Value:
 Value Percent: **20.000**
 Continuous Index: **F01**
 Within 8" of Joint: **NO**
 Remarks:

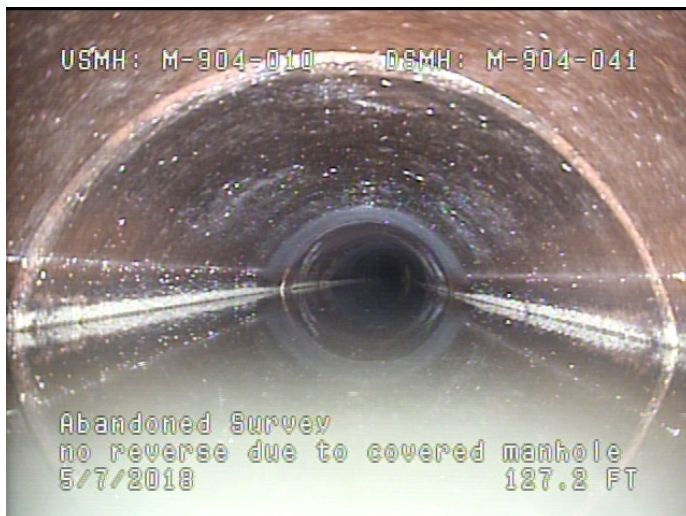
Code: **MSA**
 Description: **Abandoned Survey**

Distance (ft): **127.2**
 Structural Grade: **0**
 O&M Grade: **0**
 Clock Start/From:
 Clock To:
 1st Value:
 2nd Value:
 Value Percent:
 Continuous Index:
 Within 8" of Joint: **NO**
 Remarks: **no reverse due to covered manhole**
