## Profile/Photo Observation Report

Date:	<b>01/28/2025</b>	Weather:		Coding:	<b>PACP 7.0</b>
Pipe Length (ft):	<b>151.0</b>	Owner:	<b>City of Hobart</b>	Pre Clean:	<b>Heavy Cleaning</b>
P.O.#:	<b>YES502259</b>	Surveyor:	<b>S. Bucklin</b>	PSR:	<b>P-904-010-041</b>
Customer:	<b>City of Hobart</b>	Clean Date:	<b>12/10/2024</b>	Shape:	<b>C</b>

Street:	<b>Hickey Place</b>	Flow Control:	<b>Not Controlled</b>
City:	<b>Hobart, IN</b>	Year Renewed:	
Location:	<b>Other</b>	Tape/Media #:	
Purpose:	<b>Sewer System Evaluation Survey (SS</b>	Dia/Height:	<b>18"</b>
Use:	<b>Sanitary Sewage Pipe</b>	Material:	<b>VCP</b>
Drain Area:		Lining:	<b>None</b>
Category:	<b>NA</b>		
Comment:			
Location Details:	<b>BIKE TRAIL ACCESS</b>	Direction of Survey:	<b>Downstream</b>
US MH:	<b>M-904-010</b>	DS MH:	<b>M-904-041</b>
		Total Length Surveyed (ft):	<b>151.6</b>

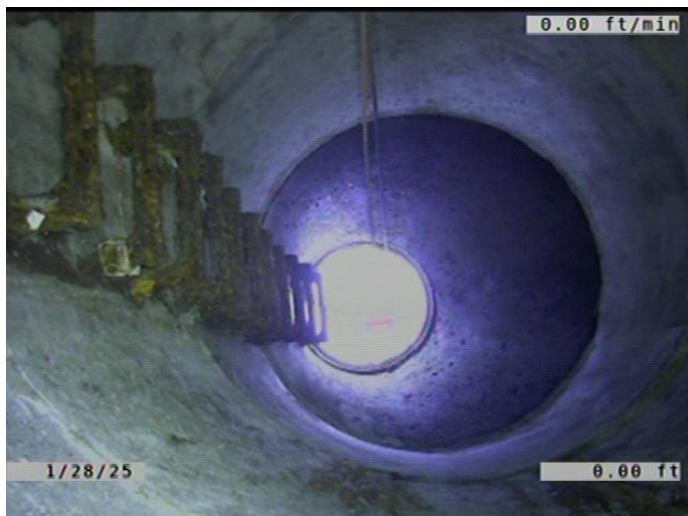
Code: **AMH**  
Description: **Manhole**

Distance (ft): **.0**  
Structural Grade: **0**  
O&M Grade: **0**  
Clock Start/From:  
Clock To:  
1st Value:  
2nd Value:  
Value Percent:  
Continuous Index:  
Within 8" of Joint: **NO**  
Remarks: **M-904-010**

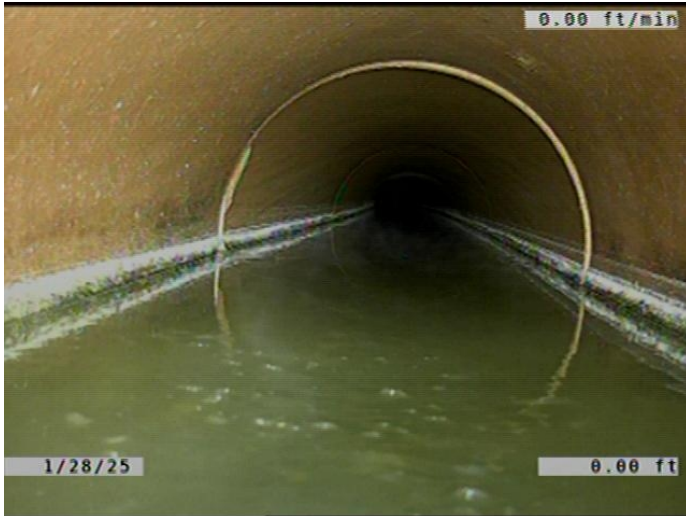
Code: **MWL**  
Description: **Miscellaneous Water Level**

Distance (ft): **.0**  
Structural Grade: **0**  
O&M Grade: **0**  
Clock Start/From:  
Clock To:  
1st Value:  
2nd Value:  
Value Percent: **45.000**  
Continuous Index:  
Within 8" of Joint: **NO**  
Remarks:

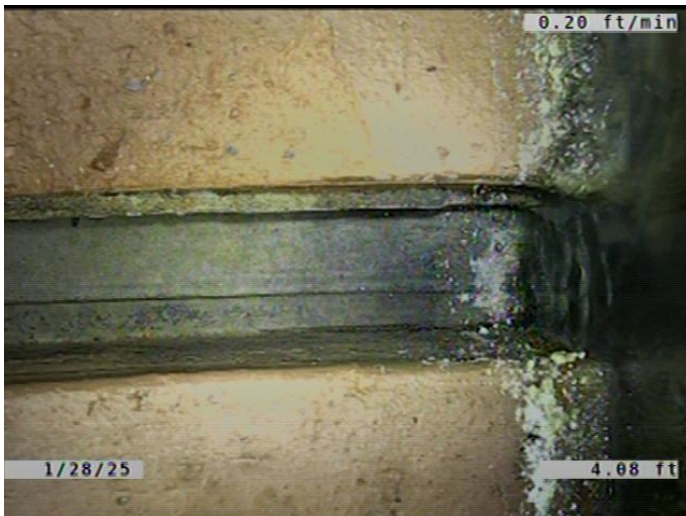
Code: **JAM**  
Description: **Joint Angular Medium**

Distance (ft): **4.1**  
Structural Grade: **3**  
O&M Grade: **0**  
Clock Start/From:  
Clock To:  
1st Value:  
2nd Value:  
Value Percent:  
Continuous Index:  
Within 8" of Joint: **NO**  
Remarks:

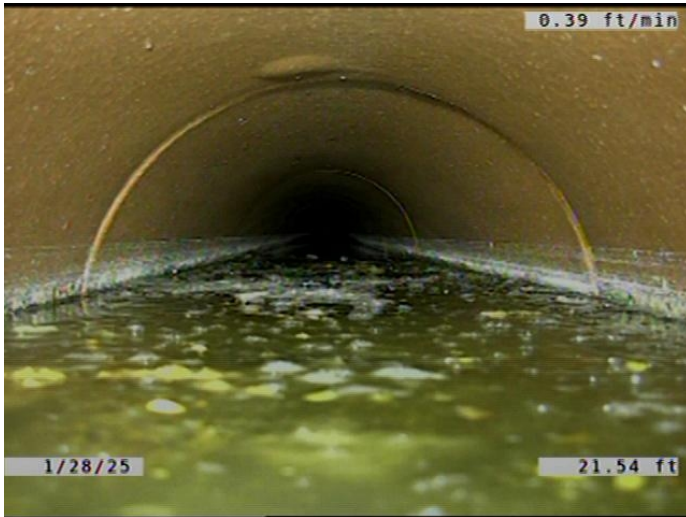
Code: **MWL**  
Description: **Miscellaneous Water Level**

Distance (ft): **21.5**  
Structural Grade: **0**  
O&M Grade: **0**  
Clock Start/From:  
Clock To:  
1st Value:  
2nd Value:  
Value Percent: **65.000**  
Continuous Index:  
Within 8" of Joint: **NO**  
Remarks:

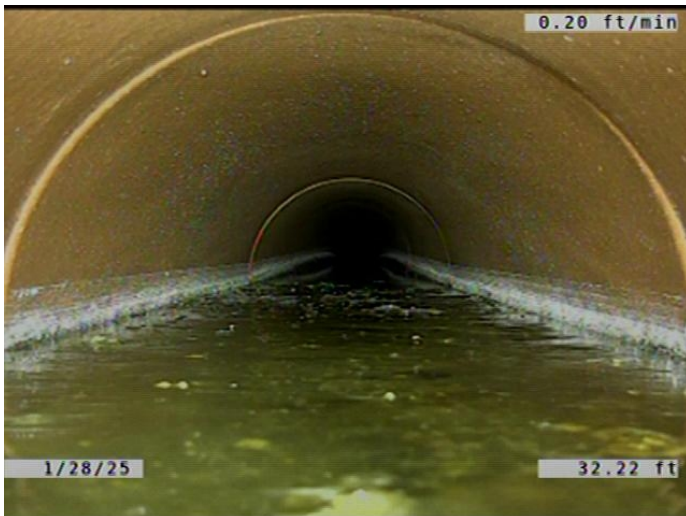
Code: **MWL**  
Description: **Miscellaneous Water Level**

Distance (ft): **32.2**  
Structural Grade: **0**  
O&M Grade: **0**  
Clock Start/From:  
Clock To:  
1st Value:  
2nd Value:  
Value Percent: **45.000**  
Continuous Index:  
Within 8" of Joint: **NO**  
Remarks:

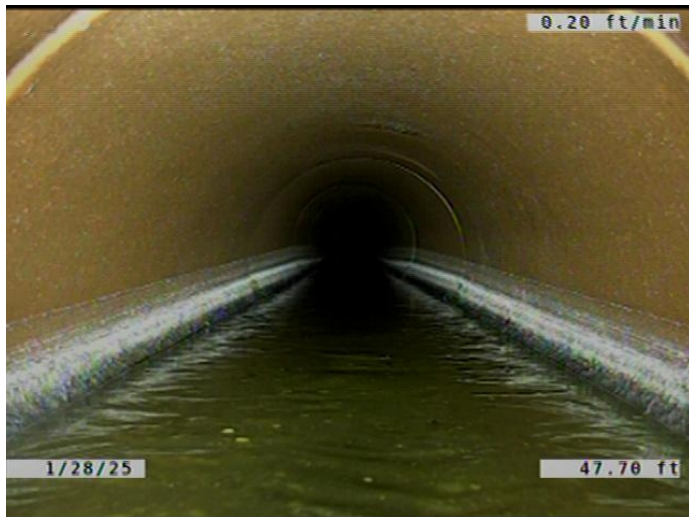
Code: **MWL**  
 Description: **Miscellaneous Water Level**

Distance (ft): **47.7**  
 Structural Grade: **0**  
 O&M Grade: **0**  
 Clock Start/From:  
 Clock To:  
 1st Value:  
 2nd Value:  
 Value Percent: **25.000**  
 Continuous Index:  
 Within 8" of Joint: **NO**  
 Remarks:

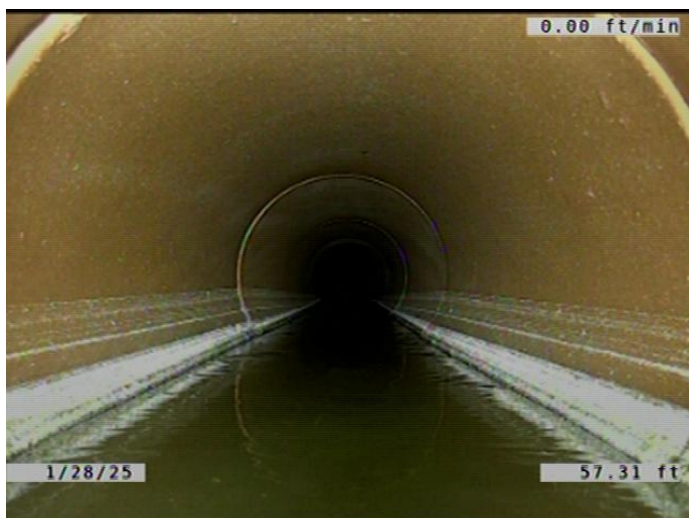
Code: **MWL**  
 Description: **Miscellaneous Water Level**

Distance (ft): **57.3**  
 Structural Grade: **0**  
 O&M Grade: **0**  
 Clock Start/From:  
 Clock To:  
 1st Value:  
 2nd Value:  
 Value Percent: **15.000**  
 Continuous Index:  
 Within 8" of Joint: **NO**  
 Remarks:

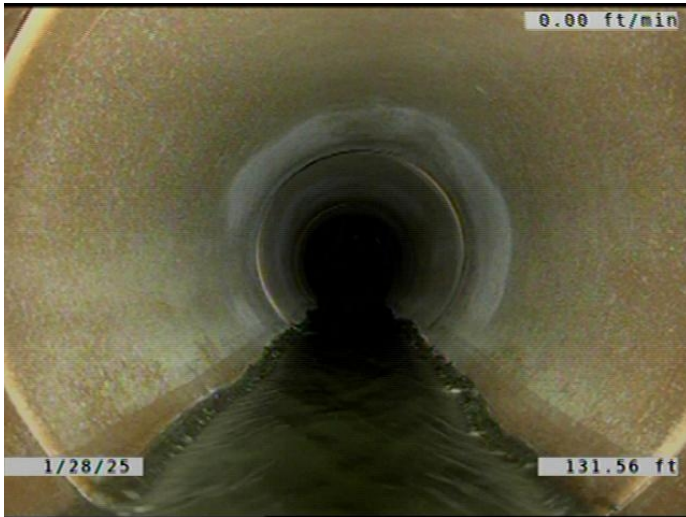
Code: **MWL**  
Description: **Miscellaneous Water Level**

Distance (ft): **131.6**  
Structural Grade: **0**  
O&M Grade: **0**  
Clock Start/From:  
Clock To:  
1st Value:  
2nd Value:  
Value Percent: **5.000**  
Continuous Index:  
Within 8" of Joint: **NO**  
Remarks:

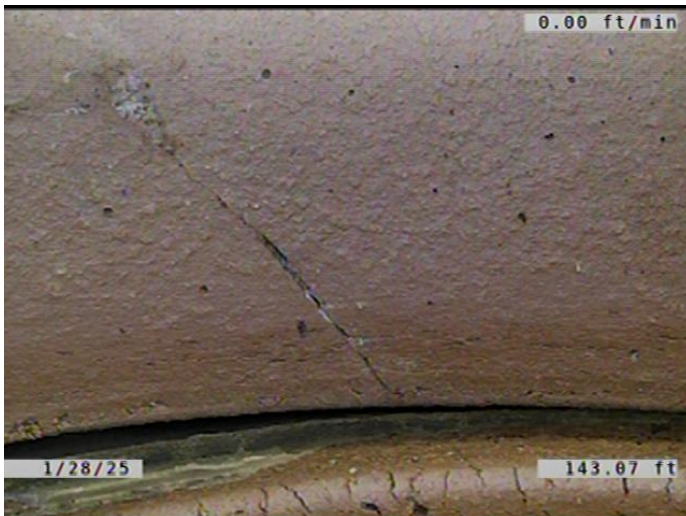
Code: **CL**  
Description: **Crack Longitudinal**

Distance (ft): **143.1**  
Structural Grade: **2**  
O&M Grade: **0**  
Clock Start/From: **10**  
Clock To:  
1st Value:  
2nd Value:  
Value Percent:  
Continuous Index:  
Within 8" of Joint: **YES**  
Remarks:

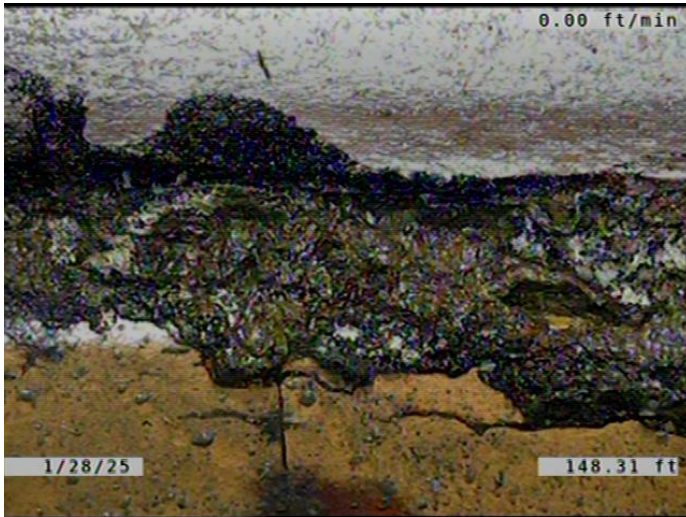
Code: **DAE**  
Description: **Deposits Attached Encrustation**

Distance (ft): **148.3**  
Structural Grade: **0**  
O&M Grade: **2**  
Clock Start/From: **7**  
Clock To: **5**  
1st Value:  
2nd Value:  
Value Percent: **5.000**  
Continuous Index:  
Within 8" of Joint: **YES**  
Remarks:

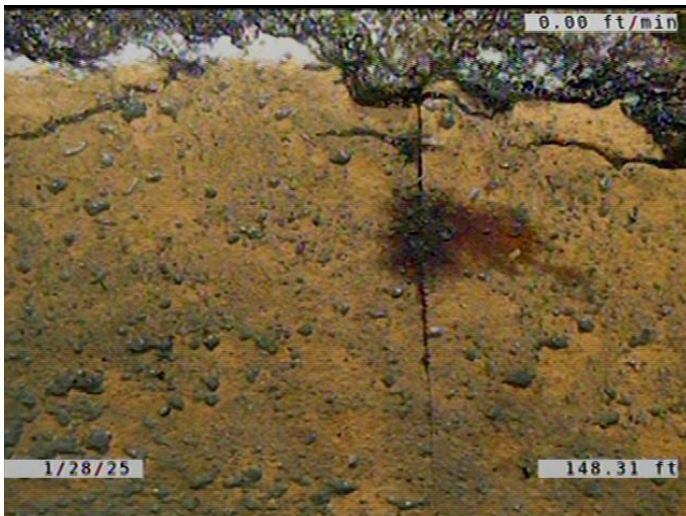
Code: **CL**  
Description: **Crack Longitudinal**

Distance (ft): **148.3**  
Structural Grade: **2**  
O&M Grade: **0**  
Clock Start/From: **12**  
Clock To:  
1st Value:  
2nd Value:  
Value Percent:  
Continuous Index:  
Within 8" of Joint: **YES**  
Remarks:

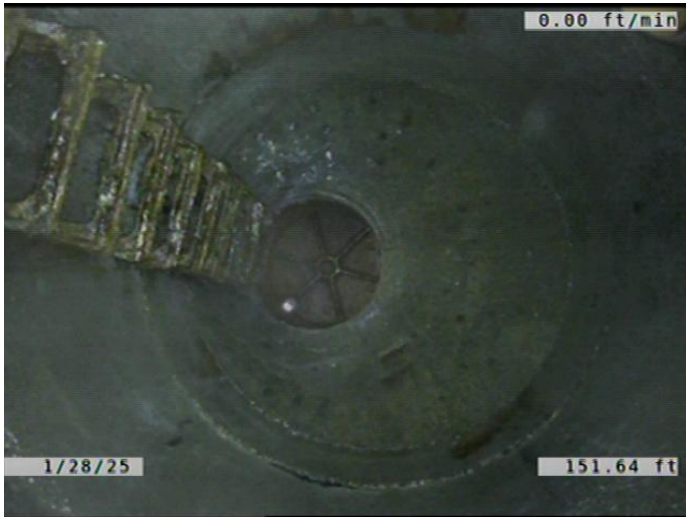
Code:	AMH
Description:	Manhole
Distance (ft):	151.6
Structural Grade:	0
O&M Grade:	0
Clock Start/From:	
Clock To:	
1st Value:	
2nd Value:	
Value Percent:	
Continuous Index:	
Within 8" of Joint:	NO
Remarks:	M-904-041
