Profile/Photo Observation Report

Date:	04/16/2018	Weather:		Coding:	PACP 6.0
Pipe Length (ft):	74.1	Owner:	NA	Pre Clean:	Not Known
P.O.#:		Surveyor:	Selasie Honu	PSR:	P-904-013-012
Customer:		Clean Date:	01/01/1900	Shape:	C

Street:	FRASER LN	Flow Control:	Not Controlled
City:	Hobart, IN	Year Renewed:	
Location:	Other	Tape/Media #:	
Purpose:	Not Known	Dia/Height:	8"
Use:	Sanitary	Material:	VCP
Drain Area:	NA	Lining:	
Category:	NA		
Comment:

Location Details:		Direction of Survey:	Upstream
US MH:	M-904-013	DS MH:	M-904-012
		Total Length Surveyed (ft):	70.4

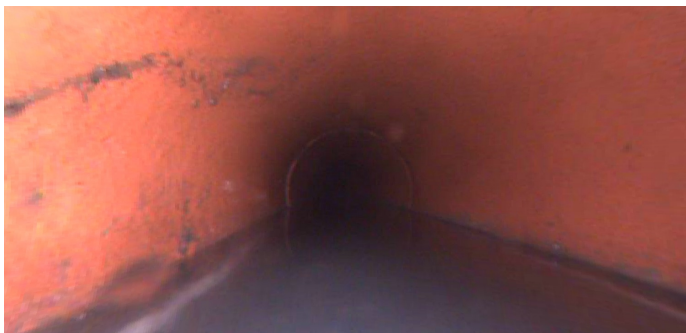
Code: **AMH**
Description: **Manhole**

Distance (ft): **.0**
Structural Grade: **0**
O&M Grade: **0**
Clock Start/From:
Clock To:
1st Value:
2nd Value:
Value Percent:
Continuous Index:
Within 8" of Joint: **NO**
Remarks: **M-904-012**

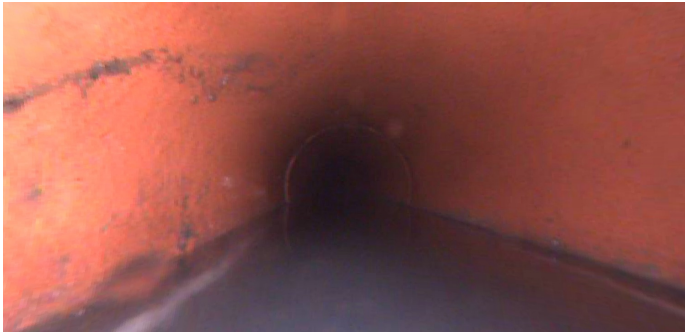
Code:	MWL
Description:	Water Level

Distance (ft):	.0
Structural Grade:	0
O&M Grade:	0
Clock Start/From:	
Clock To:	
1st Value:	
2nd Value:	
Value Percent:	5.000
Continuous Index:	
Within 8" of Joint:	NO
Remarks:

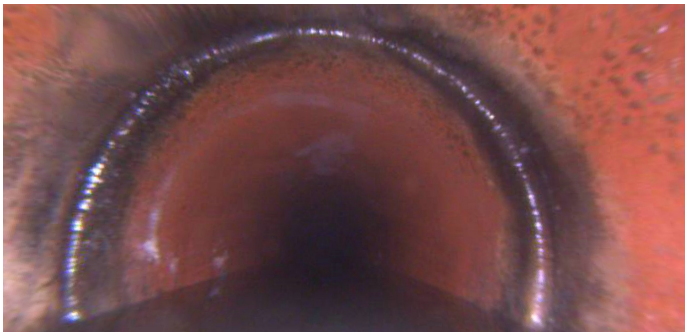
Code:	IW
Description:	Infil Weeper

Distance (ft):	27.2
Structural Grade:	0
O&M Grade:	2
Clock Start/From:	8
Clock To:	4
1st Value:	
2nd Value:	
Value Percent:	
Continuous Index:	
Within 8" of Joint:	YES
Remarks:

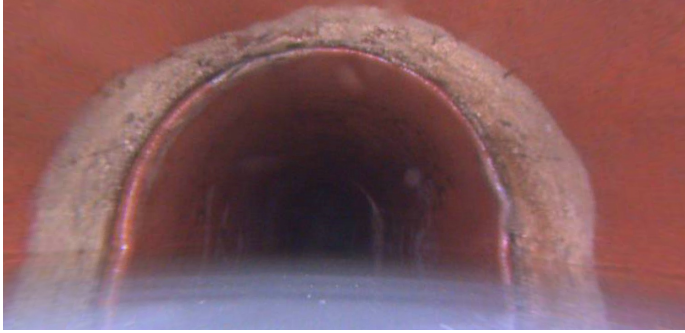
Code: **DAE**
Description: **Deposits Attached Encrustation**

Distance (ft): **66.1**
Structural Grade: **0**
O&M Grade: **2**
Clock Start/From: **8**
Clock To: **4**
1st Value:
2nd Value:
Value Percent: **5.000**
Continuous Index:
Within 8" of Joint: **YES**
Remarks:

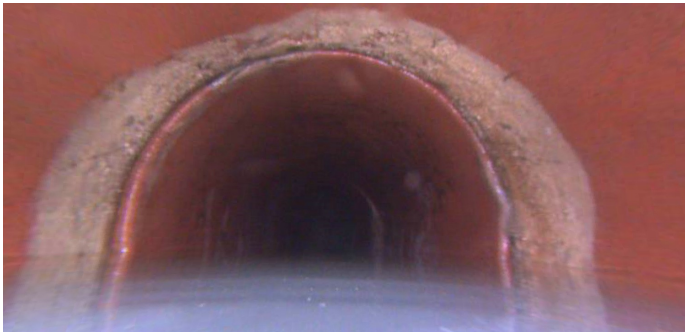
Code: **MWL**
Description: **Water Level**

Distance (ft): **66.1**
Structural Grade: **0**
O&M Grade: **0**
Clock Start/From:
Clock To:
1st Value:
2nd Value:
Value Percent: **40.000**
Continuous Index:
Within 8" of Joint: **NO**
Remarks:

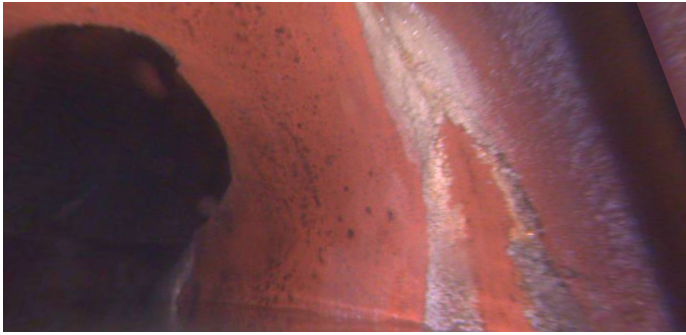
Code: **CC**
Description: **Crack Circumferential**

Distance (ft): **67.9**
Structural Grade: **1**
O&M Grade: **0**
Clock Start/From: **2**
Clock To: **4**
1st Value:
2nd Value:
Value Percent:
Continuous Index:
Within 8" of Joint:
Remarks:

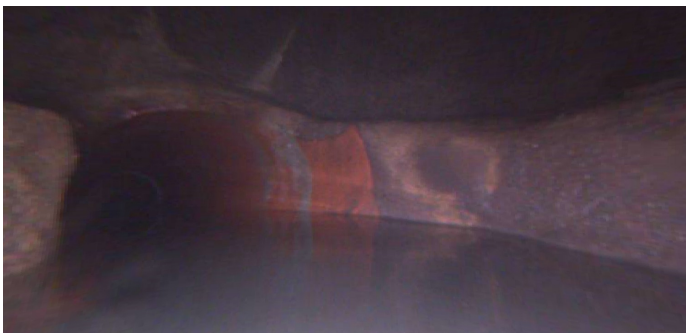
Code: **AMH**
Description: **Manhole**

Distance (ft): **70.4**
Structural Grade: **0**
O&M Grade: **0**
Clock Start/From:
Clock To:
1st Value:
2nd Value:
Value Percent:
Continuous Index:
Within 8" of Joint: **NO**
Remarks: **M-904-013**
