Profile/Photo Observation Report

Date:	04/16/2018	Weather:		Coding:	PACP 6.0
Pipe Length (ft):	74.1	Owner:	NA	Pre Clean:	Not Known
P.O.#:		Surveyor:	Selasie Honu	PSR:	P-904-013-012
Customer:		Clean Date:	01/01/1900	Shape:	C

Street:	Fraser Ln.	Flow Control:	Not Controlled
City:	Hobart, IN	Year Renewed:	
Location:	Other	Tape/Media #:	
Purpose:	Not Known	Dia/Height:	8"
Use:	Sanitary	Material:	VCP
Drain Area:	NA	Lining:	
Category:	NA		
Comment:

Location Details:		Direction of Survey:	Upstream
US MH:	M-904-013	DS MH:	M-904-012
		Total Length Surveyed (ft):	70.4

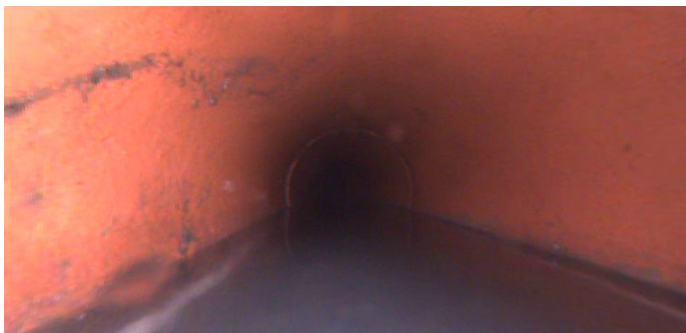
Code: **AMH**
Description: **Manhole**

Distance (ft): **.0**
Structural Grade: **0**
O&M Grade: **0**
Clock Start/From:
Clock To:
1st Value:
2nd Value:
Value Percent:
Continuous Index:
Within 8" of Joint: **NO**
Remarks: **M-904-012**

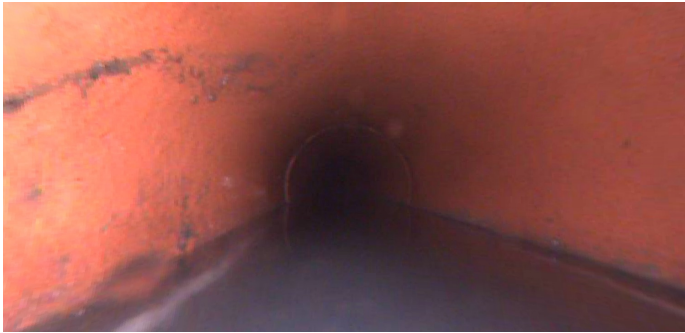
Code:	MWL
Description:	Water Level

Distance (ft):	.0
Structural Grade:	0
O&M Grade:	0
Clock Start/From:	
Clock To:	
1st Value:	
2nd Value:	
Value Percent:	5.000
Continuous Index:	
Within 8" of Joint:	NO
Remarks:

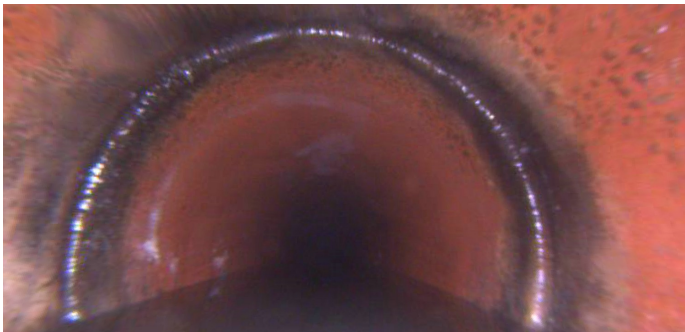
Code:	IW
Description:	Infil Weeper

Distance (ft):	27.2
Structural Grade:	0
O&M Grade:	2
Clock Start/From:	8
Clock To:	4
1st Value:	
2nd Value:	
Value Percent:	
Continuous Index:	
Within 8" of Joint:	YES
Remarks:

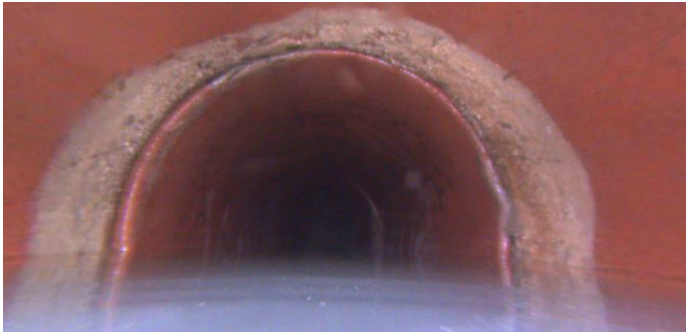
Code: **DAE**
Description: **Deposits Attached Encrustation**

Distance (ft): **66.1**
Structural Grade: **0**
O&M Grade: **2**
Clock Start/From: **8**
Clock To: **4**
1st Value:
2nd Value:
Value Percent: **5.000**
Continuous Index:
Within 8" of Joint: **YES**
Remarks:

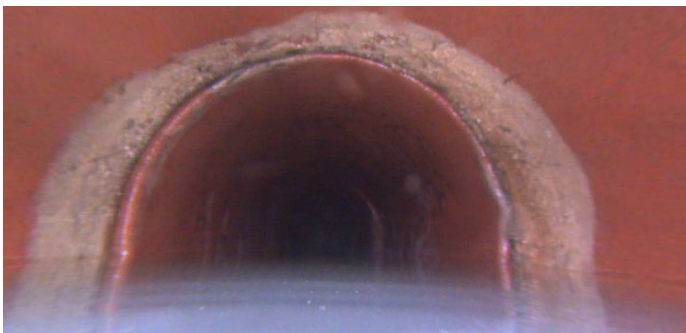
Code: **MWL**
Description: **Water Level**

Distance (ft): **66.1**
Structural Grade: **0**
O&M Grade: **0**
Clock Start/From:
Clock To:
1st Value:
2nd Value:
Value Percent: **40.000**
Continuous Index:
Within 8" of Joint: **NO**
Remarks:

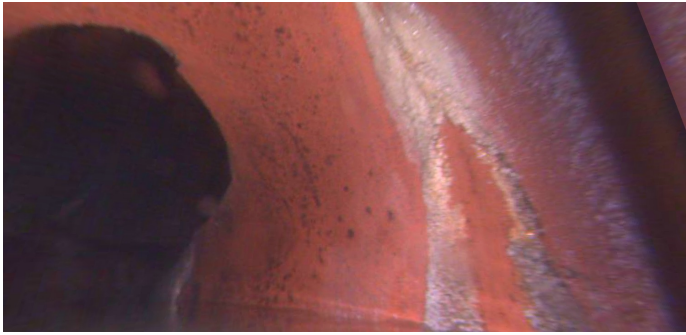
Code: **CC**
Description: **Crack Circumferential**

Distance (ft): **67.9**
Structural Grade: **1**
O&M Grade: **0**
Clock Start/From: **2**
Clock To: **4**
1st Value:
2nd Value:
Value Percent:
Continuous Index:
Within 8" of Joint:
Remarks:

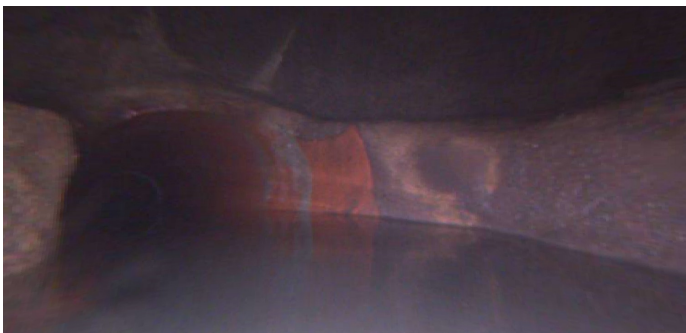
Code: **AMH**
Description: **Manhole**

Distance (ft): **70.4**
Structural Grade: **0**
O&M Grade: **0**
Clock Start/From:
Clock To:
1st Value:
2nd Value:
Value Percent:
Continuous Index:
Within 8" of Joint: **NO**
Remarks: **M-904-013**
