Profile/Photo Observation Report

Street:	FRASER LN	Flow Control:	Not Controlled
City:	Hobart, IN	Year Renewed:	
Location:	Other	Tape/Media #:	
Purpose:	Not Known	Dia/Height:	10"
Use:	Sanitary	Material:	VCP
Drain Area:	NA	Lining:	
Category:	NA		
Comment:

Location Details:		Direction of Survey:	Downstream
US MH:	M-904-014	DS MH:	M-904-013
		Total Length Surveyed (ft):	30.9

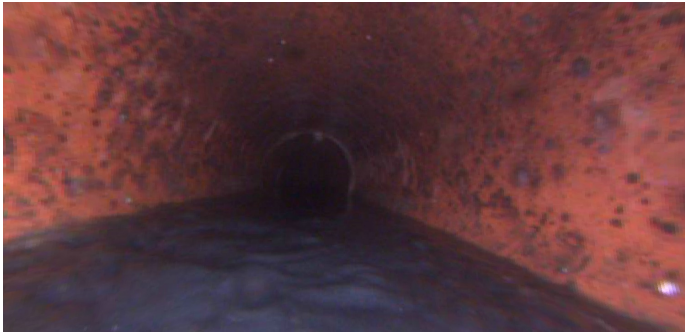
Code:	MWL
Description:	Water Level

Distance (ft):	.0
Structural Grade:	0
O&M Grade:	0
Clock Start/From:	
Clock To:	
1st Value:	
2nd Value:	
Value Percent:	5.000
Continuous Index:	
Within 8" of Joint:	NO
Remarks:

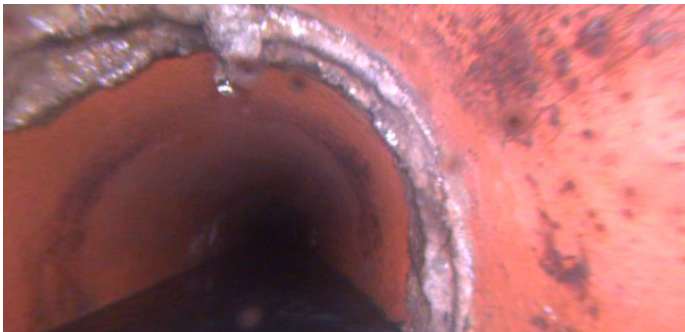
Code:	ID
Description:	Infil Dripper

Distance (ft):	3.2
Structural Grade:	0
O&M Grade:	3
Clock Start/From:	12
Clock To:	
1st Value:	
2nd Value:	
Value Percent:	
Continuous Index:	
Within 8" of Joint:	YES
Remarks:

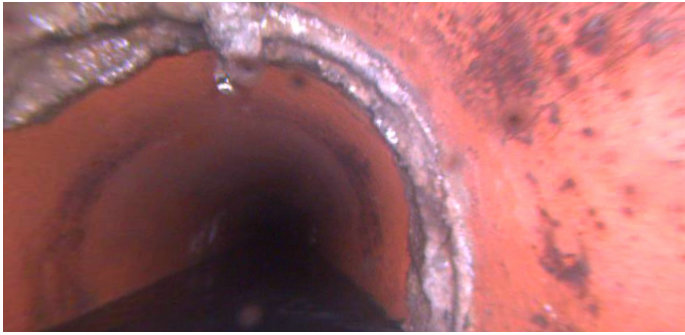
Code: **DAE**
Description: **Deposits Attached Encrustation**

Distance (ft): **3.2**
Structural Grade: **0**
O&M Grade: **2**
Clock Start/From: **8**
Clock To: **4**
1st Value:
2nd Value:
Value Percent: **5.000**
Continuous Index:
Within 8" of Joint: **YES**
Remarks:

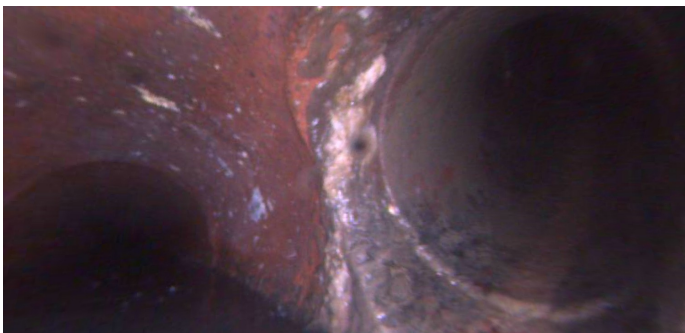
Code: **TF**
Description: **Tap Factory**

Distance (ft): **13.4**
Structural Grade: **0**
O&M Grade: **0**
Clock Start/From: **3**
Clock To:
1st Value: **4.000**
2nd Value:
Value Percent:
Continuous Index:
Within 8" of Joint:
Remarks:

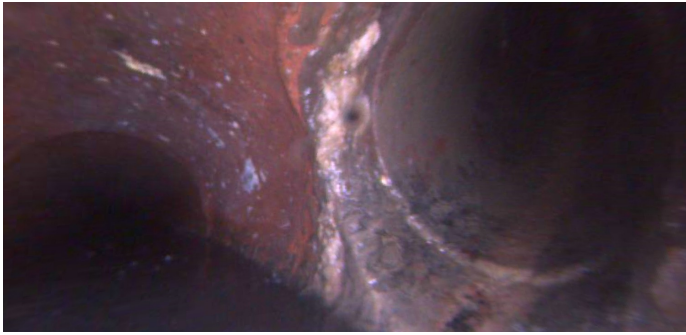
Code: **TBI**
Description: **Tap Break-in Intruding**

Distance (ft): **13.4**
Structural Grade: **0**
O&M Grade: **2**
Clock Start/From: **3**
Clock To:
1st Value: **4.000**
2nd Value: **1.000**
Value Percent:
Continuous Index:
Within 8" of Joint:
Remarks:

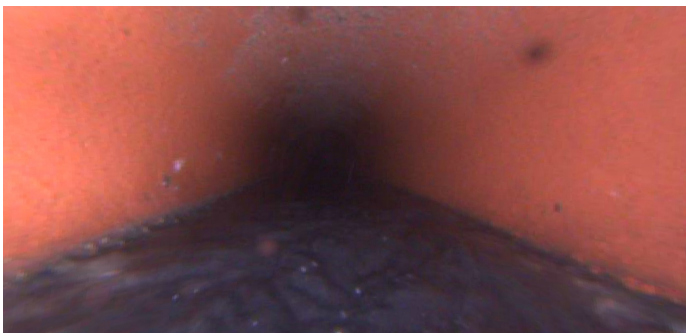
Code: **MSA**
Description: **Abandoned Survey**

Distance (ft): **30.9**
Structural Grade: **0**
O&M Grade: **0**
Clock Start/From:
Clock To:
1st Value:
2nd Value:
Value Percent:
Continuous Index:
Within 8" of Joint: **NO**
Remarks: **camera stopped**
