Profile/Photo Observation Report

Date:	04/15/2018	Weather:		Coding:	PACP 6.0
Pipe Length (ft):	248.4	Owner:	NA	Pre Clean:	Not Known
P.O.#:		Surveyor:	Selasie Honu	PSR:	P-904-014-013
Customer:		Clean Date:	01/01/1900	Shape:	C

Street:	Fraser Ln.	Flow Control:	Not Controlled
City:	Hobart, IN	Year Renewed:	
Location:	Other	Tape/Media #:	
Purpose:	Not Known	Dia/Height:	10"
Use:	Sanitary	Material:	VCP
Drain Area:	NA	Lining:	
Category:	NA		
Comment:

Location Details:		Direction of Survey:	Downstream
US MH:	M-904-014	DS MH:	M-904-013
		Total Length Surveyed (ft):	30.9

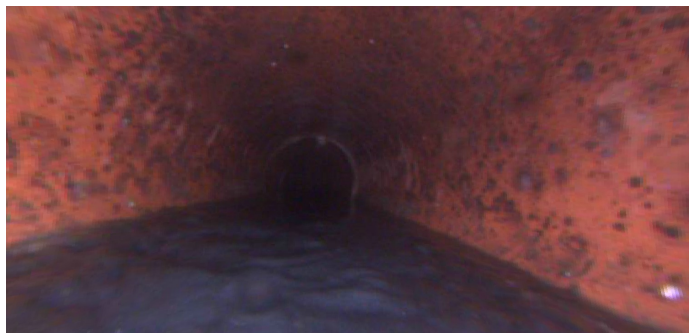
Code: **AMH**
 Description: **Manhole**

Distance (ft): **.0**
 Structural Grade: **0**
 O&M Grade: **0**
 Clock Start/From:
 Clock To:
 1st Value:
 2nd Value:
 Value Percent:
 Continuous Index:
 Within 8" of Joint: **NO**
 Remarks: **M-904-014**

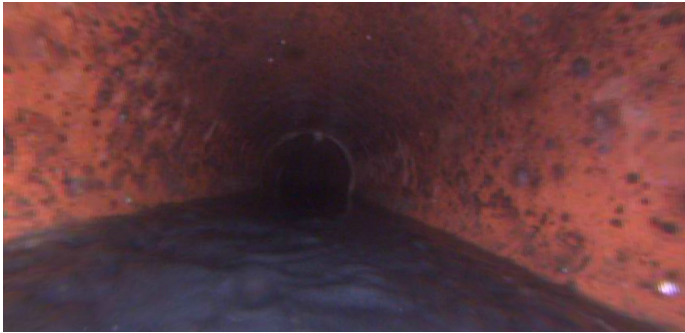
Code:	MWL
Description:	Water Level

Distance (ft):	.0
Structural Grade:	0
O&M Grade:	0
Clock Start/From:	
Clock To:	
1st Value:	
2nd Value:	
Value Percent:	5.000
Continuous Index:	
Within 8" of Joint:	NO
Remarks:

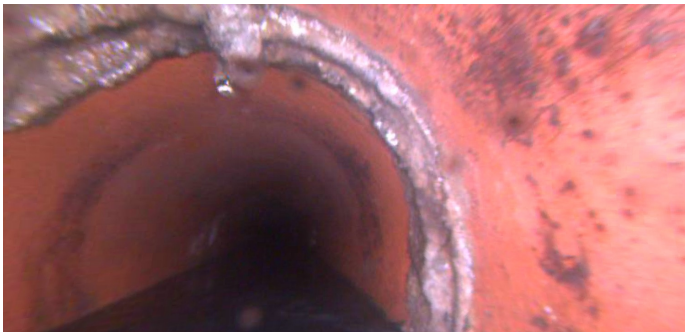
Code:	ID
Description:	Infil Dripper

Distance (ft):	3.2
Structural Grade:	0
O&M Grade:	3
Clock Start/From:	12
Clock To:	
1st Value:	
2nd Value:	
Value Percent:	
Continuous Index:	
Within 8" of Joint:	YES
Remarks:

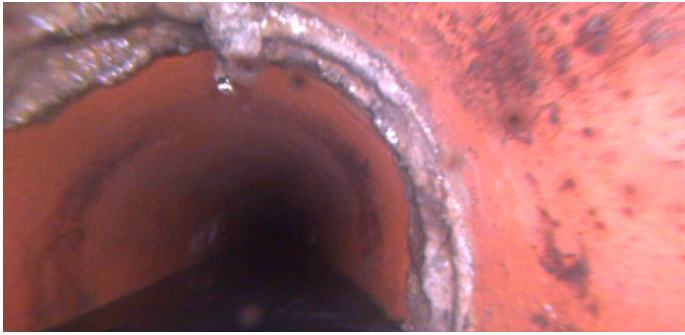
Code: **DAE**
Description: **Deposits Attached Encrustation**

Distance (ft): **3.2**
Structural Grade: **0**
O&M Grade: **2**
Clock Start/From: **8**
Clock To: **4**
1st Value:
2nd Value:
Value Percent: **5.000**
Continuous Index:
Within 8" of Joint: **YES**
Remarks:

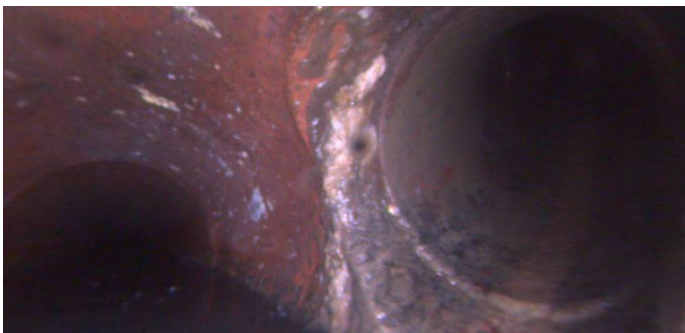
Code: **TF**
Description: **Tap Factory**

Distance (ft): **13.4**
Structural Grade: **0**
O&M Grade: **0**
Clock Start/From: **3**
Clock To:
1st Value: **4.000**
2nd Value:
Value Percent:
Continuous Index:
Within 8" of Joint:
Remarks:

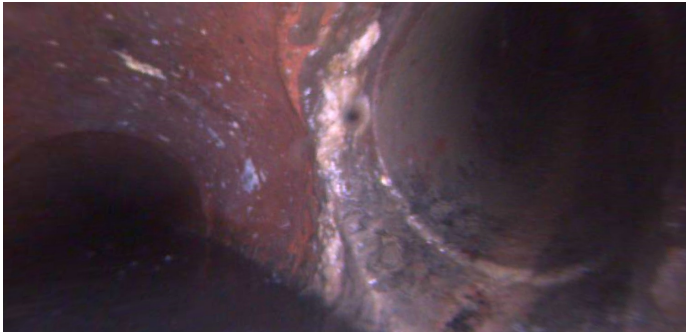
Code: **TBI**
Description: **Tap Break-in Intruding**

Distance (ft): **13.4**
Structural Grade: **0**
O&M Grade: **2**
Clock Start/From: **3**
Clock To:
1st Value: **4.000**
2nd Value: **1.000**
Value Percent:
Continuous Index:
Within 8" of Joint:
Remarks:

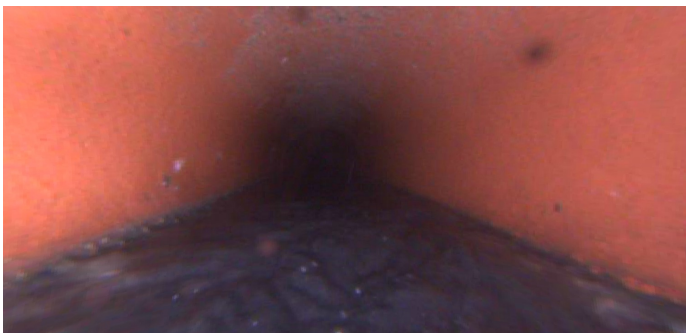
Code: **MSA**
Description: **Abandoned Survey**

Distance (ft): **30.9**
Structural Grade: **0**
O&M Grade: **0**
Clock Start/From:
Clock To:
1st Value:
2nd Value:
Value Percent:
Continuous Index:
Within 8" of Joint: **NO**
Remarks: **camera stopped**
