# Profile/Photo Observation Report

Date:	<b>04/15/2018</b>	Weather:		Coding:	<b>PACP 6.0</b>
Pipe Length (ft):	<b>216.4</b>	Owner:	<b>NA</b>	Pre Clean:	<b>Not Known</b>
P.O.#:		Surveyor:	<b>Selasie Honu</b>	PSR:	<b>P-904-016-015</b>
Customer:		Clean Date:	<b>01/01/1900</b>	Shape:	<b>C</b>

Street:	<b>Fraser Ln.</b>	Flow Control:	<b>Not Controlled</b>
City:	<b>Hobart, IN</b>	Year Renewed:	
Location:	<b>Other</b>	Tape/Media #:	
Purpose:	<b>Not Known</b>	Dia/Height:	<b>10"</b>
Use:	<b>Sanitary</b>	Material:	<b>VCP</b>
Drain Area:	<b>NA</b>	Lining:	
Category:	<b>NA</b>		
Comment:			
Location Details:		Direction of Survey:	<b>Upstream</b>
US MH:	<b>M-904-016</b>	DS MH:	<b>M-904-015</b>
		Total Length Surveyed (ft):	<b>4.1</b>

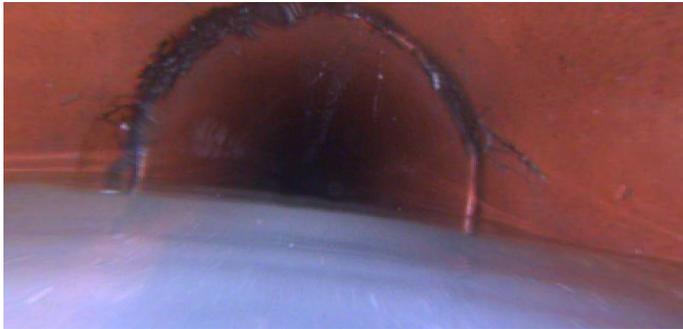
Code: **RFJ**  
Description: **Roots Fine Joint**

Distance (ft): **4.1**  
Structural Grade: **0**  
O&M Grade: **1**  
Clock Start/From: **8**  
Clock To: **4**  
1st Value:  
2nd Value:  
Value Percent:  
Continuous Index:  
Within 8" of Joint: **YES**  
Remarks:

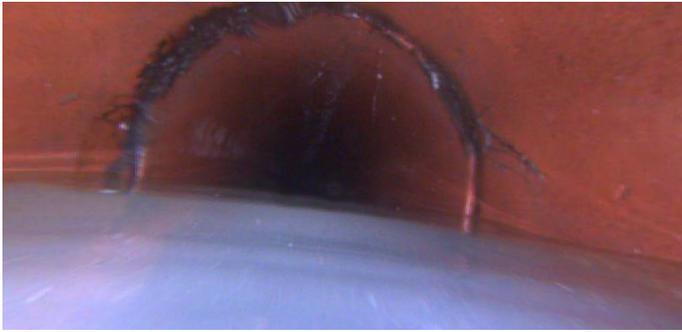
Code: **MSA**  
Description: **Abandoned Survey**

Distance (ft): **4.1**  
Structural Grade: **0**  
O&M Grade: **0**  
Clock Start/From:  
Clock To:  
1st Value:  
2nd Value:  
Value Percent:  
Continuous Index:  
Within 8" of Joint: **NO**  
Remarks: **camera stopped**

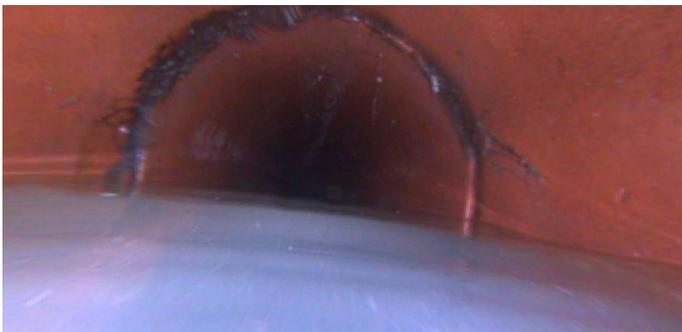
Code: **MWLS**  
Description: **Water Level Sag**

Distance (ft): **4.1**  
Structural Grade: **2**  
O&M Grade: **3**  
Clock Start/From:  
Clock To:  
1st Value:  
2nd Value:  
Value Percent: **10.000**  
Continuous Index: **F01**  
Within 8" of Joint: **NO**  
Remarks:
