## Profile/Photo Observation Report

Street:	<b>FRASER LN</b>	Flow Control:	<b>Not Controlled</b>
City:	<b>Hobart, IN</b>	Year Renewed:	
Location:	<b>Other</b>	Tape/Media #:	
Purpose:	<b>Not Known</b>	Dia/Height:	<b>10"</b>
Use:	<b>Sanitary</b>	Material:	<b>VCP</b>
Drain Area:	<b>NA</b>	Lining:	
Category:	<b>NA</b>		
Comment:

Location Details:		Direction of Survey:	<b>Downstream</b>
US MH:	<b>M-904-016</b>	DS MH:	<b>M-904-015</b>
		Total Length Surveyed (ft):	<b>4.0</b>

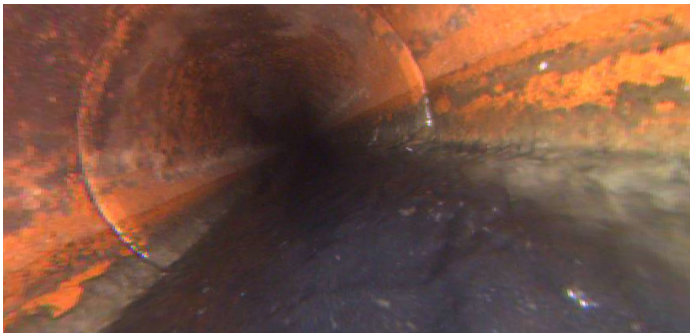
Remarks: M-904-016

Code: AMH

Description: Manhole

Distance (ft): .0

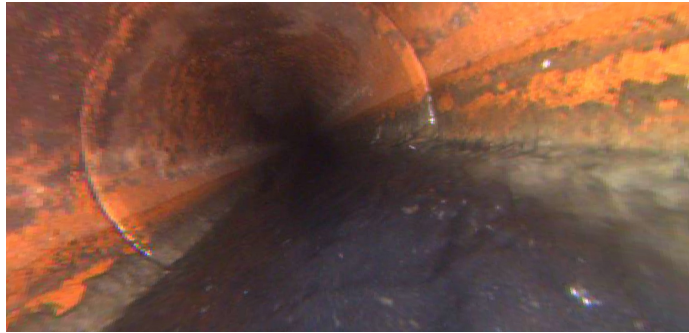
Code: **MWL**  
Description: **Water Level**

Distance (ft): **.0**  
Structural Grade: **0**  
O&M Grade: **0**  
Clock Start/From:  
Clock To:  
1st Value:  
2nd Value:  
Value Percent: **5.000**  
Continuous Index:  
Within 8" of Joint: **NO**  
Remarks:

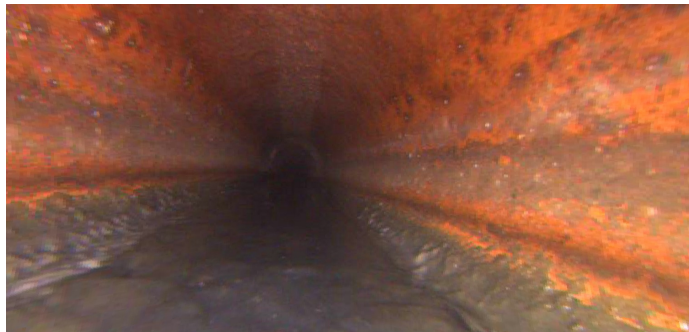
Code: **MSA**  
Description: **Abandoned Survey**

Distance (ft): **4.0**  
Structural Grade: **0**  
O&M Grade: **0**  
Clock Start/From:  
Clock To:  
1st Value:  
2nd Value:  
Value Percent:  
Continuous Index:  
Within 8" of Joint: **NO**  
Remarks: **camera stopped**
