## Profile/Photo Observation Report

Street:	<b>Fraser Ln.</b>	Flow Control:	<b>Not Controlled</b>
City:	<b>Hobart, IN</b>	Year Renewed:	
Location:	<b>Other</b>	Tape/Media #:	
Purpose:	<b>Not Known</b>	Dia/Height:	<b>10"</b>
Use:	<b>Sanitary</b>	Material:	<b>VCP</b>
Drain Area:	<b>NA</b>	Lining:	
Category:	<b>NA</b>		
Comment:

Location Details:		Direction of Survey:	<b>Downstream</b>
US MH:	<b>M-904-016</b>	DS MH:	<b>M-904-015</b>
		Total Length Surveyed (ft):	<b>4.0</b>

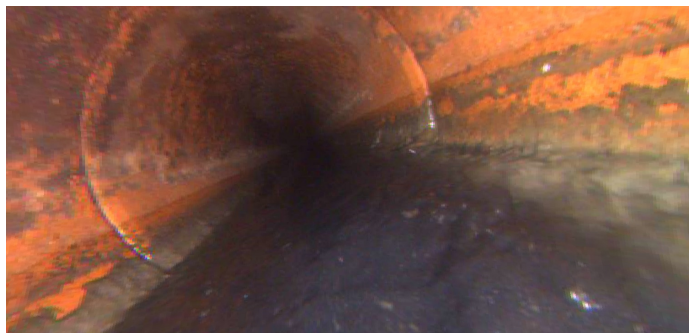
Code: **AMH**  
Description: **Manhole**

Distance (ft): **.0**  
Structural Grade: **0**  
O&M Grade: **0**  
Clock Start/From:  
Clock To:  
1st Value:  
2nd Value:  
Value Percent:  
Continuous Index:  
Within 8" of Joint: **NO**  
Remarks: **M-904-016**

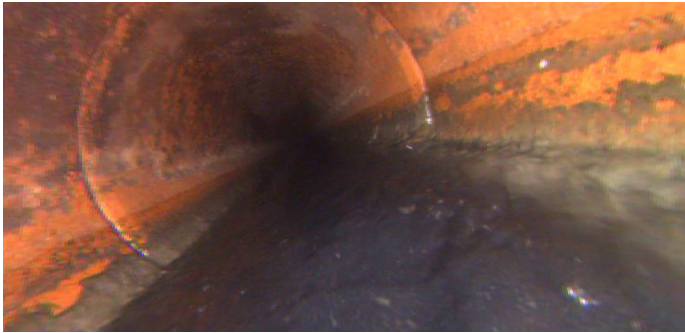
Code:	<b>MWL</b>
Description:	<b>Water Level</b>

Distance (ft):	<b>.0</b>
Structural Grade:	<b>0</b>
O&M Grade:	<b>0</b>
Clock Start/From:	
Clock To:	
1st Value:	
2nd Value:	
Value Percent:	<b>5.000</b>
Continuous Index:	
Within 8" of Joint:	<b>NO</b>
Remarks:

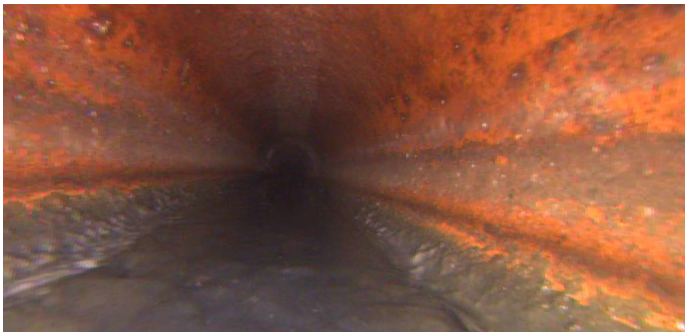
Code:	<b>MSA</b>
Description:	<b>Abandoned Survey</b>

Distance (ft):	<b>4.0</b>
Structural Grade:	<b>0</b>
O&M Grade:	<b>0</b>
Clock Start/From:	
Clock To:	
1st Value:	
2nd Value:	
Value Percent:	
Continuous Index:	
Within 8" of Joint:	<b>NO</b>
Remarks:	<b>camera stopped</b>
