Profile/Photo Observation Report

Date:	04/14/2018	Weather:		Coding:	PACP 6.0
Pipe Length (ft):	330.4	Owner:	NA	Pre Clean:	Not Known
P.O.#:		Surveyor:	Jen Costello	PSR:	P-904-017-016
Customer:		Clean Date:	01/01/1900	Shape:	C

Street:	FRASER LN	Flow Control:	Not Controlled
City:	Hobart, IN	Year Renewed:	
Location:	Other	Tape/Media #:	
Purpose:	Not Known	Dia/Height:	8"
Use:	Sanitary	Material:	VCP
Drain Area:	NA	Lining:	
Category:	NA		
Comment:

Location Details:		Direction of Survey:	Downstream
US MH:	M-904-016	DS MH:	M-904-017
		Total Length Surveyed (ft):	323.4

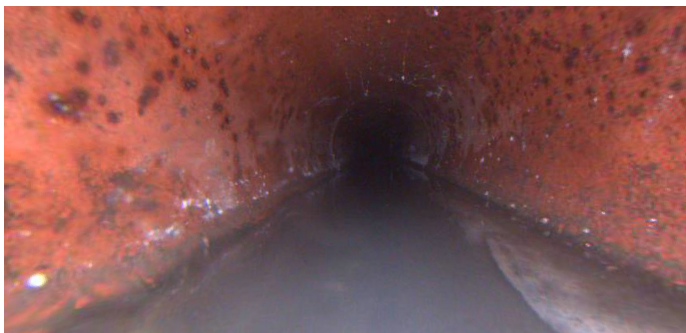
Code: **AMH**
Description: **Manhole**

Distance (ft): **.0**
Structural Grade: **0**
O&M Grade: **0**
Clock Start/From:
Clock To:
1st Value:
2nd Value:
Value Percent:
Continuous Index:
Within 8" of Joint: **NO**
Remarks: **M-904-016**

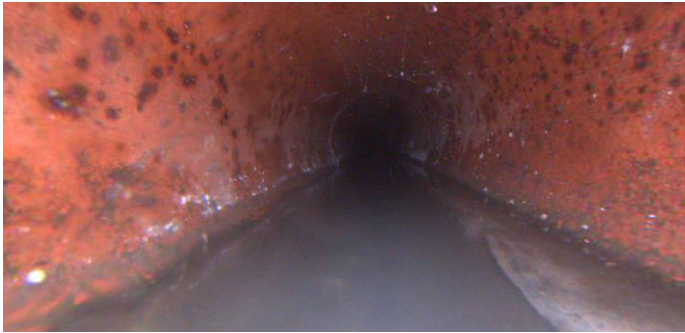
Code:	MWL
Description:	Water Level

Distance (ft):	.0
Structural Grade:	0
O&M Grade:	0
Clock Start/From:	
Clock To:	
1st Value:	
2nd Value:	
Value Percent:	10.000
Continuous Index:	
Within 8" of Joint:	NO
Remarks:

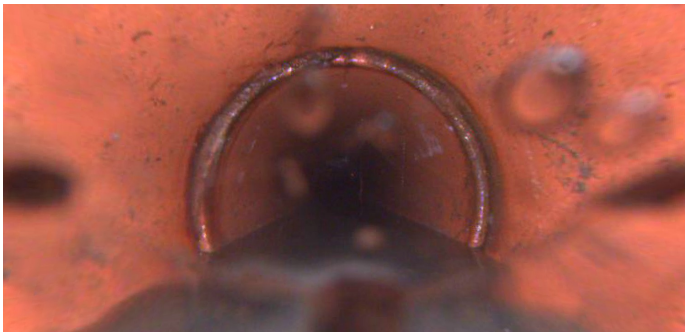
Code:	IW
Description:	Infil Weeper

Distance (ft):	91.9
Structural Grade:	0
O&M Grade:	2
Clock Start/From:	8
Clock To:	4
1st Value:	
2nd Value:	
Value Percent:	
Continuous Index:	
Within 8" of Joint:	YES
Remarks:

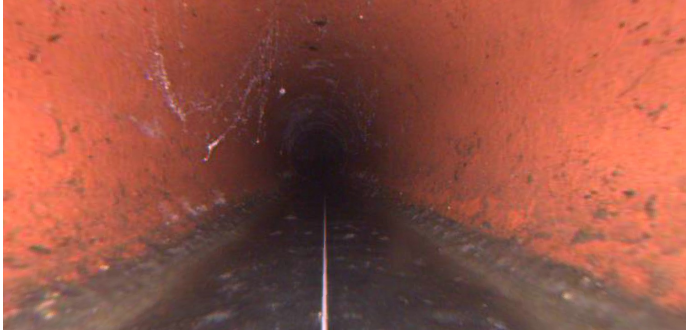
Code: **MGO**
Description: **General Observation**

Distance (ft): **91.9**
Structural Grade: **0**
O&M Grade: **0**
Clock Start/From:
Clock To:
1st Value:
2nd Value:
Value Percent:
Continuous Index:
Within 8" of Joint: **NO**
Remarks: **rear camera**

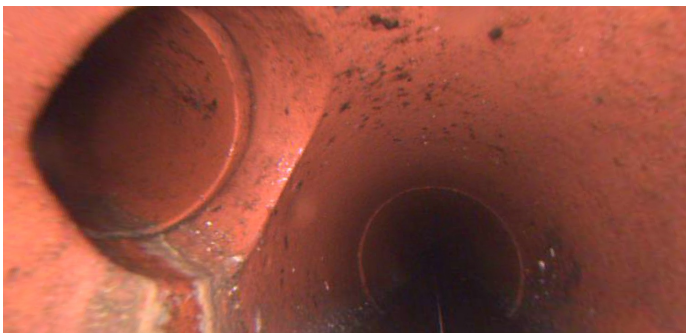
Code: **TF**
Description: **Tap Factory**

Distance (ft): **119.3**
Structural Grade: **0**
O&M Grade: **0**
Clock Start/From: **2**
Clock To:
1st Value: **4.000**
2nd Value:
Value Percent:
Continuous Index:
Within 8" of Joint:
Remarks:

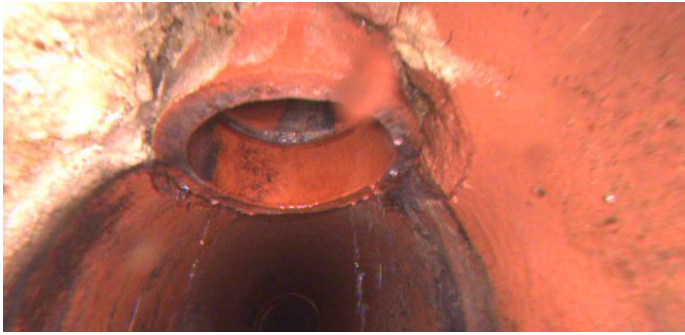
Code: **TBI**
Description: **Tap Break-in Intruding**

Distance (ft): **124.0**
Structural Grade: **0**
O&M Grade: **2**
Clock Start/From: **12**
Clock To:
1st Value: **4.000**
2nd Value: **1.000**
Value Percent:
Continuous Index:
Within 8" of Joint:
Remarks: **active**

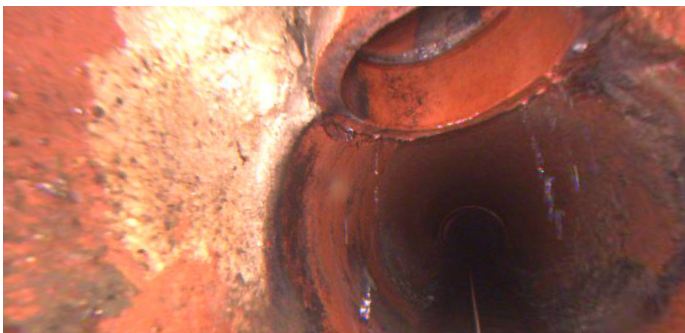
Code: **DAE**
Description: **Deposits Attached Encrustation**

Distance (ft): **124.0**
Structural Grade: **0**
O&M Grade: **2**
Clock Start/From: **1**
Clock To: **3**
1st Value:
2nd Value:
Value Percent: **5.000**
Continuous Index:
Within 8" of Joint: **NO**
Remarks:

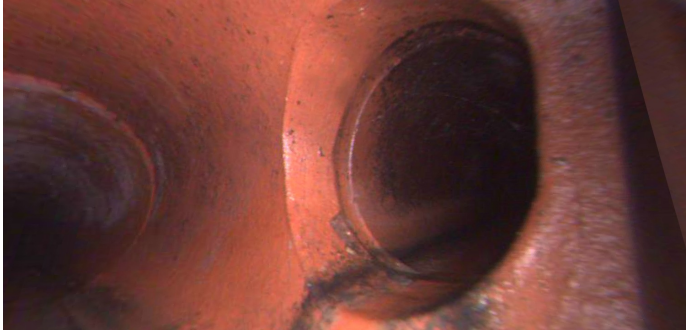
Code: **TFA**
Description: **Tap Factory Active**

Distance (ft): **200.8**
Structural Grade: **0**
O&M Grade: **0**
Clock Start/From: **9**
Clock To:
1st Value: **4.000**
2nd Value:
Value Percent:
Continuous Index:
Within 8" of Joint:
Remarks:

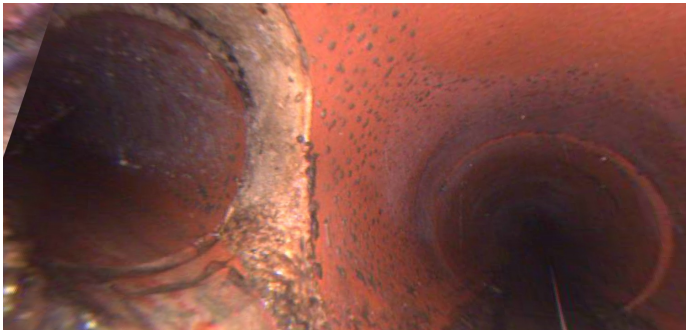
Code: **TFD**
Description: **Tap Factory Defective**

Distance (ft): **252.5**
Structural Grade: **0**
O&M Grade: **2**
Clock Start/From: **3**
Clock To:
1st Value: **4.000**
2nd Value:
Value Percent:
Continuous Index:
Within 8" of Joint:
Remarks: **dae**

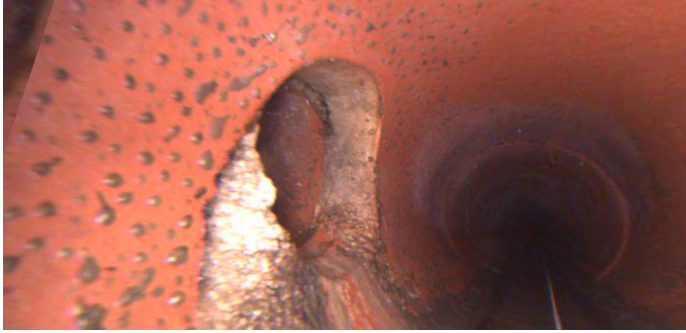
Code: **DAE**
Description: **Deposits Attached Encrustation**

Distance (ft): **253.0**
Structural Grade: **0**
O&M Grade: **2**
Clock Start/From: **2**
Clock To: **3**
1st Value:
2nd Value:
Value Percent: **5.000**
Continuous Index:
Within 8" of Joint: **NO**
Remarks:

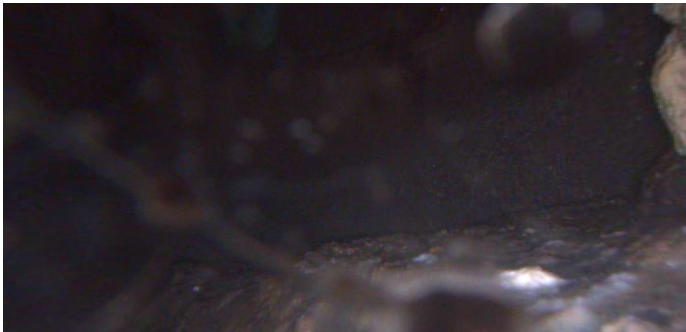
Code: **AMH**
Description: **Manhole**

Distance (ft): **323.4**
Structural Grade: **0**
O&M Grade: **0**
Clock Start/From:
Clock To:
1st Value:
2nd Value:
Value Percent:
Continuous Index:
Within 8" of Joint: **NO**
Remarks: **M-904-017**
