## Profile/Photo Observation Report

Street:	<b>Fraser Ln.</b>	Flow Control:	<b>Not Controlled</b>
City:	<b>Hobart, IN</b>	Year Renewed:	
Location:	<b>Other</b>	Tape/Media #:	
Purpose:	<b>Not Known</b>	Dia/Height:	<b>8"</b>
Use:	<b>Sanitary</b>	Material:	<b>VCP</b>
Drain Area:	<b>NA</b>	Lining:	
Category:	<b>NA</b>		
Comment:

Location Details:		Direction of Survey:	<b>Downstream</b>
US MH:	<b>M-904-016</b>	DS MH:	<b>M-904-017</b>
		Total Length Surveyed (ft):	<b>323.4</b>

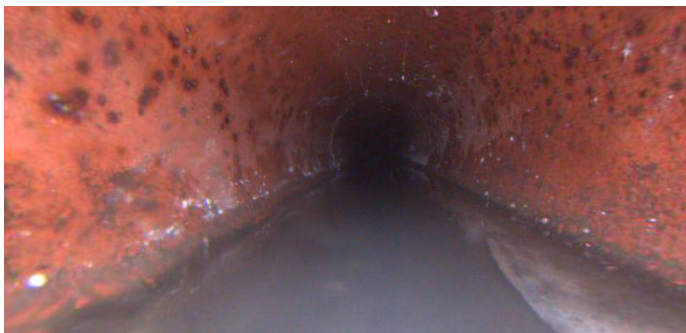
Code: **AMH**  
Description: **Manhole**

Distance (ft): **.0**  
Structural Grade: **0**  
O&M Grade: **0**  
Clock Start/From:  
Clock To:  
1st Value:  
2nd Value:  
Value Percent:  
Continuous Index:  
Within 8" of Joint: **NO**  
Remarks: **M-904-016**

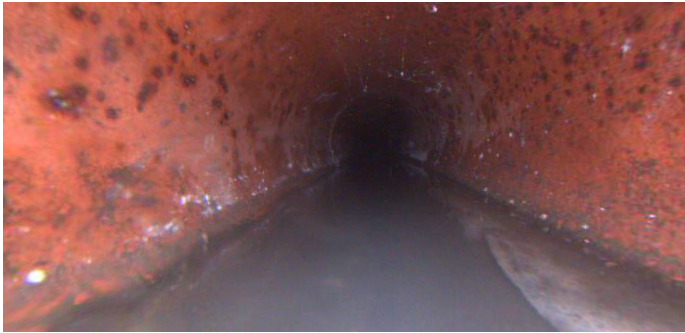
Code:	<b>MWL</b>
Description:	<b>Water Level</b>

Distance (ft):	<b>.0</b>
Structural Grade:	<b>0</b>
O&M Grade:	<b>0</b>
Clock Start/From:	
Clock To:	
1st Value:	
2nd Value:	
Value Percent:	<b>10.000</b>
Continuous Index:	
Within 8" of Joint:	<b>NO</b>
Remarks:

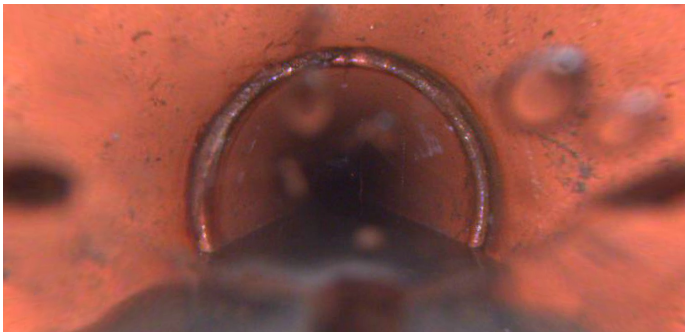
Code:	<b>IW</b>
Description:	<b>Infil Weeper</b>

Distance (ft):	<b>91.9</b>
Structural Grade:	<b>0</b>
O&M Grade:	<b>2</b>
Clock Start/From:	<b>8</b>
Clock To:	<b>4</b>
1st Value:	
2nd Value:	
Value Percent:	
Continuous Index:	
Within 8" of Joint:	<b>YES</b>
Remarks:

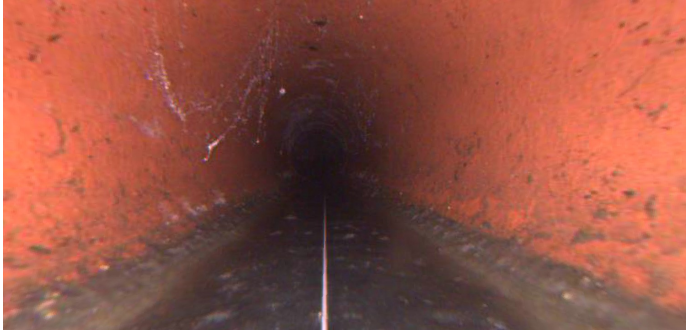
Code: **MGO**  
Description: **General Observation**

Distance (ft): **91.9**  
Structural Grade: **0**  
O&M Grade: **0**  
Clock Start/From:  
Clock To:  
1st Value:  
2nd Value:  
Value Percent:  
Continuous Index:  
Within 8" of Joint: **NO**  
Remarks: **rear camera**

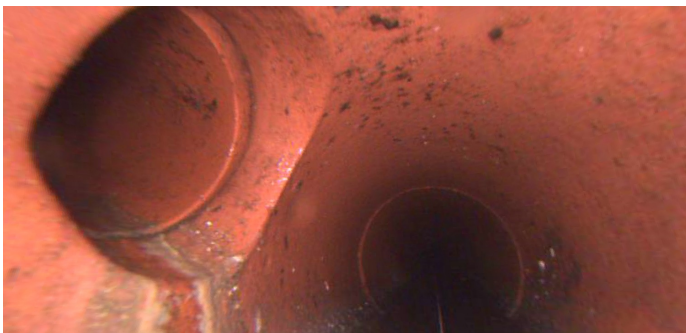
Code: **TF**  
Description: **Tap Factory**

Distance (ft): **119.3**  
Structural Grade: **0**  
O&M Grade: **0**  
Clock Start/From: **2**  
Clock To:  
1st Value: **4.000**  
2nd Value:  
Value Percent:  
Continuous Index:  
Within 8" of Joint:  
Remarks:

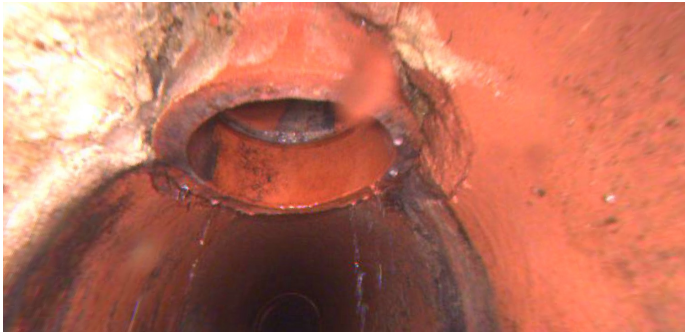
Code: **TBI**  
Description: **Tap Break-in Intruding**

Distance (ft): **124.0**  
Structural Grade: **0**  
O&M Grade: **2**  
Clock Start/From: **12**  
Clock To:  
1st Value: **4.000**  
2nd Value: **1.000**  
Value Percent:  
Continuous Index:  
Within 8" of Joint:  
Remarks: **active**

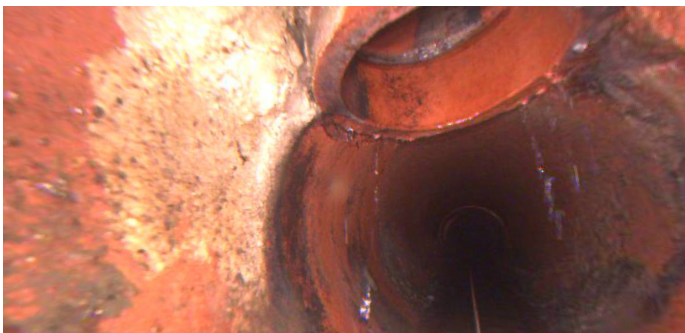
Code: **DAE**  
Description: **Deposits Attached Encrustation**

Distance (ft): **124.0**  
Structural Grade: **0**  
O&M Grade: **2**  
Clock Start/From: **1**  
Clock To: **3**  
1st Value:  
2nd Value:  
Value Percent: **5.000**  
Continuous Index:  
Within 8" of Joint: **NO**  
Remarks:

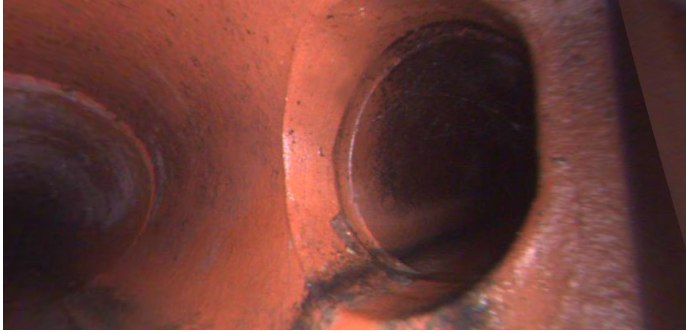
Code: **TFA**  
Description: **Tap Factory Active**

Distance (ft): **200.8**  
Structural Grade: **0**  
O&M Grade: **0**  
Clock Start/From: **9**  
Clock To:  
1st Value: **4.000**  
2nd Value:  
Value Percent:  
Continuous Index:  
Within 8" of Joint:  
Remarks:

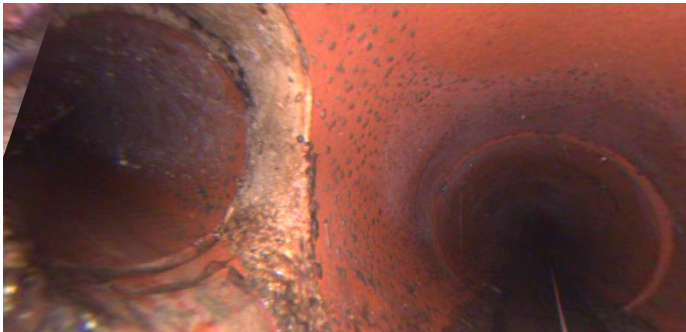
Code: **TFD**  
Description: **Tap Factory Defective**

Distance (ft): **252.5**  
Structural Grade: **0**  
O&M Grade: **2**  
Clock Start/From: **3**  
Clock To:  
1st Value: **4.000**  
2nd Value:  
Value Percent:  
Continuous Index:  
Within 8" of Joint:  
Remarks: **dae**

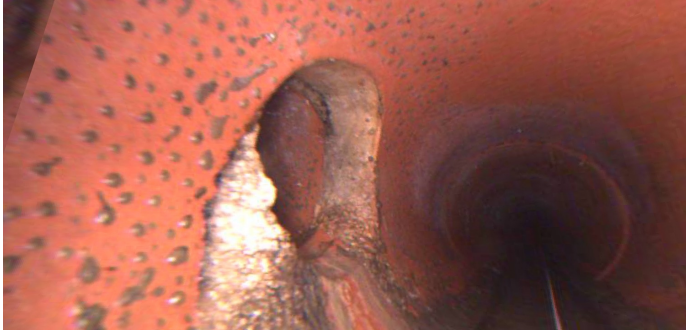
Code: **DAE**  
Description: **Deposits Attached Encrustation**

Distance (ft): **253.0**  
Structural Grade: **0**  
O&M Grade: **2**  
Clock Start/From: **2**  
Clock To: **3**  
1st Value:  
2nd Value:  
Value Percent: **5.000**  
Continuous Index:  
Within 8" of Joint: **NO**  
Remarks:

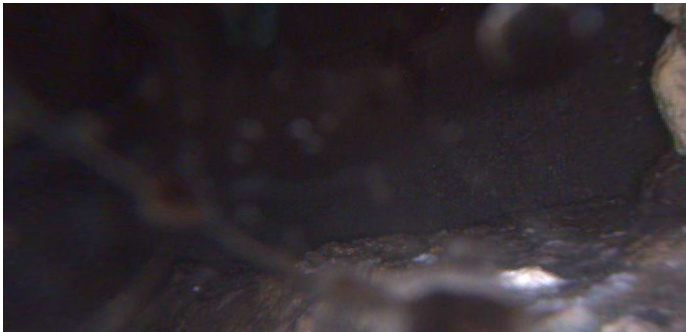
Code: **AMH**  
Description: **Manhole**

Distance (ft): **323.4**  
Structural Grade: **0**  
O&M Grade: **0**  
Clock Start/From:  
Clock To:  
1st Value:  
2nd Value:  
Value Percent:  
Continuous Index:  
Within 8" of Joint: **NO**  
Remarks: **M-904-017**
