Profile/Photo Observation Report

Street:	Fraser Ln.	Flow Control:	Not Controlled
City:	Hobart, IN	Year Renewed:	
Location:	Other	Tape/Media #:	
Purpose:	Not Known	Dia/Height:	10"
Use:	Sanitary	Material:	VCP
Drain Area:	NA	Lining:	
Category:	NA		
Comment:

Location Details:		Direction of Survey:	Downstream
US MH:	M-904-019	DS MH:	M-904-020
		Total Length Surveyed (ft):	126.3

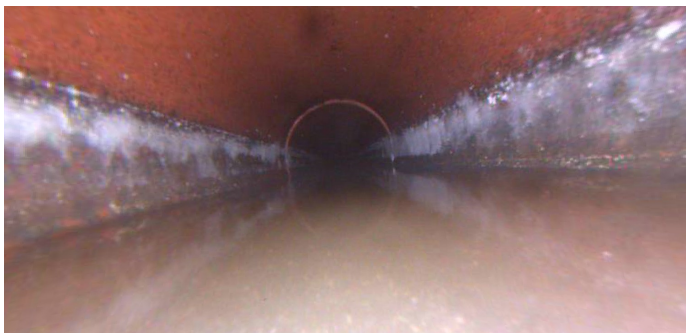
Code: **DAGS**
Description: **Deposits Attached Grease**

Distance (ft): **.0**
Structural Grade: **0**
O&M Grade: **2**
Clock Start/From: **8**
Clock To: **4**
1st Value:
2nd Value:
Value Percent: **5.000**
Continuous Index: **S01**
Within 8" of Joint: **NO**
Remarks:

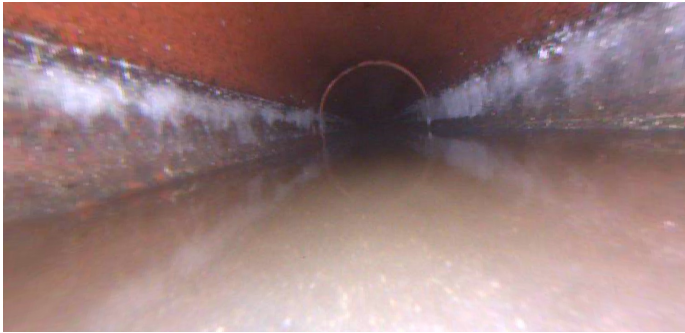
Code:	AMH
Description:	Manhole

Distance (ft):	.0
Structural Grade:	0
O&M Grade:	0
Clock Start/From:	
Clock To:	
1st Value:	
2nd Value:	
Value Percent:	
Continuous Index:	
Within 8" of Joint:	NO
Remarks:	M-904-019

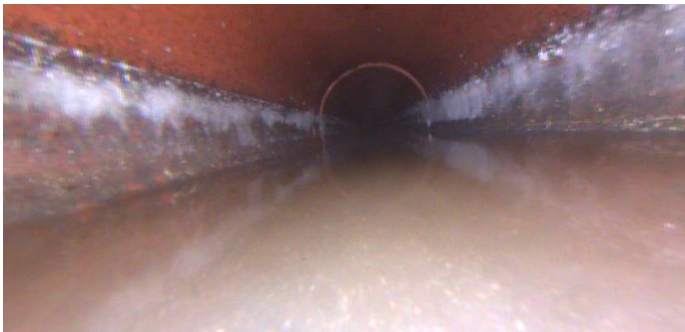
Code:	MWL
Description:	Water Level

Distance (ft):	.0
Structural Grade:	0
O&M Grade:	0
Clock Start/From:	
Clock To:	
1st Value:	
2nd Value:	
Value Percent:	40.000
Continuous Index:	
Within 8" of Joint:	NO
Remarks:

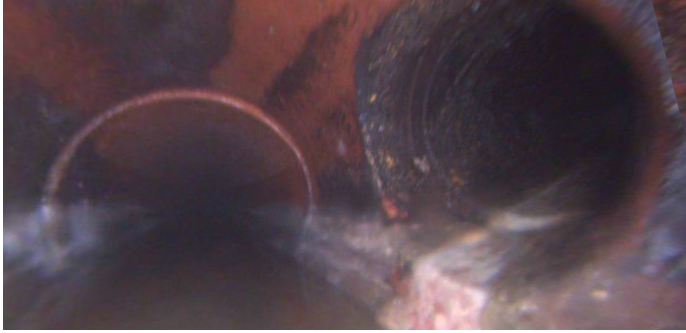
Code: **TFA**
Description: **Tap Factory Active**

Distance (ft): **14.0**
Structural Grade: **0**
O&M Grade: **0**
Clock Start/From: **3**
Clock To:
1st Value: **4.000**
2nd Value:
Value Percent:
Continuous Index:
Within 8" of Joint:
Remarks:

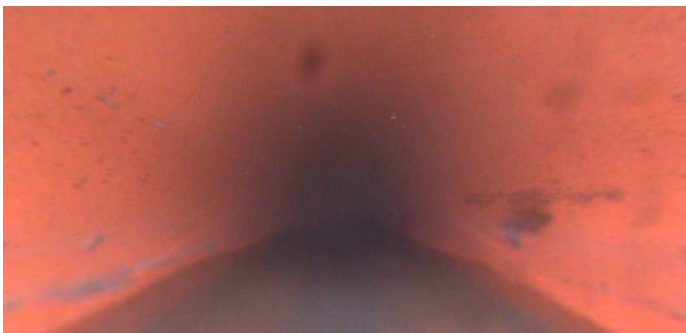
Code: **DAGS**
Description: **Deposits Attached Grease**

Distance (ft): **26.3**
Structural Grade: **0**
O&M Grade: **2**
Clock Start/From: **8**
Clock To: **4**
1st Value:
2nd Value:
Value Percent: **5.000**
Continuous Index: **F01**
Within 8" of Joint: **NO**
Remarks:

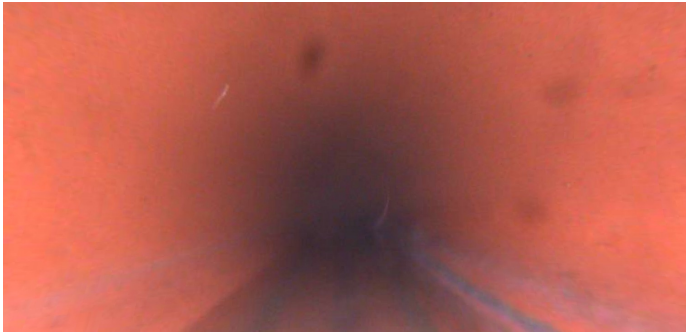
Code: **MWL**
Description: **Water Level**

Distance (ft): **37.4**
Structural Grade: **0**
O&M Grade: **0**
Clock Start/From:
Clock To:
1st Value:
2nd Value:
Value Percent: **5.000**
Continuous Index:
Within 8" of Joint: **NO**
Remarks:

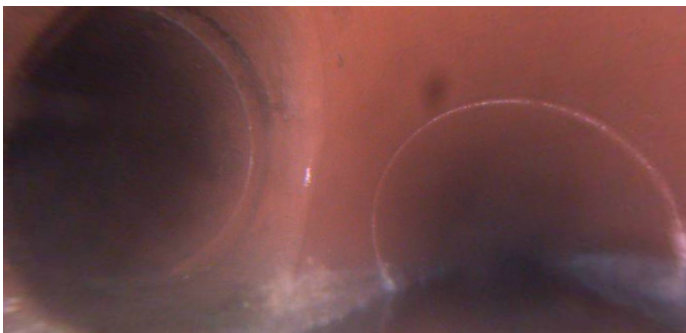
Code: **TF**
Description: **Tap Factory**

Distance (ft): **60.9**
Structural Grade: **0**
O&M Grade: **0**
Clock Start/From: **9**
Clock To:
1st Value: **4.000**
2nd Value:
Value Percent:
Continuous Index:
Within 8" of Joint:
Remarks:

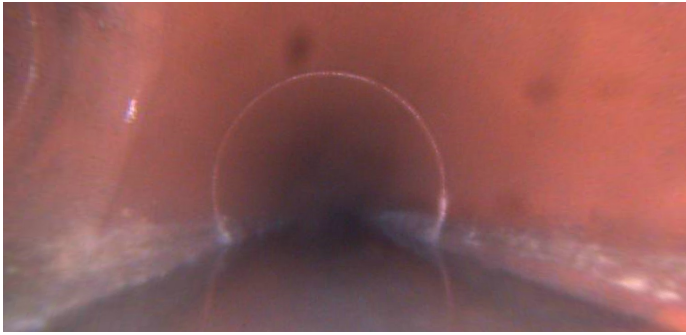
Code: **MWL**
Description: **Water Level**

Distance (ft): **60.9**
Structural Grade: **0**
O&M Grade: **0**
Clock Start/From:
Clock To:
1st Value:
2nd Value:
Value Percent: **20.000**
Continuous Index:
Within 8" of Joint: **NO**
Remarks:

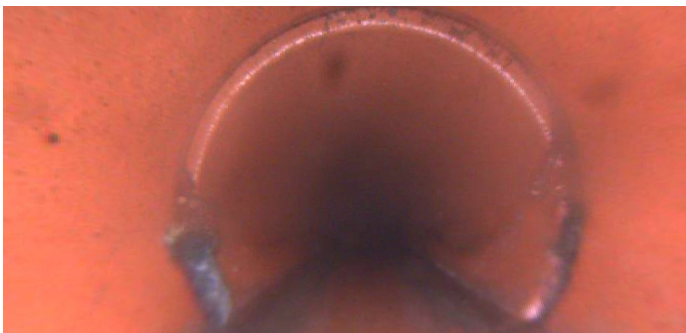
Code: **RFJ**
Description: **Roots Fine Joint**

Distance (ft): **106.1**
Structural Grade: **0**
O&M Grade: **1**
Clock Start/From: **7**
Clock To: **5**
1st Value:
2nd Value:
Value Percent:
Continuous Index:
Within 8" of Joint: **YES**
Remarks:

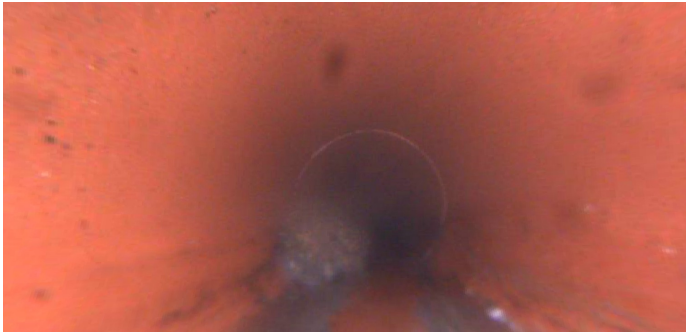
Code: **RMB**
Description: **Roots Medium Barrel**

Distance (ft): **115.1**
Structural Grade: **0**
O&M Grade: **4**
Clock Start/From: **6**
Clock To: **9**
1st Value:
2nd Value:
Value Percent: **20.000**
Continuous Index:
Within 8" of Joint: **NO**
Remarks:

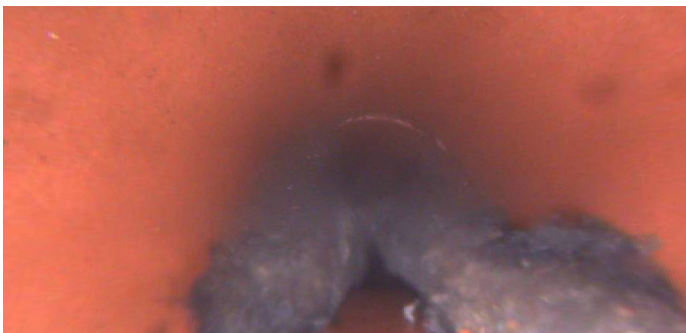
Code: **RBJ**
Description: **Roots Ball Joint**

Distance (ft): **125.3**
Structural Grade: **0**
O&M Grade: **4**
Clock Start/From: **7**
Clock To: **5**
1st Value:
2nd Value:
Value Percent: **80.000**
Continuous Index:
Within 8" of Joint: **YES**
Remarks:

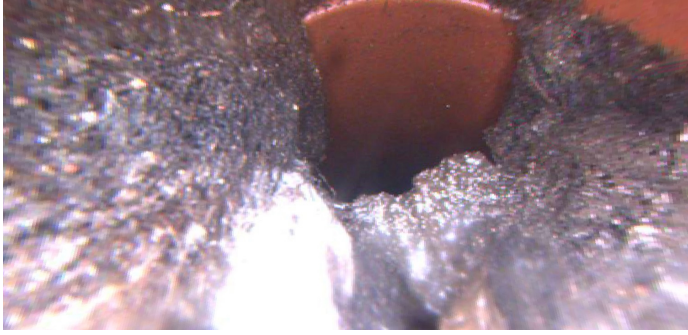
Code:	MSA
Description:	Abandoned Survey
Distance (ft):	126.3
Structural Grade:	0
O&M Grade:	0
Clock Start/From:	
Clock To:	
1st Value:	
2nd Value:	
Value Percent:	
Continuous Index:	
Within 8" of Joint:	NO
Remarks:	ROOT INFILTRATION
