Profile/Photo Observation Report

| Street: | Cleveland Terr. | Flow Control: | Not Controlled |
| City: | Hobart, IN | Year Renewed: | |

| US MH: | M-904-025 | DS MH: | M-904-024 |

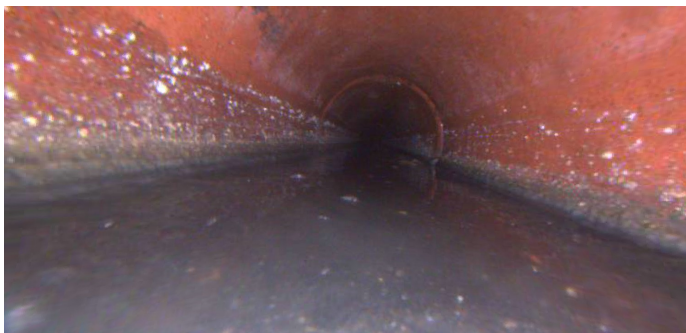
Code: **AMH**
Description: **Manhole**

Distance (ft): **.0**
Structural Grade: **0**
O&M Grade: **0**
Clock Start/From:
Clock To:
1st Value:
2nd Value:
Value Percent:
Continuous Index:
Within 8" of Joint: **NO**
Remarks: **M-904-025**

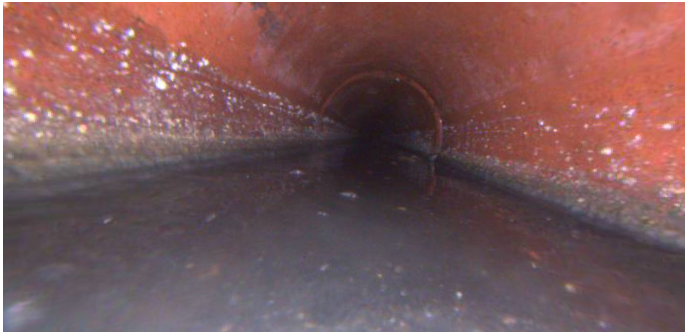
| Code: | MWL |
| Description: | Water Level |

| Value Percent: | 40.000 |

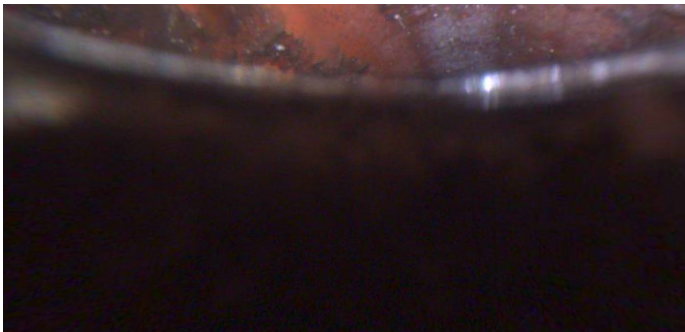
| Code: | MSA |
| Description: | Abandoned Survey |

| Distance (ft): | 18.2 |
| Remarks: | mcu |

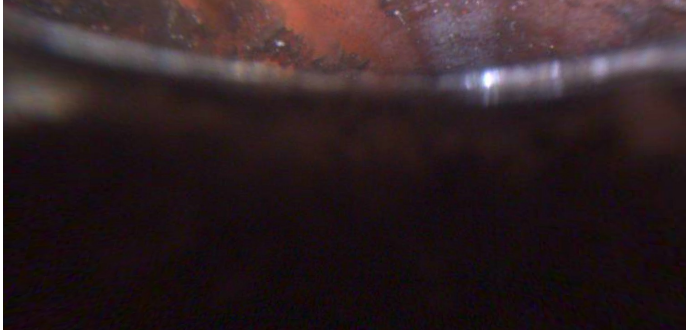
| | Position | Code | Observation | Video (sec) | Grade |
|--|---|---|---|---|---|
| | 18.2 | MCU | Camera Underwater | 80 | M 4 |

Code: **MCU**
Description: **Camera Underwater**

Distance (ft): **18.2**
Structural Grade: **0**
O&M Grade: **4**
Clock Start/From:
Clock To:
1st Value:
2nd Value:
Value Percent:
Continuous Index:
Within 8" of Joint: **NO**
Remarks:

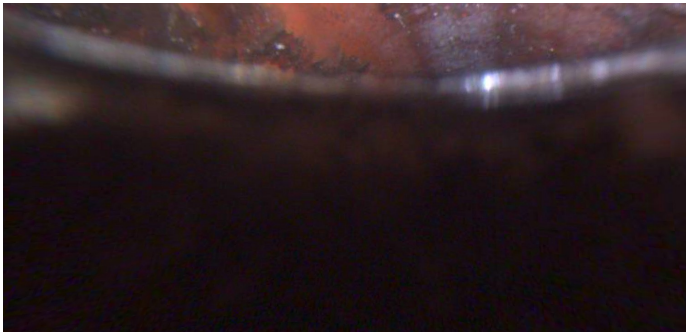
Code: **MWL**
Description: **Water Level**

Distance (ft): **18.2**
Structural Grade: **0**
O&M Grade: **0**
Clock Start/From:
Clock To:
1st Value:
2nd Value:
Value Percent: **60.000**
Continuous Index:
Within 8" of Joint: **NO**
Remarks:
