Profile/Photo Observation Report

Street:	CLEVELAND TERR	Flow Control:	Not Controlled
City:	Hobart, IN	Year Renewed:	
Location:	Other	Tape/Media #:	
Purpose:	Not Known	Dia/Height:	10"
Use:	Sanitary	Material:	VCP
Drain Area:	NA	Lining:	
Category:	NA		
Comment:

Location Details:		Direction of Survey:	Upstream
US MH:	M-904-026	DS MH:	M-904-031
		Total Length Surveyed (ft):	210.5

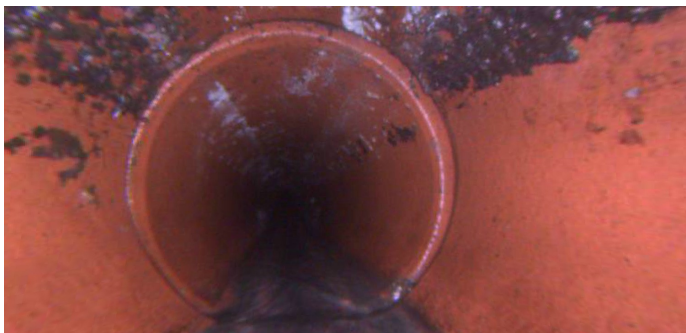
Code: **DAGS**
Description: **Deposits Attached Grease**

Distance (ft): **.0**
Structural Grade: **0**
O&M Grade: **2**
Clock Start/From: **8**
Clock To: **4**
1st Value:
2nd Value:
Value Percent: **5.000**
Continuous Index: **S01**
Within 8" of Joint: **NO**
Remarks:

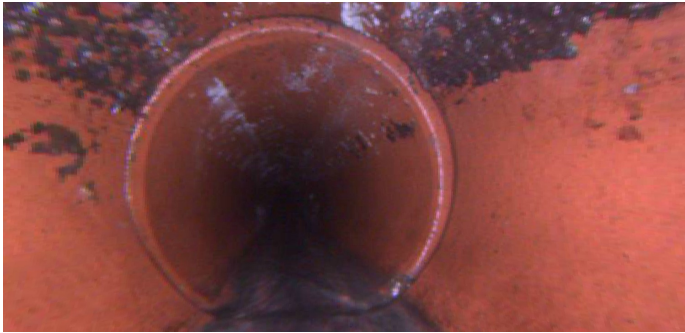
Code:	MWL
Description:	Water Level

Distance (ft):	.0
Structural Grade:	0
O&M Grade:	0
Clock Start/From:	
Clock To:	
1st Value:	
2nd Value:	
Value Percent:	5.000
Continuous Index:	
Within 8" of Joint:	NO
Remarks:

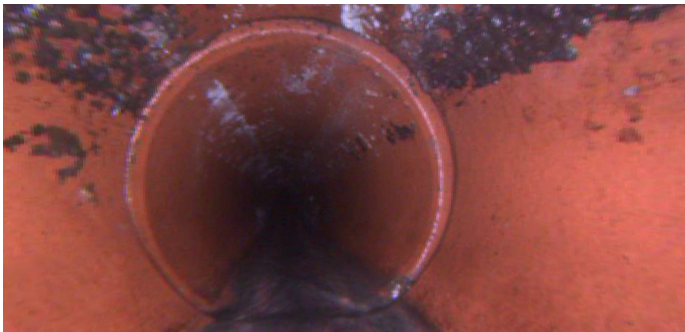
Code:	AMH
Description:	Manhole

Distance (ft):	.0
Structural Grade:	0
O&M Grade:	0
Clock Start/From:	
Clock To:	
1st Value:	
2nd Value:	
Value Percent:	
Continuous Index:	
Within 8" of Joint:	NO
Remarks:	M-904-031

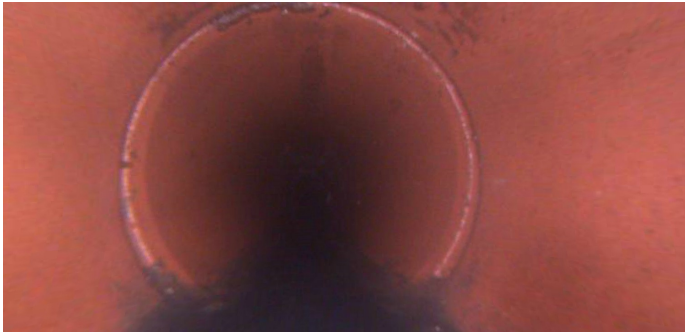
Code: **DAGS**
Description: **Deposits Attached Grease**

Distance (ft): **25.9**
Structural Grade: **0**
O&M Grade: **2**
Clock Start/From: **8**
Clock To: **4**
1st Value:
2nd Value:
Value Percent: **5.000**
Continuous Index: **F01**
Within 8" of Joint: **NO**
Remarks:

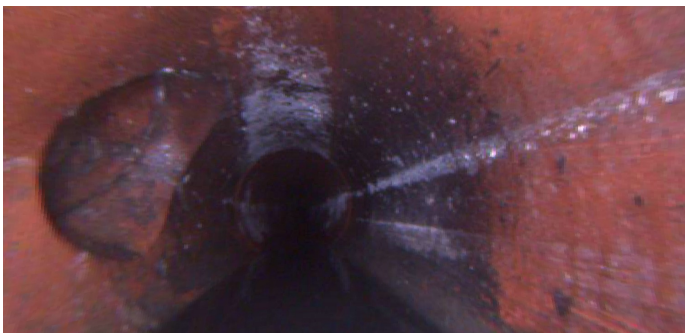
Code: **TF**
Description: **Tap Factory**

Distance (ft): **85.9**
Structural Grade: **0**
O&M Grade: **0**
Clock Start/From: **9**
Clock To:
1st Value: **4.000**
2nd Value:
Value Percent:
Continuous Index:
Within 8" of Joint:
Remarks:

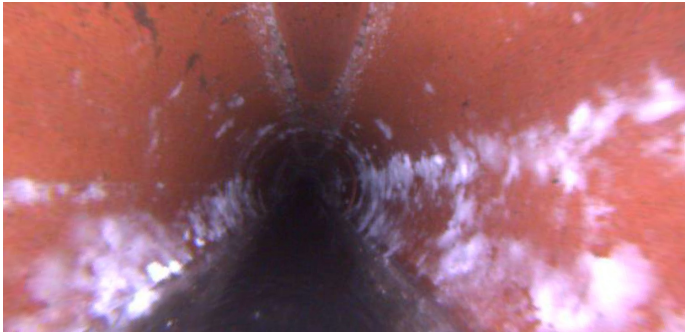
Code: **DAGS**
Description: **Deposits Attached Grease**

Distance (ft): **95.3**
Structural Grade: **0**
O&M Grade: **2**
Clock Start/From: **8**
Clock To: **4**
1st Value:
2nd Value:
Value Percent: **5.000**
Continuous Index: **S02**
Within 8" of Joint: **NO**
Remarks:

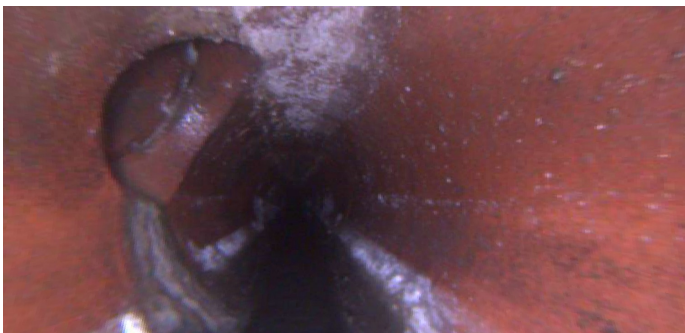
Code: **TF**
Description: **Tap Factory**

Distance (ft): **137.6**
Structural Grade: **0**
O&M Grade: **0**
Clock Start/From: **10**
Clock To:
1st Value: **4.000**
2nd Value:
Value Percent:
Continuous Index:
Within 8" of Joint:
Remarks:

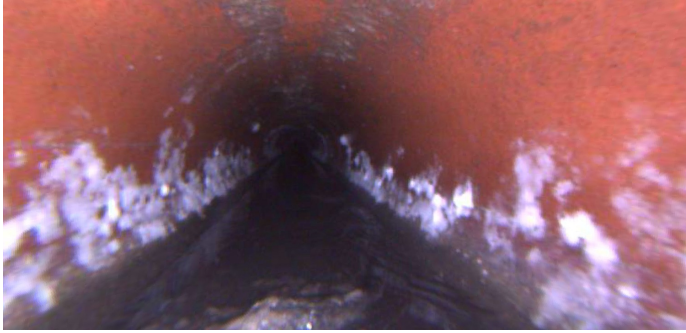
Code: **MWL**
Description: **Water Level**

Distance (ft): **146.8**
Structural Grade: **0**
O&M Grade: **0**
Clock Start/From:
Clock To:
1st Value:
2nd Value:
Value Percent: **20.000**
Continuous Index:
Within 8" of Joint: **NO**
Remarks:

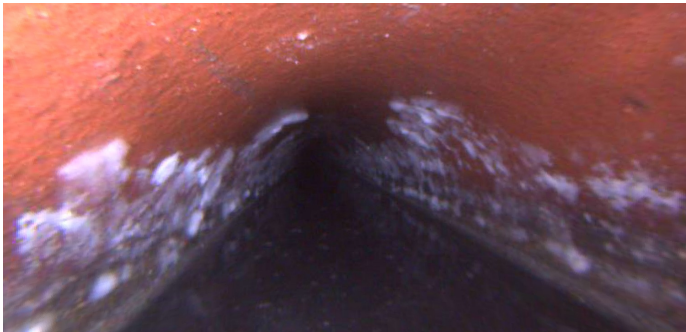
Code: **DAGS**
Description: **Deposits Attached Grease**

Distance (ft): **209.7**
Structural Grade: **0**
O&M Grade: **2**
Clock Start/From: **8**
Clock To: **4**
1st Value:
2nd Value:
Value Percent: **5.000**
Continuous Index: **F02**
Within 8" of Joint: **NO**
Remarks:
