Profile/Photo Observation Report

Date:	04/16/2018	Weather:		Coding:	PACP 6.0
Pipe Length (ft):	291.9	Owner:	NA	Pre Clean:	Not Known
P.O.#:		Surveyor:	Selasie Honu	PSR:	P-904-031-026
Customer:		Clean Date:	01/01/1900	Shape:	C

Street:	Cleveland Terr.	Flow Control:	Not Controlled
City:	Hobart, IN	Year Renewed:	
Location:	Other	Tape/Media #:	
Purpose:	Not Known	Dia/Height:	10"
Use:	Sanitary	Material:	VCP
Drain Area:	NA	Lining:	
Category:	NA		
Comment:

Location Details:		Direction of Survey:	Upstream
US MH:	M-904-026	DS MH:	M-904-031
		Total Length Surveyed (ft):	210.5

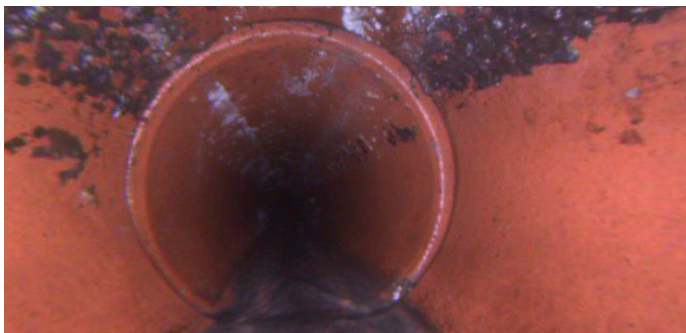
Code: **DAGS**
Description: **Deposits Attached Grease**

Distance (ft): **.0**
Structural Grade: **0**
O&M Grade: **2**
Clock Start/From: **8**
Clock To: **4**
1st Value:
2nd Value:
Value Percent: **5.000**
Continuous Index: **S01**
Within 8" of Joint: **NO**
Remarks:

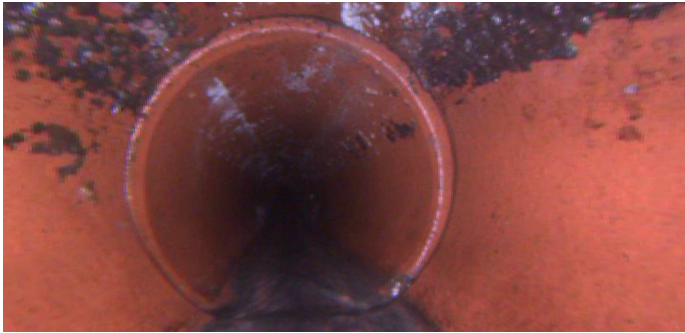
Code:	MWL
Description:	Water Level

Distance (ft):	.0
Structural Grade:	0
O&M Grade:	0
Clock Start/From:	
Clock To:	
1st Value:	
2nd Value:	
Value Percent:	5.000
Continuous Index:	
Within 8" of Joint:	NO
Remarks:

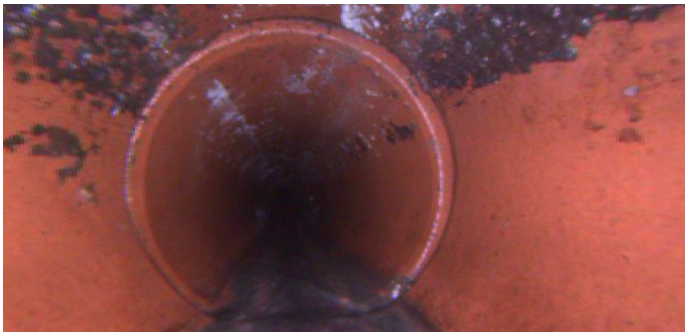
Code:	AMH
Description:	Manhole

Distance (ft):	.0
Structural Grade:	0
O&M Grade:	0
Clock Start/From:	
Clock To:	
1st Value:	
2nd Value:	
Value Percent:	
Continuous Index:	
Within 8" of Joint:	NO
Remarks:	M-904-031

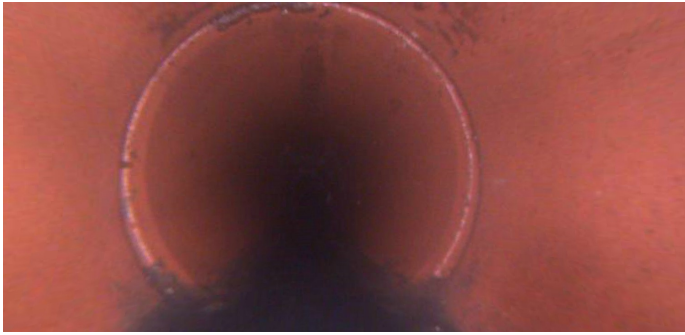
Code: **DAGS**
Description: **Deposits Attached Grease**

Distance (ft): **25.9**
Structural Grade: **0**
O&M Grade: **2**
Clock Start/From: **8**
Clock To: **4**
1st Value:
2nd Value:
Value Percent: **5.000**
Continuous Index: **F01**
Within 8" of Joint: **NO**
Remarks:

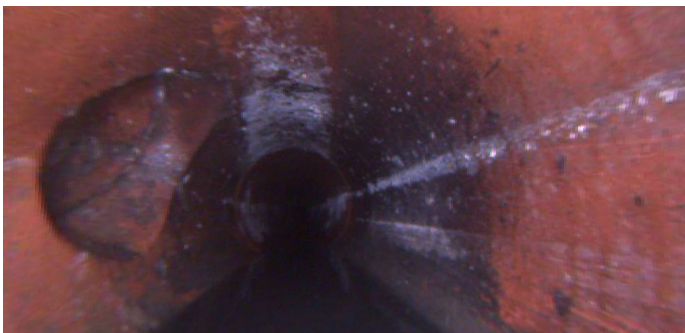
Code: **TF**
Description: **Tap Factory**

Distance (ft): **85.9**
Structural Grade: **0**
O&M Grade: **0**
Clock Start/From: **9**
Clock To:
1st Value: **4.000**
2nd Value:
Value Percent:
Continuous Index:
Within 8" of Joint:
Remarks:

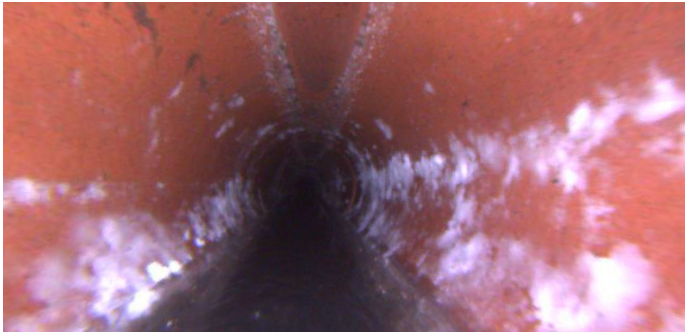
Code: **DAGS**
Description: **Deposits Attached Grease**

Distance (ft): **95.3**
Structural Grade: **0**
O&M Grade: **2**
Clock Start/From: **8**
Clock To: **4**
1st Value:
2nd Value:
Value Percent: **5.000**
Continuous Index: **S02**
Within 8" of Joint: **NO**
Remarks:

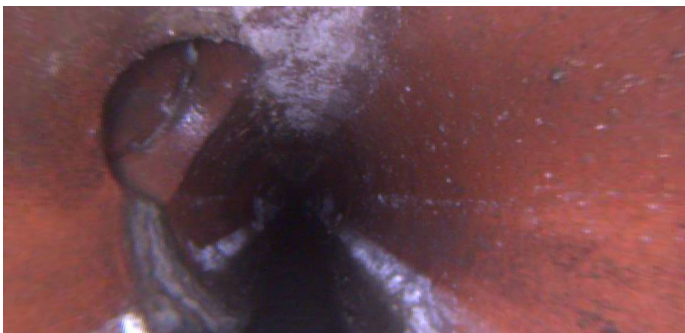
Code: **TF**
Description: **Tap Factory**

Distance (ft): **137.6**
Structural Grade: **0**
O&M Grade: **0**
Clock Start/From: **10**
Clock To:
1st Value: **4.000**
2nd Value:
Value Percent:
Continuous Index:
Within 8" of Joint:
Remarks:

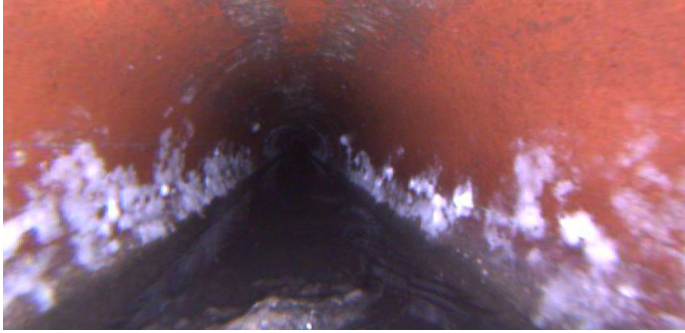
Code: **MWL**
Description: **Water Level**

Distance (ft): **146.8**
Structural Grade: **0**
O&M Grade: **0**
Clock Start/From:
Clock To:
1st Value:
2nd Value:
Value Percent: **20.000**
Continuous Index:
Within 8" of Joint: **NO**
Remarks:

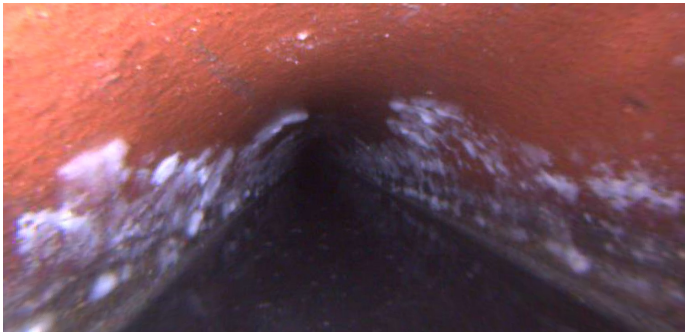
Code: **DAGS**
Description: **Deposits Attached Grease**

Distance (ft): **209.7**
Structural Grade: **0**
O&M Grade: **2**
Clock Start/From: **8**
Clock To: **4**
1st Value:
2nd Value:
Value Percent: **5.000**
Continuous Index: **F02**
Within 8" of Joint: **NO**
Remarks:
