Profile/Ph	oto Observation	Report				RedZone
Date:	04/16/2018	Weather:			Coding:	PACP 6.0
Pipe Length (ft): 173.9	Owner:	NA		Pre Clean:	Not Known
P.O.#:		Surveyor:	Selasie Hor	u	PSR:	P-904-028-029
Customer:		Clean Date:	01/01/190)	Shape:	С
Street:	Cleveland Terr.		Flow Control	:	Not Controlled	
City:	Hobart, IN		Year Renewe	d:		
Location:	Other		Tape/Media	#:		
Purpose:	Not Known		Dia/Height:		10"	
Use:	Sanitary		Material:		VCP	
Drain Area:	NA		Lining:			
Category:	NA					
Comment:						
Location Detail	ls:		Direction of S	Survey:	Downstream	
US MH:	M-904-029	DS MH:	M-904-028	Т	otal Length Surveyed (ft):	5.2
0&M Index:	2.00	O&M Quick:		2100	O&M Rating:	2.00
tructural Index:	0.00	Structural Qu	lick:	0000	 Structural Rating:	0.00
Overall Index:	2.00	Overall Quick	<:	2100	Overall Rating:	2.00

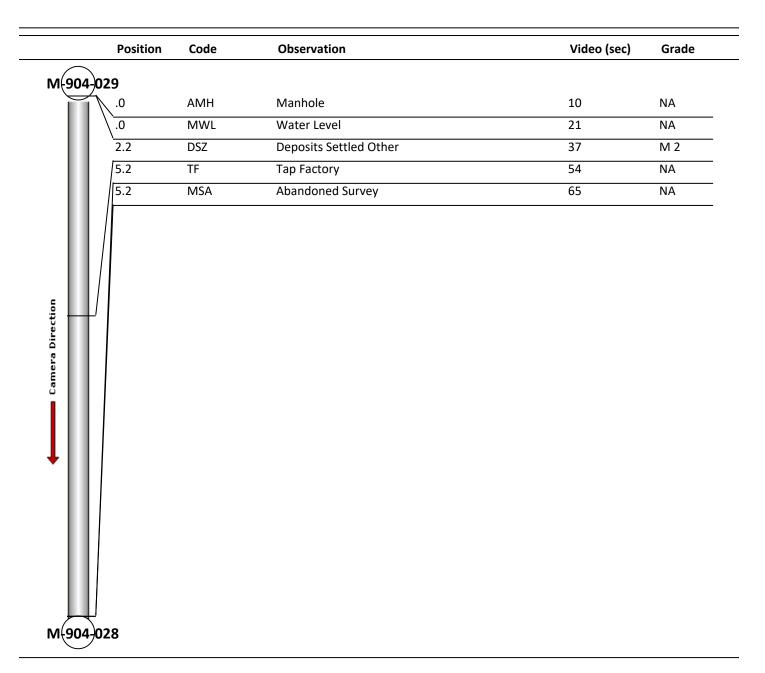
Code: Description:	AMH Manhole
Distance (ft):	.0
Structural Grade:	0
O&M Grade:	0
Clock Start/From:	
Clock To:	
1st Value:	
2nd Value:	
Value Percent:	
Continuous Index:	
Within 8" of Joint:	NO
Remarks:	M-904-029

Code: MWL Description: Water Level

Distance (ft):	.0
Structural Grade:	0
O&M Grade:	0
Clock Start/From:	
Clock To:	
1st Value:	
2nd Value:	
Value Percent:	5.000
Continuous Index:	
Within 8" of Joint:	NO
Remarks:

Code: Description:	DSZ Deposits Settled Other
Distance (ft):	2.2
Structural Grade:	0
O&M Grade:	2
Clock Start/From:	6
Clock To:	
1st Value:	
2nd Value:	
Value Percent:	10.000
Continuous Index:	
Within 8" of Joint:	NO
Remarks:	mixed material

Code: Description:	TF Tap Factory
Distance (ft):	5.2
Structural Grade:	0
O&M Grade:	0
Clock Start/From:	9
Clock To:	
1st Value:	4.000
2nd Value:	
Value Percent:	
Continuous Index:	
Within 8" of Joint:	
Remarks:

Code:	MSA
Description:	Abandoned Survey
Distance (ft):	5.2
Structural Grade:	0
O&M Grade:	0
Clock Start/From:	
Clock To:	
1st Value:	
2nd Value:	
Value Percent:	
Continuous Index:	
Within 8" of Joint:	NO
Remarks:	camera stopped by mixed material
