## Profile/Photo Observation Report

Street:	<b>Cleveland Terr.</b>	Flow Control:	<b>Not Controlled</b>
City:	<b>Hobart, IN</b>	Year Renewed:	
Location:	<b>Other</b>	Tape/Media #:	
Purpose:	<b>Not Known</b>	Dia/Height:	<b>10"</b>
Use:	<b>Sanitary</b>	Material:	<b>VCP</b>
Drain Area:	<b>NA</b>	Lining:	
Category:	<b>NA</b>		
Comment:

Location Details:		Direction of Survey:	<b>Upstream</b>
US MH:	<b>M-904-030</b>	DS MH:	<b>M-904-029</b>
		Total Length Surveyed (ft):	<b>31.3</b>

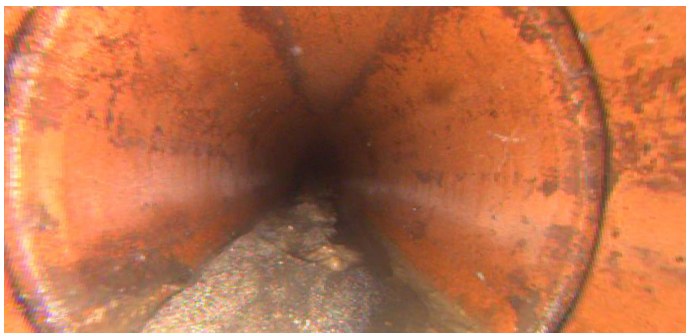
Code: **AMH**  
Description: **Manhole**

Distance (ft): **.0**  
Structural Grade: **0**  
O&M Grade: **0**  
Clock Start/From:  
Clock To:  
1st Value:  
2nd Value:  
Value Percent:  
Continuous Index:  
Within 8" of Joint: **NO**  
Remarks: **M-904-029**

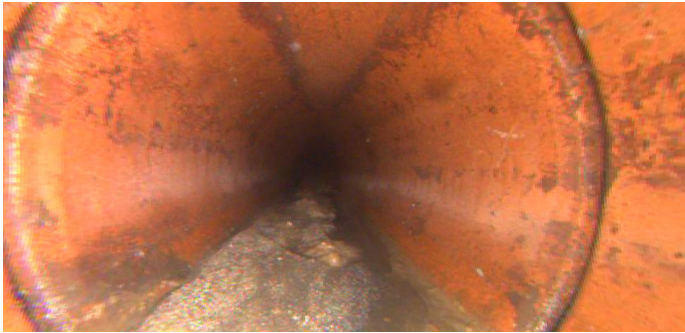
Code:	<b>MWL</b>
Description:	<b>Water Level</b>

Distance (ft):	<b>.0</b>
Structural Grade:	<b>0</b>
O&M Grade:	<b>0</b>
Clock Start/From:	
Clock To:	
1st Value:	
2nd Value:	
Value Percent:	<b>5.000</b>
Continuous Index:	
Within 8" of Joint:	<b>NO</b>
Remarks:

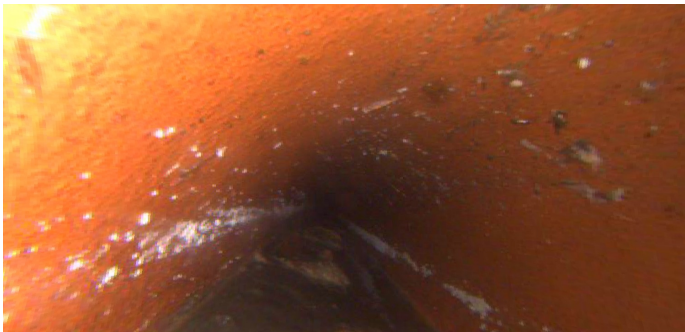
Code:	<b>MSA</b>
Description:	<b>Abandoned Survey</b>

Distance (ft):	<b>31.3</b>
Structural Grade:	<b>0</b>
O&M Grade:	<b>0</b>
Clock Start/From:	
Clock To:	
1st Value:	
2nd Value:	
Value Percent:	
Continuous Index:	
Within 8" of Joint:	<b>NO</b>
Remarks:	<b>debris</b>
