## Profile/Photo Observation Report

Street:	<b>CLEVELAND TERR</b>	Flow Control:	<b>Not Controlled</b>
City:	<b>Hobart, IN</b>	Year Renewed:	
Location:	<b>Other</b>	Tape/Media #:	
Purpose:	<b>Not Known</b>	Dia/Height:	<b>10"</b>
Use:	<b>Sanitary</b>	Material:	<b>VCP</b>
Drain Area:	<b>NA</b>	Lining:	
Category:	<b>NA</b>		
Comment:

Location Details:		Direction of Survey:	<b>Downstream</b>
US MH:	<b>M-904-030</b>	DS MH:	<b>M-904-029</b>
		Total Length Surveyed (ft):	<b>51.2</b>

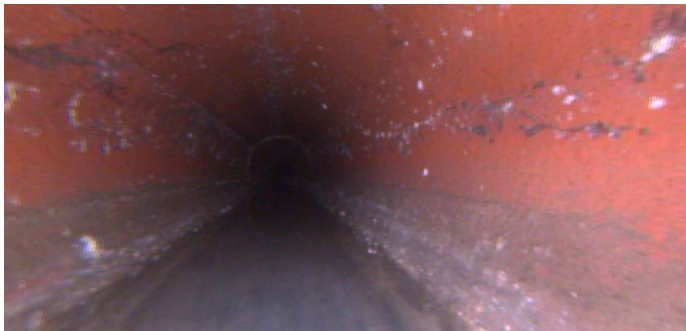
Code: **AMH**  
Description: **Manhole**

Distance (ft): **.0**  
Structural Grade: **0**  
O&M Grade: **0**  
Clock Start/From:  
Clock To:  
1st Value:  
2nd Value:  
Value Percent:  
Continuous Index:  
Within 8" of Joint: **NO**  
Remarks: **M-904-030**

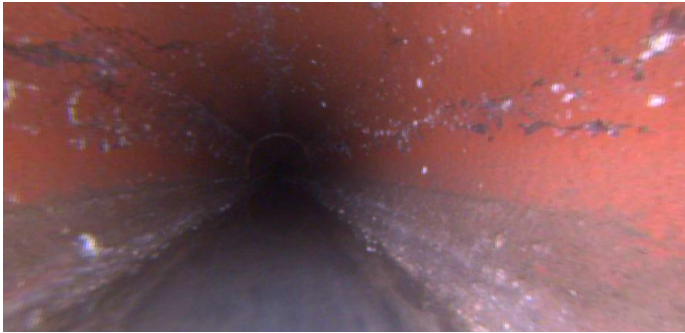
Code:	<b>MWL</b>
Description:	<b>Water Level</b>

Distance (ft):	<b>.0</b>
Structural Grade:	<b>0</b>
O&M Grade:	<b>0</b>
Clock Start/From:	
Clock To:	
1st Value:	
2nd Value:	
Value Percent:	<b>5.000</b>
Continuous Index:	
Within 8" of Joint:	<b>NO</b>
Remarks:

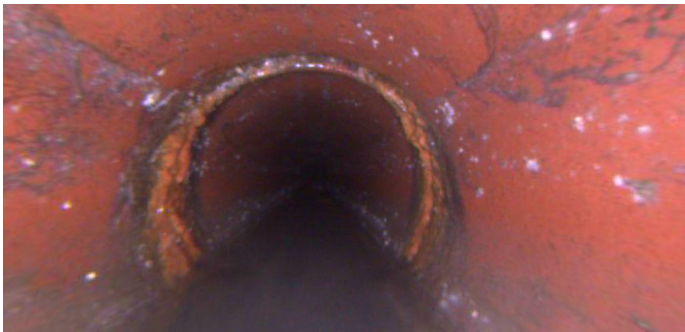
Code:	<b>IW</b>
Description:	<b>Infil Weeper</b>

Distance (ft):	<b>3.8</b>
Structural Grade:	<b>0</b>
O&M Grade:	<b>2</b>
Clock Start/From:	<b>8</b>
Clock To:	<b>4</b>
1st Value:	
2nd Value:	
Value Percent:	
Continuous Index:	
Within 8" of Joint:	<b>YES</b>
Remarks:

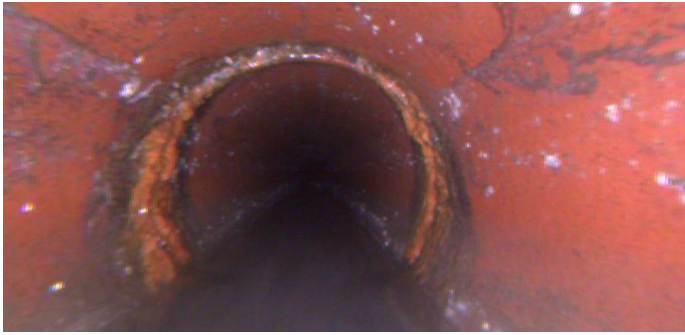
Code: **DAE**  
Description: **Deposits Attached Encrustation**

Distance (ft): **3.8**  
Structural Grade: **0**  
O&M Grade: **3**  
Clock Start/From: **7**  
Clock To: **5**  
1st Value:  
2nd Value:  
Value Percent: **20.000**  
Continuous Index:  
Within 8" of Joint: **YES**  
Remarks:

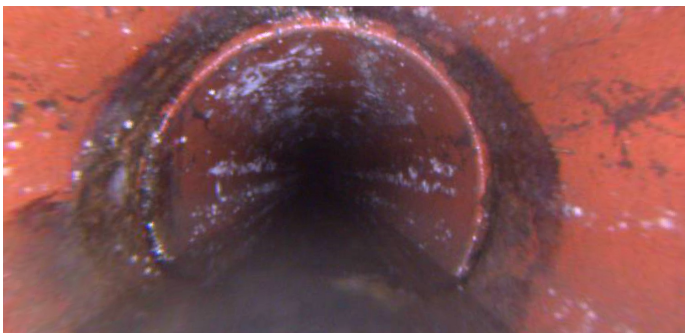
Code: **IW**  
Description: **Infil Weeper**

Distance (ft): **18.7**  
Structural Grade: **0**  
O&M Grade: **2**  
Clock Start/From: **8**  
Clock To: **4**  
1st Value:  
2nd Value:  
Value Percent:  
Continuous Index:  
Within 8" of Joint: **YES**  
Remarks:

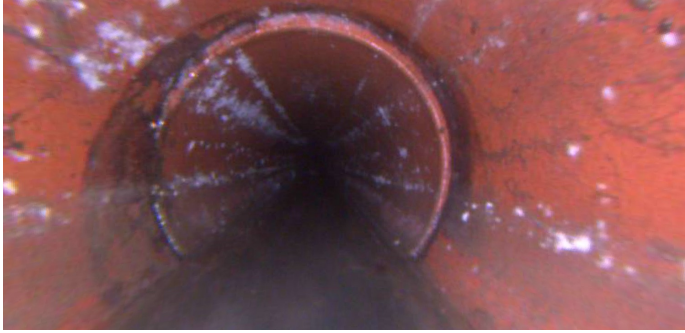
Code: **IW**  
Description: **Infil Weeper**

Distance (ft): **33.4**  
Structural Grade: **0**  
O&M Grade: **2**  
Clock Start/From: **8**  
Clock To: **4**  
1st Value:  
2nd Value:  
Value Percent:  
Continuous Index:  
Within 8" of Joint: **YES**  
Remarks:

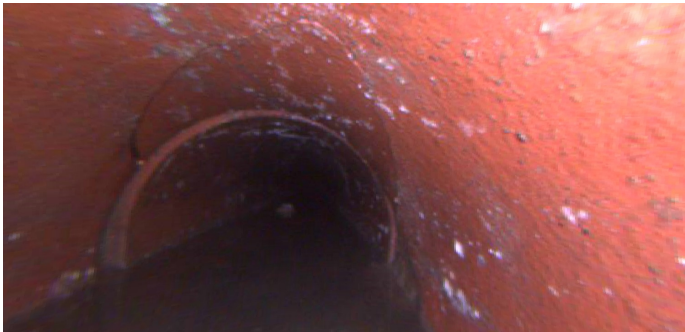
Code: **FC**  
Description: **Fracture Circumferential**

Distance (ft): **48.3**  
Structural Grade: **2**  
O&M Grade: **0**  
Clock Start/From: **10**  
Clock To: **3**  
1st Value:  
2nd Value:  
Value Percent:  
Continuous Index:  
Within 8" of Joint: **YES**  
Remarks:

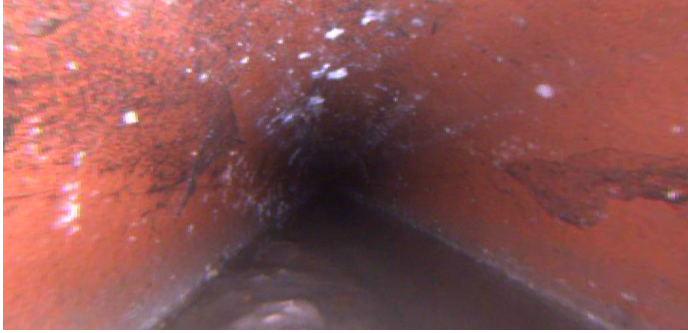
Code:	<b>MSA</b>
Description:	<b>Abandoned Survey</b>
Distance (ft):	<b>51.2</b>
Structural Grade:	<b>0</b>
O&M Grade:	<b>0</b>
Clock Start/From:	
Clock To:	
1st Value:	
2nd Value:	
Value Percent:	
Continuous Index:	
Within 8" of Joint:	<b>NO</b>
Remarks:	<b>debris</b>
