## Profile/Photo Observation Report

Street:	<b>Cleveland Terr.</b>	Flow Control:	<b>Not Controlled</b>
City:	<b>Hobart, IN</b>	Year Renewed:	
Location:	<b>Other</b>	Tape/Media #:	
Purpose:	<b>Not Known</b>	Dia/Height:	<b>10"</b>
Use:	<b>Sanitary</b>	Material:	<b>VCP</b>
Drain Area:	<b>NA</b>	Lining:	
Category:	<b>NA</b>		
Comment:

Location Details:		Direction of Survey:	<b>Downstream</b>
US MH:	<b>M-904-030</b>	DS MH:	<b>M-904-029</b>
		Total Length Surveyed (ft):	<b>51.2</b>

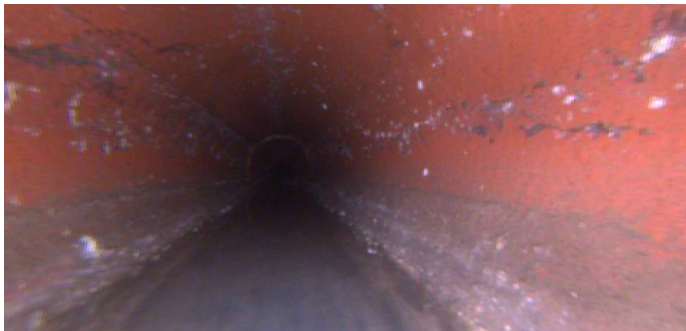
Code: **AMH**  
Description: **Manhole**

Distance (ft): **.0**  
Structural Grade: **0**  
O&M Grade: **0**  
Clock Start/From:  
Clock To:  
1st Value:  
2nd Value:  
Value Percent:  
Continuous Index:  
Within 8" of Joint: **NO**  
Remarks: **M-904-030**

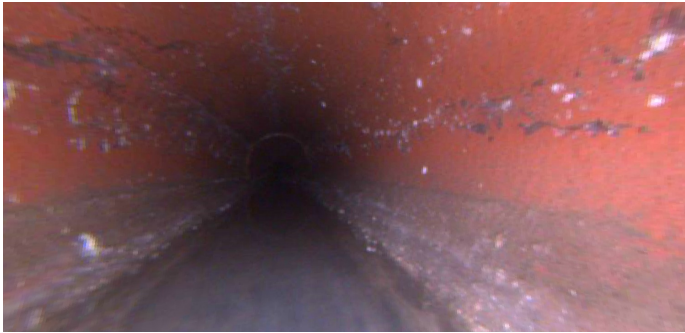
Code:	<b>MWL</b>
Description:	<b>Water Level</b>

Distance (ft):	<b>.0</b>
Structural Grade:	<b>0</b>
O&M Grade:	<b>0</b>
Clock Start/From:	
Clock To:	
1st Value:	
2nd Value:	
Value Percent:	<b>5.000</b>
Continuous Index:	
Within 8" of Joint:	<b>NO</b>
Remarks:

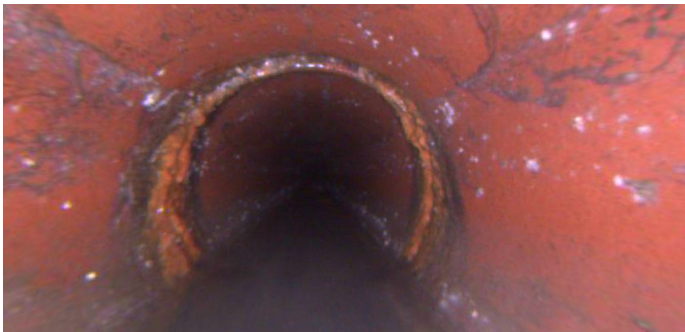
Code:	<b>IW</b>
Description:	<b>Infil Weeper</b>

Distance (ft):	<b>3.8</b>
Structural Grade:	<b>0</b>
O&M Grade:	<b>2</b>
Clock Start/From:	<b>8</b>
Clock To:	<b>4</b>
1st Value:	
2nd Value:	
Value Percent:	
Continuous Index:	
Within 8" of Joint:	<b>YES</b>
Remarks:

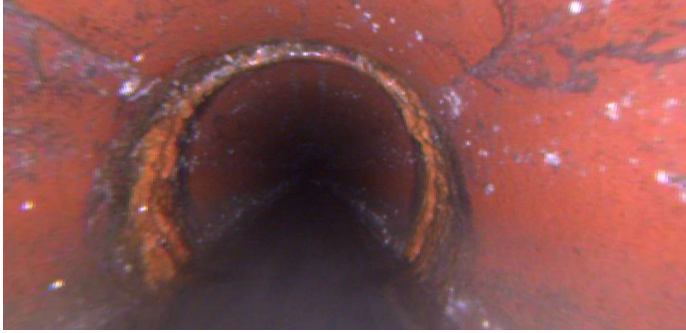
Code: **DAE**  
Description: **Deposits Attached Encrustation**

Distance (ft): **3.8**  
Structural Grade: **0**  
O&M Grade: **3**  
Clock Start/From: **7**  
Clock To: **5**  
1st Value:  
2nd Value:  
Value Percent: **20.000**  
Continuous Index:  
Within 8" of Joint: **YES**  
Remarks:

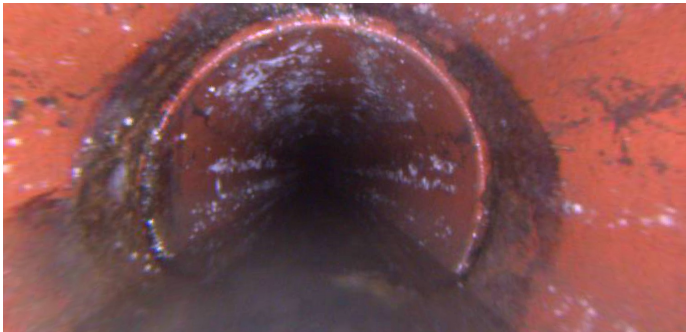
Code: **IW**  
Description: **Infil Weeper**

Distance (ft): **18.7**  
Structural Grade: **0**  
O&M Grade: **2**  
Clock Start/From: **8**  
Clock To: **4**  
1st Value:  
2nd Value:  
Value Percent:  
Continuous Index:  
Within 8" of Joint: **YES**  
Remarks:

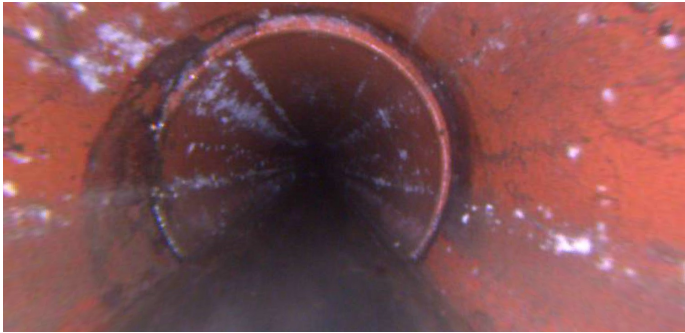
Code: **IW**  
Description: **Infil Weeper**

Distance (ft): **33.4**  
Structural Grade: **0**  
O&M Grade: **2**  
Clock Start/From: **8**  
Clock To: **4**  
1st Value:  
2nd Value:  
Value Percent:  
Continuous Index:  
Within 8" of Joint: **YES**  
Remarks:

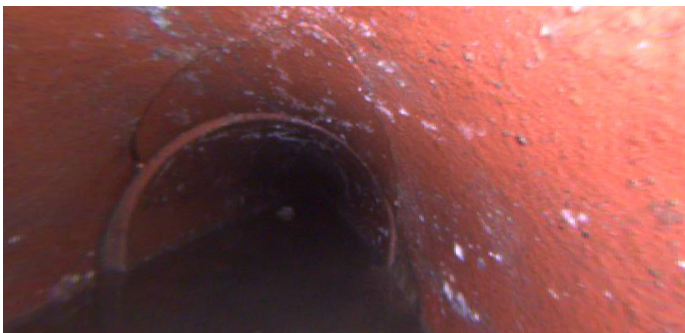
Code: **FC**  
Description: **Fracture Circumferential**

Distance (ft): **48.3**  
Structural Grade: **2**  
O&M Grade: **0**  
Clock Start/From: **10**  
Clock To: **3**  
1st Value:  
2nd Value:  
Value Percent:  
Continuous Index:  
Within 8" of Joint: **YES**  
Remarks:

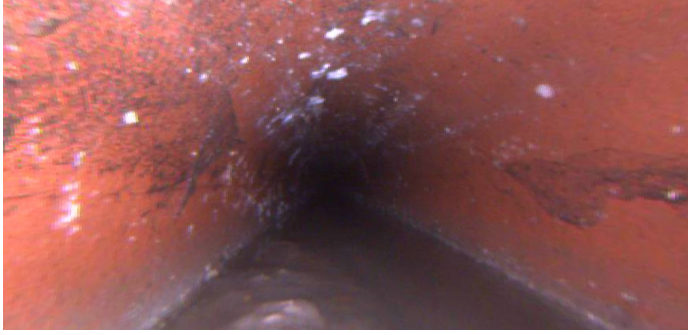
Code:	<b>MSA</b>
Description:	<b>Abandoned Survey</b>
Distance (ft):	<b>51.2</b>
Structural Grade:	<b>0</b>
O&M Grade:	<b>0</b>
Clock Start/From:	
Clock To:	
1st Value:	
2nd Value:	
Value Percent:	
Continuous Index:	
Within 8" of Joint:	<b>NO</b>
Remarks:	<b>debris</b>
