## Profile/Photo Observation Report

Street:	<b>CLEVELAND TERR</b>	Flow Control:	<b>Not Controlled</b>
City:	<b>Hobart, IN</b>	Year Renewed:	
Location:	<b>Other</b>	Tape/Media #:	
Purpose:	<b>Not Known</b>	Dia/Height:	<b>10"</b>
Use:	<b>Sanitary</b>	Material:	<b>VCP</b>
Drain Area:	<b>NA</b>	Lining:	
Category:	<b>NA</b>		
Comment:

Location Details:		Direction of Survey:	<b>Downstream</b>
US MH:	<b>M-904-031</b>	DS MH:	<b>M-904-030</b>
		Total Length Surveyed (ft):	<b>158.8</b>

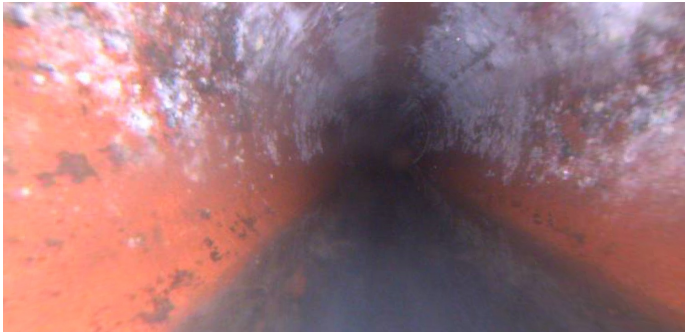
Code:	<b>MWL</b>
Description:	<b>Water Level</b>

Distance (ft):	<b>.0</b>
Structural Grade:	<b>0</b>
O&M Grade:	<b>0</b>
Clock Start/From:	
Clock To:	
1st Value:	
2nd Value:	
Value Percent:	<b>10.000</b>
Continuous Index:	
Within 8" of Joint:	<b>NO</b>
Remarks:

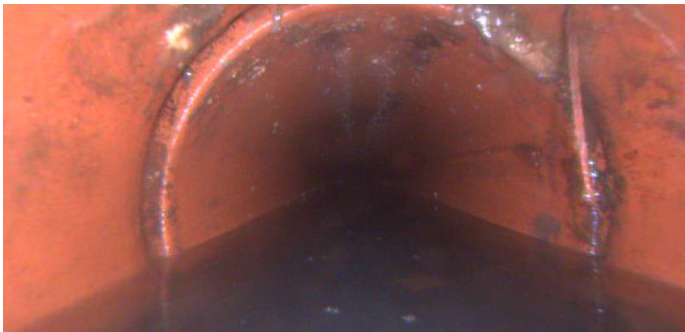
Code:	<b>RFJ</b>
Description:	<b>Roots Fine Joint</b>

Distance (ft):	<b>52.8</b>
Structural Grade:	<b>0</b>
O&M Grade:	<b>1</b>
Clock Start/From:	<b>2</b>
Clock To:	
1st Value:	
2nd Value:	
Value Percent:	
Continuous Index:	
Within 8" of Joint:	<b>YES</b>
Remarks:

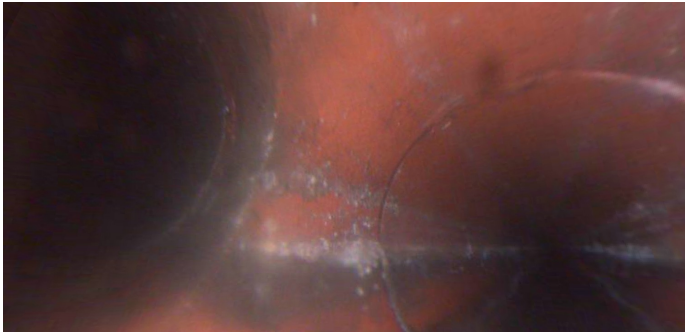
Code: **TF**  
Description: **Tap Factory**

Distance (ft): **98.0**  
Structural Grade: **0**  
O&M Grade: **0**  
Clock Start/From: **9**  
Clock To:  
1st Value: **4.000**  
2nd Value:  
Value Percent:  
Continuous Index:  
Within 8" of Joint:  
Remarks:

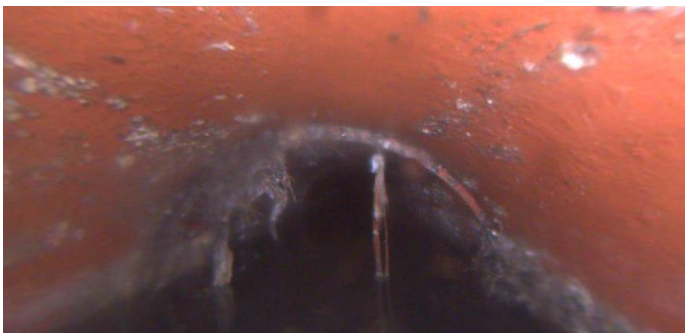
Code: **RFJ**  
Description: **Roots Fine Joint**

Distance (ft): **142.9**  
Structural Grade: **0**  
O&M Grade: **1**  
Clock Start/From: **8**  
Clock To: **4**  
1st Value:  
2nd Value:  
Value Percent:  
Continuous Index:  
Within 8" of Joint: **YES**  
Remarks:

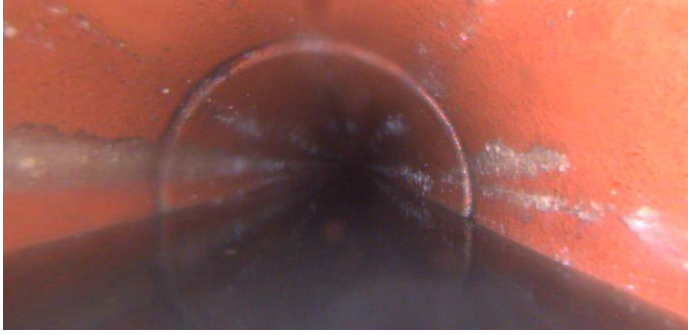
Code:	<b>MSA</b>
Description:	<b>Abandoned Survey</b>
Distance (ft):	<b>158.8</b>
Structural Grade:	<b>0</b>
O&M Grade:	<b>0</b>
Clock Start/From:	
Clock To:	
1st Value:	
2nd Value:	
Value Percent:	
Continuous Index:	
Within 8" of Joint:	<b>NO</b>
Remarks:	<b>No blockage</b>
