## Profile/Photo Observation Report

Street:	<b>CLEVELAND TERR</b>	Flow Control:	<b>Not Controlled</b>
City:	<b>Hobart, IN</b>	Year Renewed:	
Location:	<b>Other</b>	Tape/Media #:	
Purpose:	<b>Not Known</b>	Dia/Height:	<b>10"</b>
Use:	<b>Sanitary</b>	Material:	<b>VCP</b>
Drain Area:	<b>NA</b>	Lining:	
Category:	<b>NA</b>		
Comment:

Location Details:		Direction of Survey:	<b>Upstream</b>
US MH:	<b>M-904-031</b>	DS MH:	<b>M-904-032</b>
		Total Length Surveyed (ft):	<b>107.4</b>

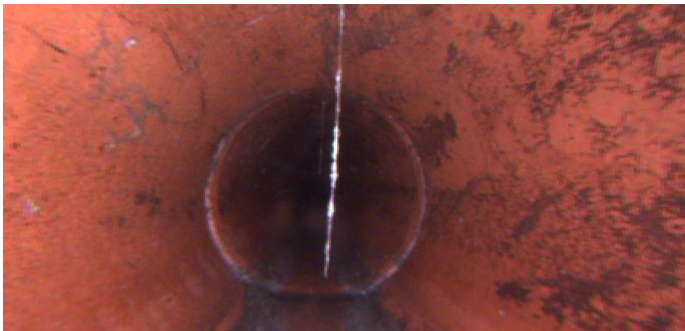
Code: **AMH**  
Description: **Manhole**

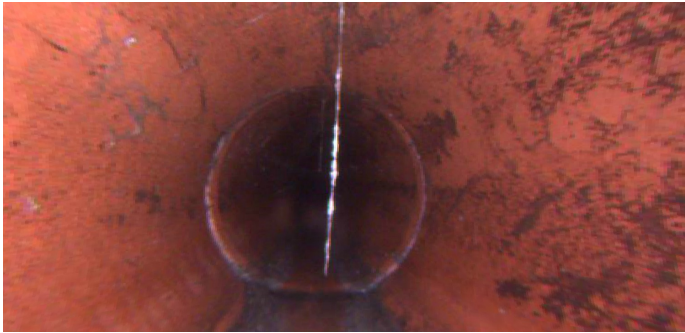
Code:	<b>MWL</b>
Description:	<b>Water Level</b>

Distance (ft):	<b>.0</b>
Structural Grade:	<b>0</b>
O&M Grade:	<b>0</b>
Clock Start/From:	
Clock To:	
1st Value:	
2nd Value:	
Value Percent:	<b>5.000</b>
Continuous Index:	
Within 8" of Joint:	<b>NO</b>
Remarks:

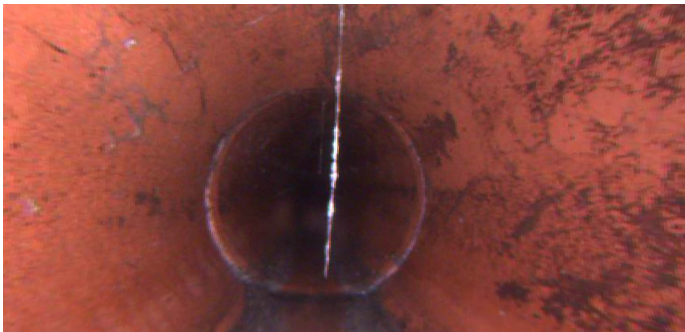
Code:	<b>DAZ</b>
Description:	<b>Deposits Attached Other</b>

Distance (ft):	<b>.0</b>
Structural Grade:	<b>0</b>
O&M Grade:	<b>2</b>
Clock Start/From:	<b>7</b>
Clock To:	<b>5</b>
1st Value:	
2nd Value:	
Value Percent:	<b>5.000</b>
Continuous Index:	<b>S01</b>
Within 8" of Joint:	<b>YES</b>
Remarks:	<b>WANDER</b>

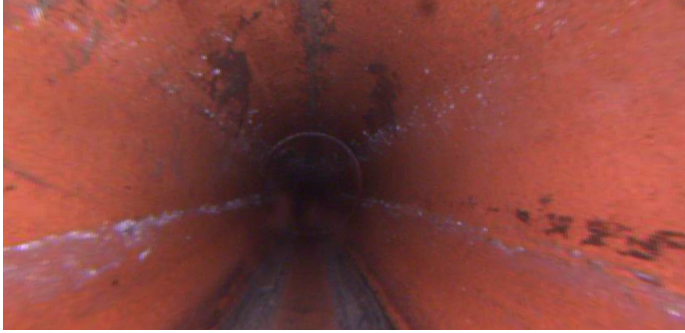
Code: **DAGS**  
Description: **Deposits Attached Grease**

Distance (ft): **4.9**  
Structural Grade: **0**  
O&M Grade: **2**  
Clock Start/From: **7**  
Clock To: **5**  
1st Value:  
2nd Value:  
Value Percent: **5.000**  
Continuous Index: **S02**  
Within 8" of Joint: **YES**  
Remarks: **WANDER**
