Profile/Photo Observation Report

Street:	Cleveland Terr.	Flow Control:	Not Controlled
City:	Hobart, IN	Year Renewed:	
Location:	Other	Tape/Media #:	
Purpose:	Not Known	Dia/Height:	10"
Use:	Sanitary	Material:	VCP
Drain Area:	NA	Lining:	
Category:	NA		
Comment:

Location Details:		Direction of Survey:	Upstream
US MH:	M-904-031	DS MH:	M-904-032
		Total Length Surveyed (ft):	107.4

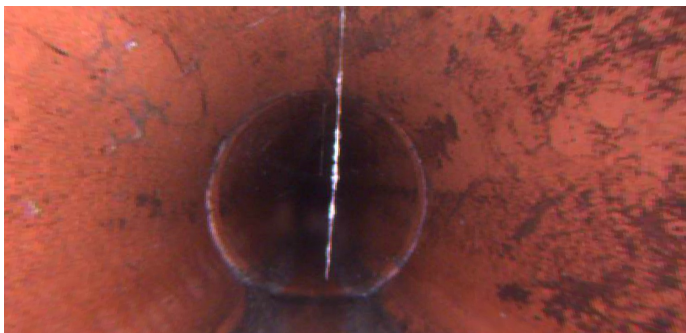
Code: **AMH**
Description: **Manhole**

Distance (ft): **.0**
Structural Grade: **0**
O&M Grade: **0**
Clock Start/From:
Clock To:
1st Value:
2nd Value:
Value Percent:
Continuous Index:
Within 8" of Joint: **NO**
Remarks: **M-904-032**

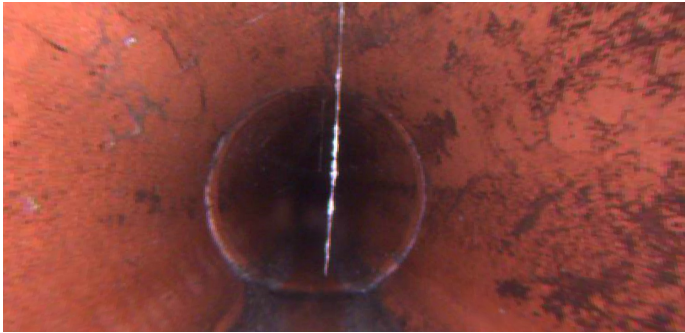
Code:	MWL
Description:	Water Level

Distance (ft):	.0
Structural Grade:	0
O&M Grade:	0
Clock Start/From:	
Clock To:	
1st Value:	
2nd Value:	
Value Percent:	5.000
Continuous Index:	
Within 8" of Joint:	NO
Remarks:

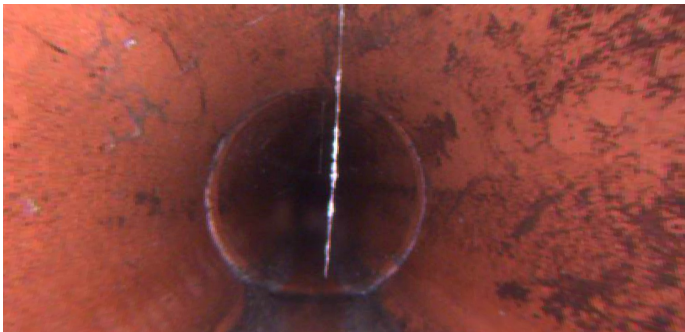
Code:	DAZ
Description:	Deposits Attached Other

Distance (ft):	.0
Structural Grade:	0
O&M Grade:	2
Clock Start/From:	7
Clock To:	5
1st Value:	
2nd Value:	
Value Percent:	5.000
Continuous Index:	S01
Within 8" of Joint:	YES
Remarks:	WANDER

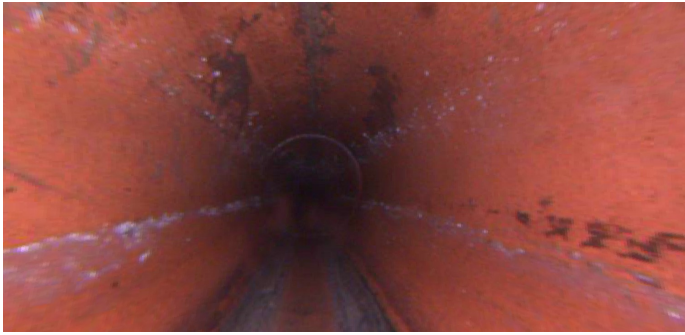
Code: **DAGS**
Description: **Deposits Attached Grease**

Distance (ft): **4.9**
Structural Grade: **0**
O&M Grade: **2**
Clock Start/From: **7**
Clock To: **5**
1st Value:
2nd Value:
Value Percent: **5.000**
Continuous Index: **S02**
Within 8" of Joint: **YES**
Remarks: **WANDER**
