Profile/Photo Observation Report

| Street: | CLEVELAND TERR | Flow Control: | Not Controlled |
| City: | Hobart, IN | Year Renewed: | |

| US MH: | M-904-033 | DS MH: | M-904-032 |

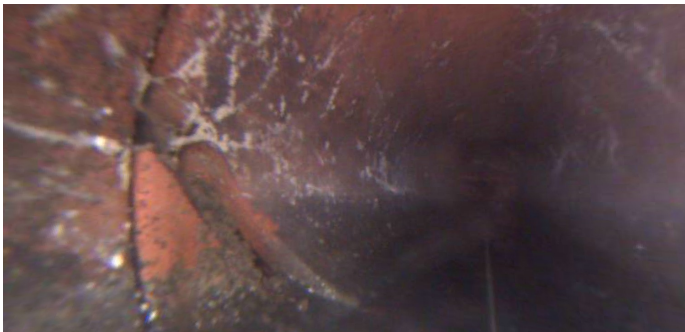
| | Position | Code | Observation | Video (sec) | Grade |
|---|---|---|---|---|---|
| | 4.2 | BSV | Broken Soil Visible | 43 | S 5 |

| Code: | BSV |
| Description: | Broken Soil Visible |

| Distance (ft): | 4.2 |
| Structural Grade: | 5 |

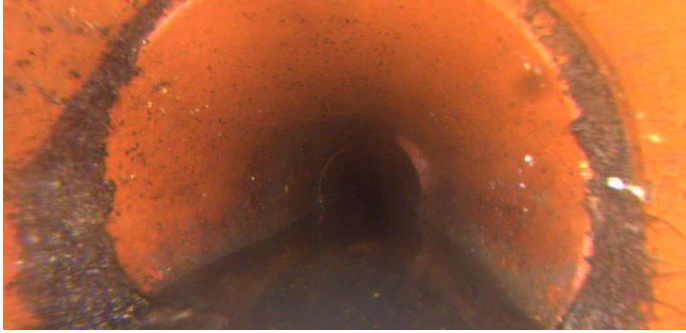
| | Position | Code | Observation | Video (sec) | Grade |
|---|---|---|---|---|---|
| | 62.9 | RFJ | Roots Fine Joint | 174 | M 1 |

Code: **RFJ**
Description: **Roots Fine Joint**

Distance (ft): **62.9**
Structural Grade: **0**
O&M Grade: **1**
Clock Start/From: **8**
Clock To: **4**
1st Value:
2nd Value:
Value Percent:
Continuous Index:
Within 8" of Joint: **YES**
Remarks:

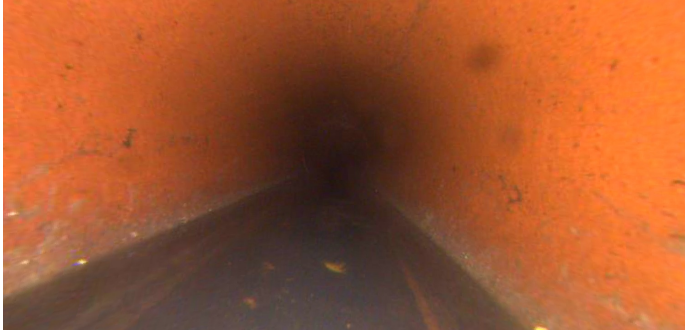
Code: **MWL**
Description: **Water Level**

Distance (ft): **71.8**
Structural Grade: **0**
O&M Grade: **0**
Clock Start/From:
Clock To:
1st Value:
2nd Value:
Value Percent: **20.000**
Continuous Index:
Within 8" of Joint: **NO**
Remarks:

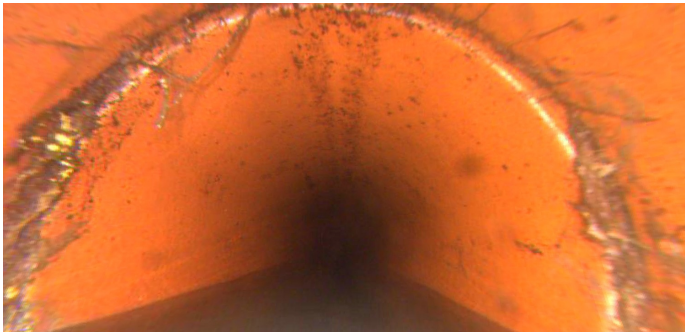
| | Position | Code | Observation | Video (sec) | Grade |
|---|---|---|---|---|---|
| | 95.1 | RFJ | Roots Fine Joint | 273 | M 1 |

Code: **RFJ**
Description: **Roots Fine Joint**

Distance (ft): **95.1**
Structural Grade: **0**
O&M Grade: **1**
Clock Start/From: **8**
Clock To: **4**
1st Value:
2nd Value:
Value Percent:
Continuous Index:
Within 8" of Joint: **YES**
Remarks:

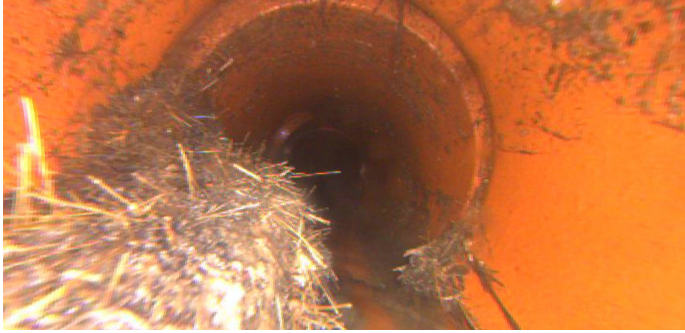
| | Position | Code | Observation | Video (sec) | Grade |
|---|---|---|---|---|---|
| | 104.4 | RMJ | Roots Medium Joint | 303 | M 3 |

Code: **RMJ**
Description: **Roots Medium Joint**

Distance (ft): **104.4**
Structural Grade: **0**
O&M Grade: **3**
Clock Start/From: **7**
Clock To: **5**
1st Value:
2nd Value:
Value Percent: **20.000**
Continuous Index:
Within 8" of Joint: **YES**
Remarks:

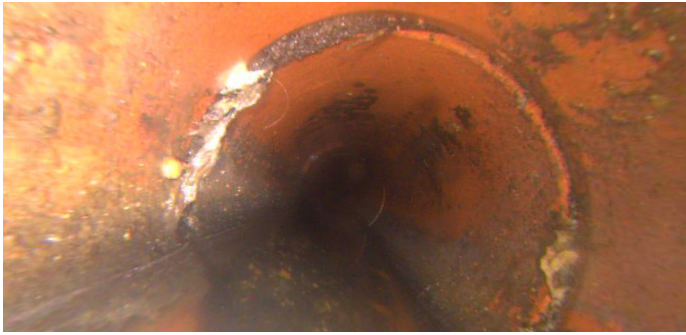
| | Position | Code | Observation | Video (sec) | Grade |
|---|---|---|---|---|---|
| | 106.8 | RFJ | Roots Fine Joint | 331 | M 1 |

Code: **RFJ**
Description: **Roots Fine Joint**

Distance (ft): **106.8**
Structural Grade: **0**
O&M Grade: **1**
Clock Start/From: **8**
Clock To: **4**
1st Value:
2nd Value:
Value Percent:
Continuous Index:
Within 8" of Joint: **YES**
Remarks:

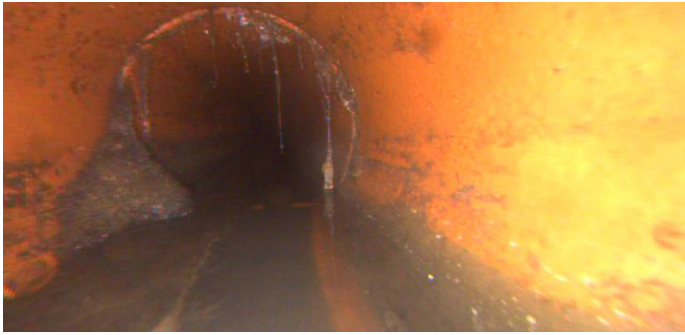
| | Position | Code | Observation | Video (sec) | Grade |
|---|---|---|---|---|---|
| | 112.9 | RMJ | Roots Medium Joint | 366 | M 3 |

Code: **RMJ**
Description: **Roots Medium Joint**

Distance (ft): **112.9**
Structural Grade: **0**
O&M Grade: **3**
Clock Start/From: **7**
Clock To: **5**
1st Value:
2nd Value:
Value Percent: **20.000**
Continuous Index:
Within 8" of Joint: **YES**
Remarks:

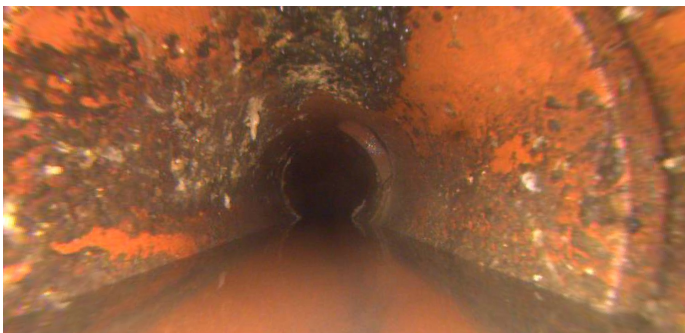
| | Position | Code | Observation | Video (sec) | Grade |
|---|---|---|---|---|---|
| | 143.5 | DAGS | Deposits Attached Grease | 439 | M 2 |

Code: **DAGS**
Description: **Deposits Attached Grease**

Distance (ft): **143.5**
Structural Grade: **0**
O&M Grade: **2**
Clock Start/From: **8**
Clock To: **4**
1st Value:
2nd Value:
Value Percent: **5.000**
Continuous Index:
Within 8" of Joint: **NO**
Remarks:

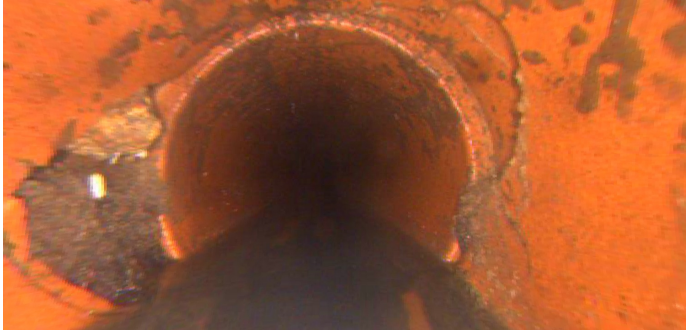
| | Position | Code | Observation | Video (sec) | Grade |
|---|---|---|---|---|---|
| | 176.9 | FM | Fracture Multiple | 540 | S 4 |

Code: **FM**
Description: **Fracture Multiple**

Distance (ft): **176.9**
Structural Grade: **4**
O&M Grade: **0**
Clock Start/From: **7**
Clock To: **3**
1st Value:
2nd Value:
Value Percent:
Continuous Index:
Within 8" of Joint: **YES**
Remarks:

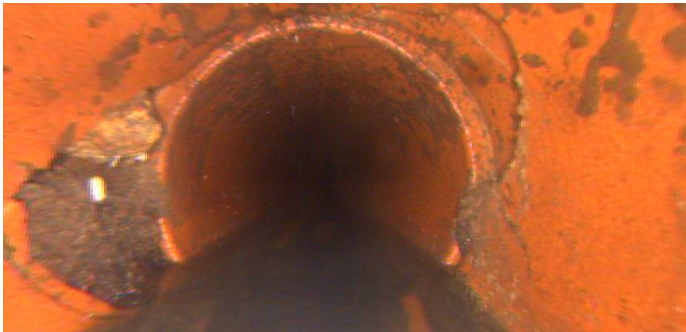
| | Position | Code | Observation | Video (sec) | Grade |
|---|---|---|---|---|---|
| | 176.9 | HSV | Hole Soil Visible | 551 | S 5 |

Code: **HSV**
Description: **Hole Soil Visible**

Distance (ft): **176.9**
Structural Grade: **5**
O&M Grade: **0**
Clock Start/From: **7**
Clock To: **9**
1st Value:
2nd Value:
Value Percent:
Continuous Index:
Within 8" of Joint: **YES**
Remarks:

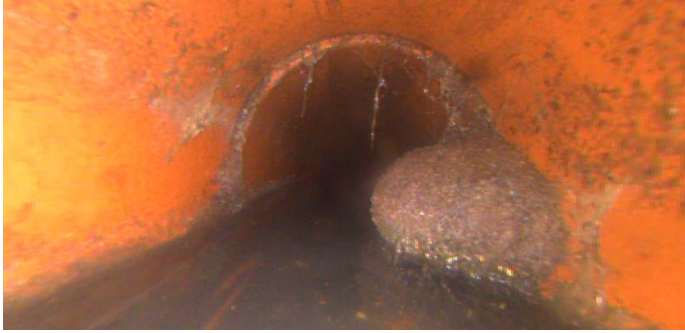
| | Position | Code | Observation | Video (sec) | Grade |
|---|---|---|---|---|---|
| | 216.5 | RMJ | Roots Medium Joint | 642 | M 3 |

Code: **RMJ**
Description: **Roots Medium Joint**

Distance (ft): **216.5**
Structural Grade: **0**
O&M Grade: **3**
Clock Start/From: **7**
Clock To: **5**
1st Value:
2nd Value:
Value Percent: **20.000**
Continuous Index:
Within 8" of Joint: **YES**
Remarks:
