## Profile/Photo Observation Report

Date:	<b>04/11/2018</b>	Weather:		Coding:	<b>PACP 6.0</b>
Pipe Length (ft):	<b>175.6</b>	Owner:	<b>NA</b>	Pre Clean:	<b>Not Known</b>
P.O.#:		Surveyor:	<b>Jen Costello</b>	PSR:	<b>P-904-036-034</b>
Customer:		Clean Date:	<b>01/01/1900</b>	Shape:	<b>C</b>

Street:	<b>CLEVELAND TERR</b>	Flow Control:	<b>Not Controlled</b>
City:	<b>Hobart, IN</b>	Year Renewed:	
Location:	<b>Other</b>	Tape/Media #:	
Purpose:	<b>Not Known</b>	Dia/Height:	<b>10"</b>
Use:	<b>Sanitary</b>	Material:	<b>VCP</b>
Drain Area:	<b>NA</b>	Lining:	
Category:	<b>NA</b>		
Comment:	<b>NULL - MH-M-704-063 Debris at entrance</b>		
Location Details:		Direction of Survey:	<b>Upstream</b>
US MH:	<b>M-904-034</b>	DS MH:	<b>M-904-036</b>
		Total Length Surveyed (ft):	<b>67.5</b>

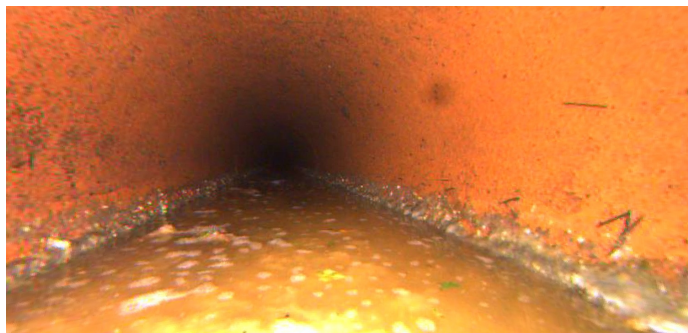
Code: **AMH**  
Description: **Manhole**

Distance (ft): **.0**  
Structural Grade: **0**  
O&M Grade: **0**  
Clock Start/From:  
Clock To:  
1st Value:  
2nd Value:  
Value Percent:  
Continuous Index:  
Within 8" of Joint: **NO**  
Remarks: **M-904-036**

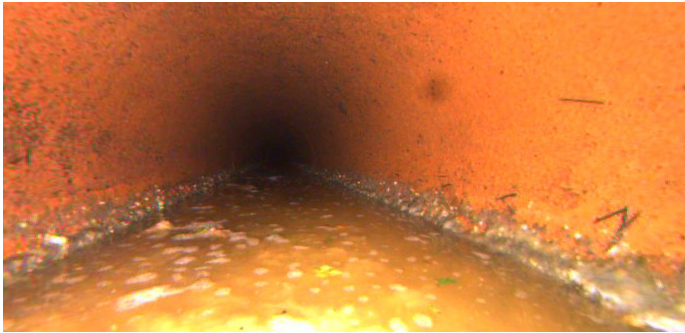
Code:	<b>MWL</b>
Description:	<b>Water Level</b>

Distance (ft):	<b>.0</b>
Structural Grade:	<b>0</b>
O&M Grade:	<b>0</b>
Clock Start/From:	
Clock To:	
1st Value:	
2nd Value:	
Value Percent:	<b>30.000</b>
Continuous Index:	
Within 8" of Joint:	<b>NO</b>
Remarks:

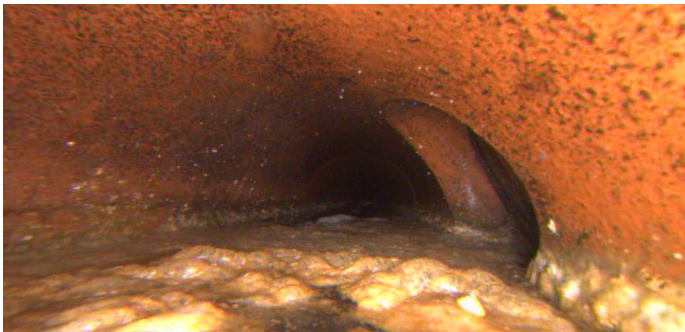
Code:	<b>TFA</b>
Description:	<b>Tap Factory Active</b>

Distance (ft):	<b>39.0</b>
Structural Grade:	<b>0</b>
O&M Grade:	<b>0</b>
Clock Start/From:	<b>3</b>
Clock To:	
1st Value:	<b>4.000</b>
2nd Value:	
Value Percent:	
Continuous Index:	
Within 8" of Joint:	
Remarks:

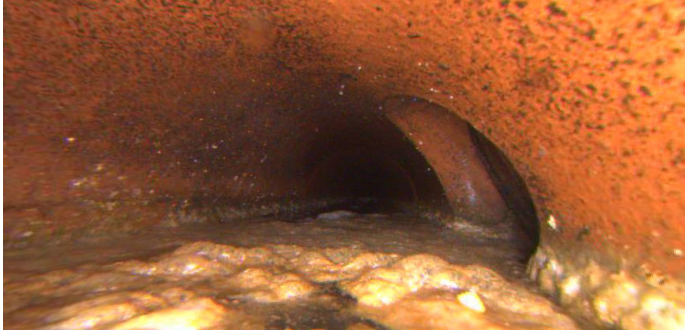
Code: **MWL**  
Description: **Water Level**

Distance (ft): **39.0**  
Structural Grade: **0**  
O&M Grade: **0**  
Clock Start/From:  
Clock To:  
1st Value:  
2nd Value:  
Value Percent: **40.000**  
Continuous Index:  
Within 8" of Joint: **NO**  
Remarks:

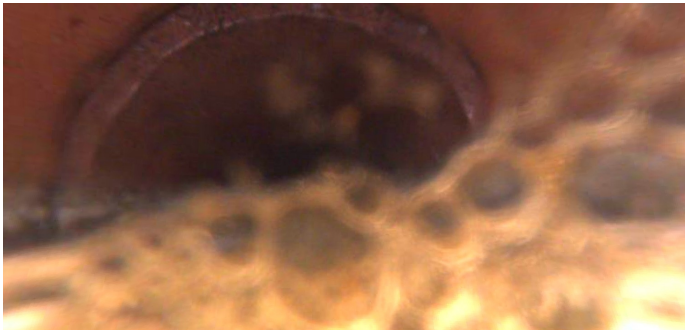
Code: **MGO**  
Description: **General Observation**

Distance (ft): **41.4**  
Structural Grade: **0**  
O&M Grade: **0**  
Clock Start/From:  
Clock To:  
1st Value:  
2nd Value:  
Value Percent:  
Continuous Index:  
Within 8" of Joint: **NO**  
Remarks: **REAR CAMERA**

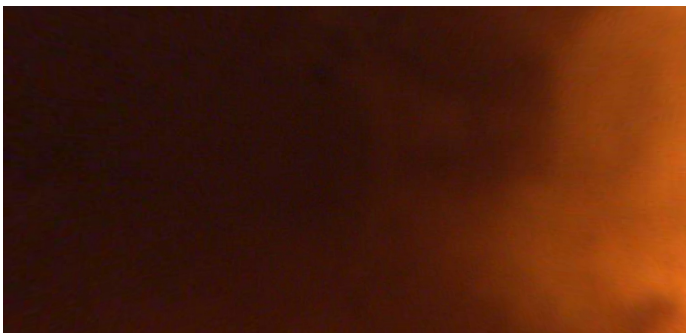
Code: **MCU**  
Description: **Camera Underwater**

Distance (ft): **67.5**  
Structural Grade: **0**  
O&M Grade: **4**  
Clock Start/From:  
Clock To:  
1st Value:  
2nd Value:  
Value Percent:  
Continuous Index: **F01**  
Within 8" of Joint: **NO**  
Remarks:

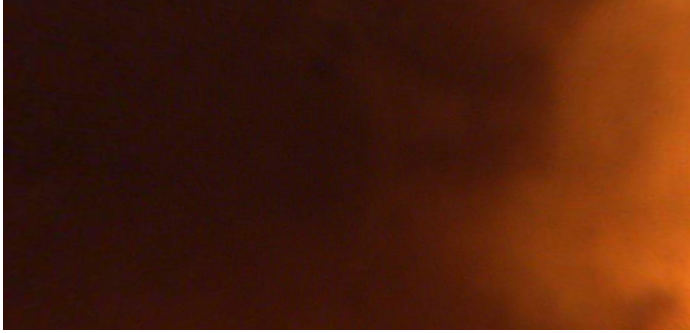
Code:	<b>MSA</b>
Description:	<b>Abandoned Survey</b>
Distance (ft):	<b>67.5</b>
Structural Grade:	<b>0</b>
O&M Grade:	<b>0</b>
Clock Start/From:	
Clock To:	
1st Value:	
2nd Value:	
Value Percent:	
Continuous Index:	
Within 8" of Joint:	<b>NO</b>
Remarks:	<b>UNDER WATER</b>
