Profile/Photo Observation Report

Date:	04/11/2018	Weather:		Coding:	PACP 6.0
Pipe Length (ft):	175.6	Owner:	NA	Pre Clean:	Not Known
P.O.#:		Surveyor:	Jen Costello	PSR:	P-904-036-034
Customer:		Clean Date:	01/01/1900	Shape:	C

Street:	Cleveland Terr.	Flow Control:	Not Controlled
City:	Hobart, IN	Year Renewed:	
Location:	Other	Tape/Media #:	
Purpose:	Not Known	Dia/Height:	10"
Use:	Sanitary	Material:	VCP
Drain Area:	NA	Lining:	
Category:	NA		
Comment:	NULL - MH-M-704-063 Debris at entrance		
Location Details:		Direction of Survey:	Upstream
US MH:	M-904-034	DS MH:	M-904-036
		Total Length Surveyed (ft):	67.5

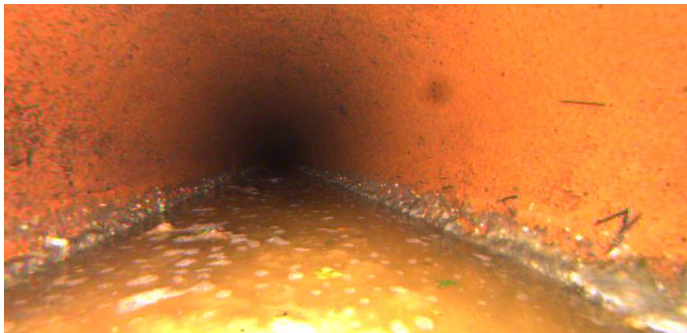
Code: **AMH**
 Description: **Manhole**

Distance (ft): **.0**
 Structural Grade: **0**
 O&M Grade: **0**
 Clock Start/From:
 Clock To:
 1st Value:
 2nd Value:
 Value Percent:
 Continuous Index:
 Within 8" of Joint: **NO**
 Remarks: **M-904-036**

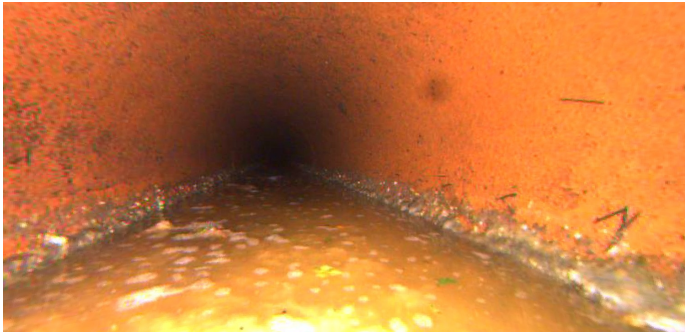
Code:	MWL
Description:	Water Level

Distance (ft):	.0
Structural Grade:	0
O&M Grade:	0
Clock Start/From:	
Clock To:	
1st Value:	
2nd Value:	
Value Percent:	30.000
Continuous Index:	
Within 8" of Joint:	NO
Remarks:

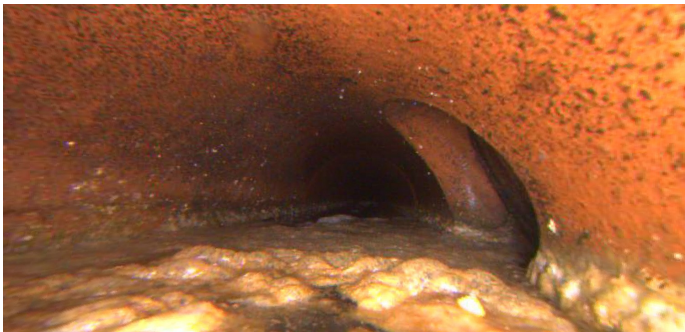
Code:	TFA
Description:	Tap Factory Active

Distance (ft):	39.0
Structural Grade:	0
O&M Grade:	0
Clock Start/From:	3
Clock To:	
1st Value:	4.000
2nd Value:	
Value Percent:	
Continuous Index:	
Within 8" of Joint:	
Remarks:

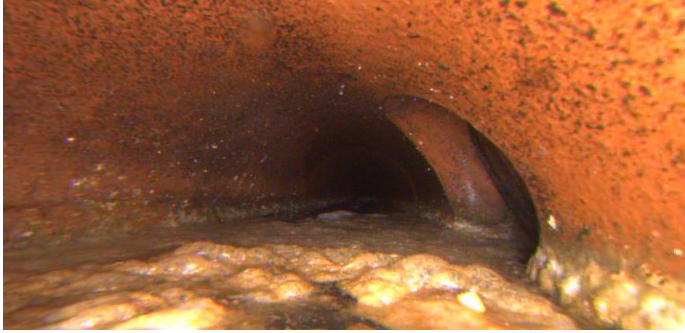
Code: **MWL**
Description: **Water Level**

Distance (ft): **39.0**
Structural Grade: **0**
O&M Grade: **0**
Clock Start/From:
Clock To:
1st Value:
2nd Value:
Value Percent: **40.000**
Continuous Index:
Within 8" of Joint: **NO**
Remarks:

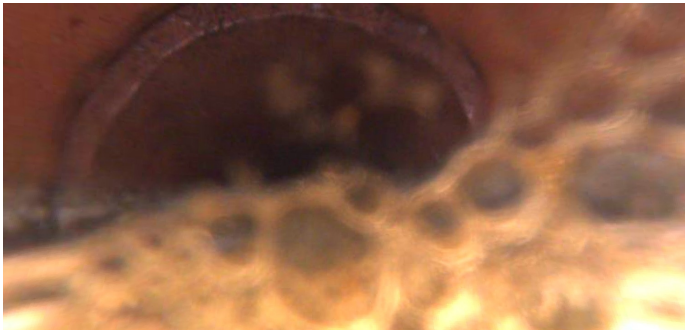
Code: **MGO**
Description: **General Observation**

Distance (ft): **41.4**
Structural Grade: **0**
O&M Grade: **0**
Clock Start/From:
Clock To:
1st Value:
2nd Value:
Value Percent:
Continuous Index:
Within 8" of Joint: **NO**
Remarks: **REAR CAMERA**

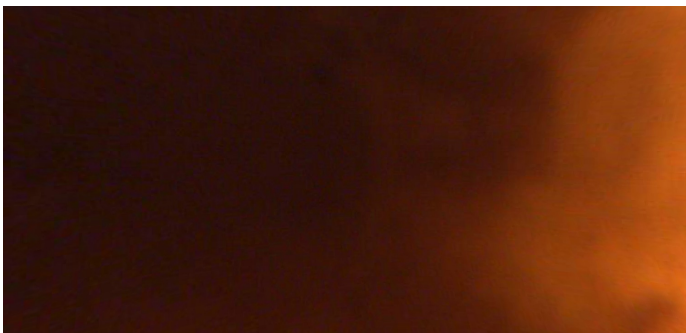
Code: **MCU**
Description: **Camera Underwater**

Distance (ft): **67.5**
Structural Grade: **0**
O&M Grade: **4**
Clock Start/From:
Clock To:
1st Value:
2nd Value:
Value Percent:
Continuous Index: **F01**
Within 8" of Joint: **NO**
Remarks:

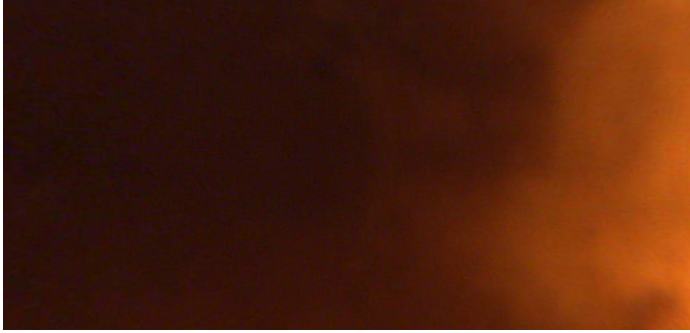
Code:	MSA
Description:	Abandoned Survey
Distance (ft):	67.5
Structural Grade:	0
O&M Grade:	0
Clock Start/From:	
Clock To:	
1st Value:	
2nd Value:	
Value Percent:	
Continuous Index:	
Within 8" of Joint:	NO
Remarks:	UNDER WATER
