## Profile/Photo Observation Report

Street:	<b>BRANDT PL</b>	Flow Control:	<b>Not Controlled</b>
City:	<b>Hobart, IN</b>	Year Renewed:	
Location:	<b>Other</b>	Tape/Media #:	
Purpose:	<b>Not Known</b>	Dia/Height:	<b>10"</b>
Use:	<b>Sanitary</b>	Material:	<b>VCP</b>
Drain Area:	<b>NA</b>	Lining:	
Category:	<b>NA</b>		
Comment:

Location Details:		Direction of Survey:	<b>Downstream</b>
US MH:	<b>M-904-039</b>	DS MH:	<b>M-904-041</b>
		Total Length Surveyed (ft):	<b>74.1</b>

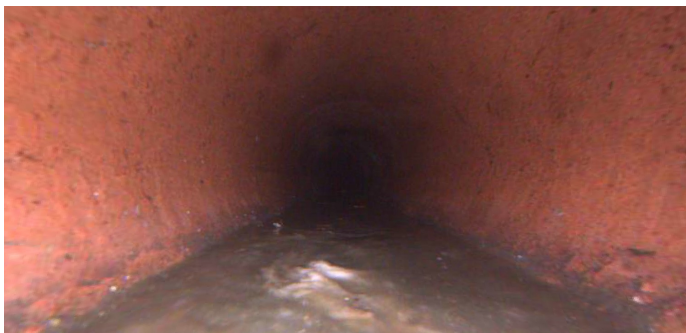
Code: **AMH**  
Description: **Manhole**

Distance (ft): **.0**  
Structural Grade: **0**  
O&M Grade: **0**  
Clock Start/From:  
Clock To:  
1st Value:  
2nd Value:  
Value Percent:  
Continuous Index:  
Within 8" of Joint: **NO**  
Remarks: **M-904-039**

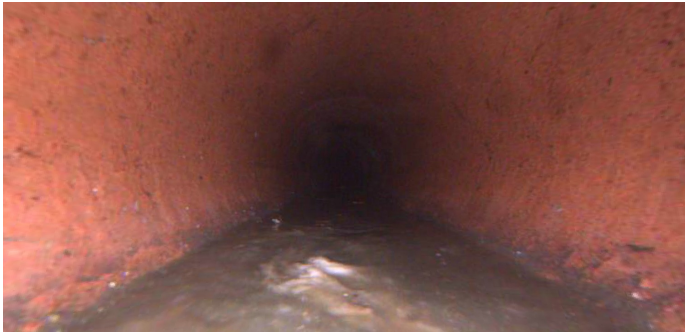
Code:	<b>MWL</b>
Description:	<b>Water Level</b>

Distance (ft):	<b>.0</b>
Structural Grade:	<b>0</b>
O&M Grade:	<b>0</b>
Clock Start/From:	
Clock To:	
1st Value:	
2nd Value:	
Value Percent:	<b>10.000</b>
Continuous Index:	
Within 8" of Joint:	<b>NO</b>
Remarks:

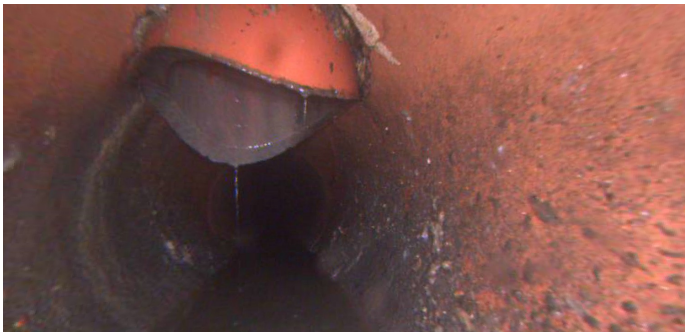
Code:	<b>TBI</b>
Description:	<b>Tap Break-in Intruding</b>

Distance (ft):	<b>22.5</b>
Structural Grade:	<b>0</b>
O&M Grade:	<b>2</b>
Clock Start/From:	<b>12</b>
Clock To:	
1st Value:	<b>4.000</b>
2nd Value:	<b>2.000</b>
Value Percent:	
Continuous Index:	
Within 8" of Joint:	
Remarks:

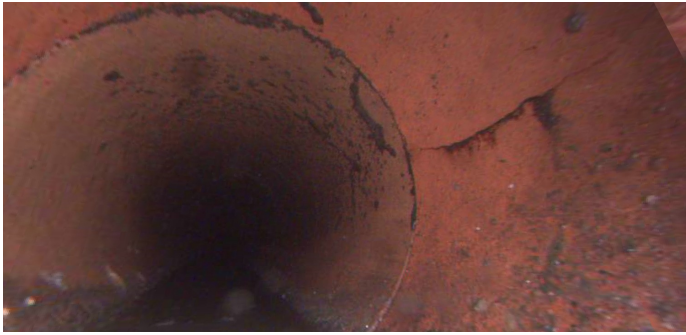
Code: **FL**  
Description: **Fracture Longitudinal**

Distance (ft): **24.0**  
Structural Grade: **3**  
O&M Grade: **0**  
Clock Start/From: **2**  
Clock To:  
1st Value:  
2nd Value:  
Value Percent:  
Continuous Index:  
Within 8" of Joint:  
Remarks:

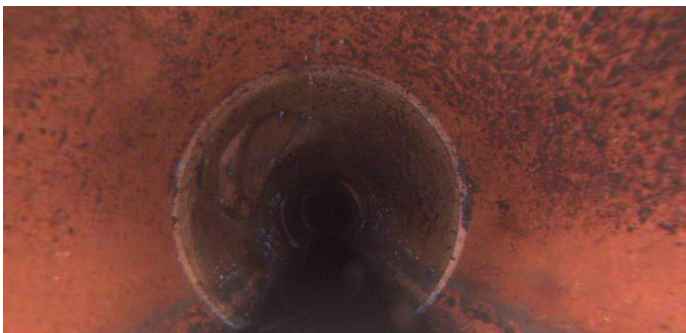
Code: **TBI**  
Description: **Tap Break-in Intruding**

Distance (ft): **74.1**  
Structural Grade: **0**  
O&M Grade: **2**  
Clock Start/From: **10**  
Clock To:  
1st Value: **4.000**  
2nd Value: **1.000**  
Value Percent:  
Continuous Index:  
Within 8" of Joint:  
Remarks:

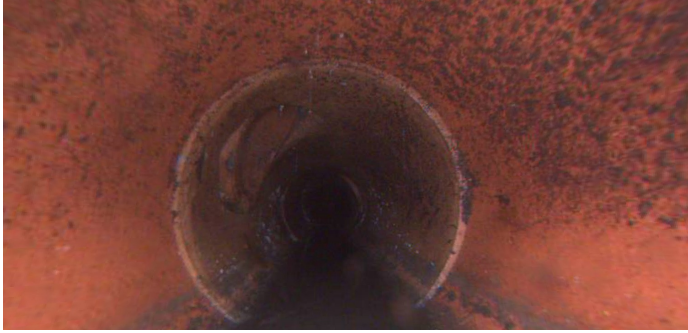
Code:	<b>MSA</b>
Description:	<b>Abandoned Survey</b>
Distance (ft):	<b>74.1</b>
Structural Grade:	<b>0</b>
O&M Grade:	<b>0</b>
Clock Start/From:	
Clock To:	
1st Value:	
2nd Value:	
Value Percent:	
Continuous Index:	
Within 8" of Joint:	<b>NO</b>
Remarks:	<b>UNKNOWN</b>
