Profile/Photo Observation Report

Street:	Brandt Pl.	Flow Control:	Not Controlled
City:	Hobart, IN	Year Renewed:	
Location:	Other	Tape/Media #:	
Purpose:	Not Known	Dia/Height:	10"
Use:	Sanitary	Material:	VCP
Drain Area:	NA	Lining:	
Category:	NA		
Comment:

Location Details:		Direction of Survey:	Downstream
US MH:	M-904-039	DS MH:	M-904-041
		Total Length Surveyed (ft):	74.1

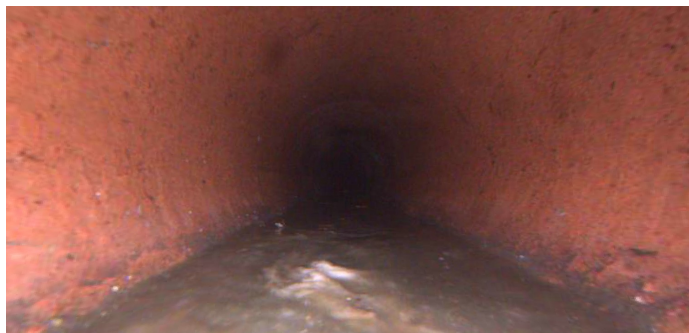
Code: **AMH**
 Description: **Manhole**

Distance (ft): **.0**
 Structural Grade: **0**
 O&M Grade: **0**
 Clock Start/From:
 Clock To:
 1st Value:
 2nd Value:
 Value Percent:
 Continuous Index:
 Within 8" of Joint: **NO**
 Remarks: **M-904-039**

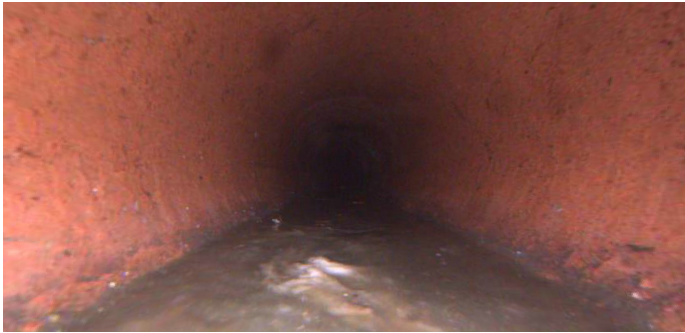
Code:	MWL
Description:	Water Level

Distance (ft):	.0
Structural Grade:	0
O&M Grade:	0
Clock Start/From:	
Clock To:	
1st Value:	
2nd Value:	
Value Percent:	10.000
Continuous Index:	
Within 8" of Joint:	NO
Remarks:

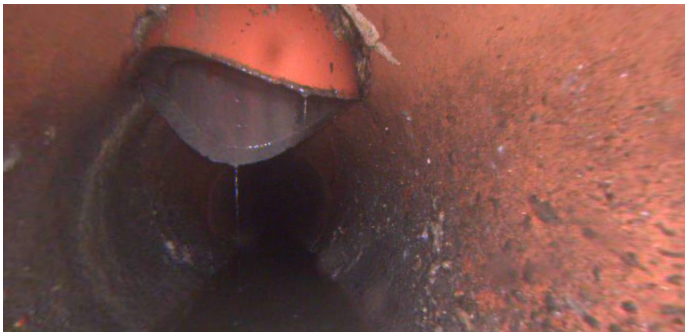
Code:	TBI
Description:	Tap Break-in Intruding

Distance (ft):	22.5
Structural Grade:	0
O&M Grade:	2
Clock Start/From:	12
Clock To:	
1st Value:	4.000
2nd Value:	2.000
Value Percent:	
Continuous Index:	
Within 8" of Joint:	
Remarks:

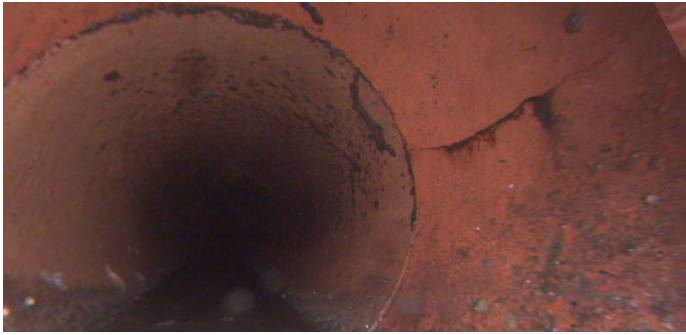
Code: **FL**
Description: **Fracture Longitudinal**

Distance (ft): **24.0**
Structural Grade: **3**
O&M Grade: **0**
Clock Start/From: **2**
Clock To:
1st Value:
2nd Value:
Value Percent:
Continuous Index:
Within 8" of Joint:
Remarks:

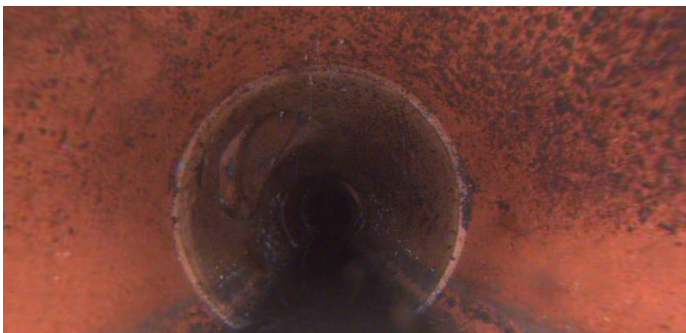
Code: **TBI**
Description: **Tap Break-in Intruding**

Distance (ft): **74.1**
Structural Grade: **0**
O&M Grade: **2**
Clock Start/From: **10**
Clock To:
1st Value: **4.000**
2nd Value: **1.000**
Value Percent:
Continuous Index:
Within 8" of Joint:
Remarks:

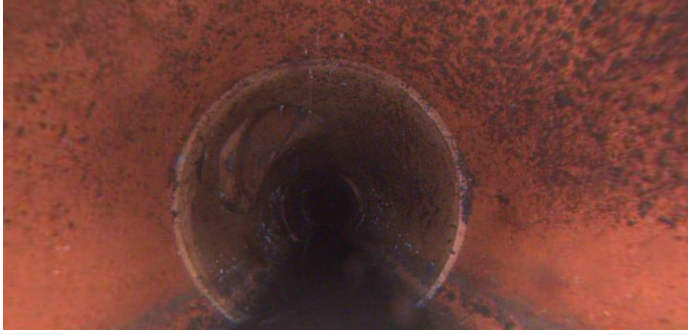
Code:	MSA
Description:	Abandoned Survey
Distance (ft):	74.1
Structural Grade:	0
O&M Grade:	0
Clock Start/From:	
Clock To:	
1st Value:	
2nd Value:	
Value Percent:	
Continuous Index:	
Within 8" of Joint:	NO
Remarks:	UNKNOWN
