## Profile/Photo Observation Report

Street:	<b>RUSH CT</b>	Flow Control:	<b>Not Controlled</b>
City:	<b>Hobart, IN</b>	Year Renewed:	
Location:	<b>Other</b>	Tape/Media #:	
Purpose:	<b>Not Known</b>	Dia/Height:	<b>8"</b>
Use:	<b>Sanitary</b>	Material:	<b>VCP</b>
Drain Area:	<b>NA</b>	Lining:	
Category:	<b>NA</b>		
Comment:	<b>NULL - CNL - REV - NULL - CNL</b>

Location Details:		Direction of Survey:	<b>Upstream</b>
US MH:	<b>M-904-042</b>	DS MH:	<b>M-904-044</b>
		Total Length Surveyed (ft):	<b>24.8</b>

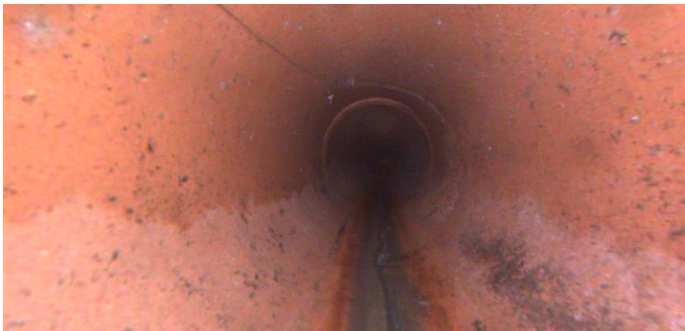
Code: **AMH**  
Description: **Manhole**

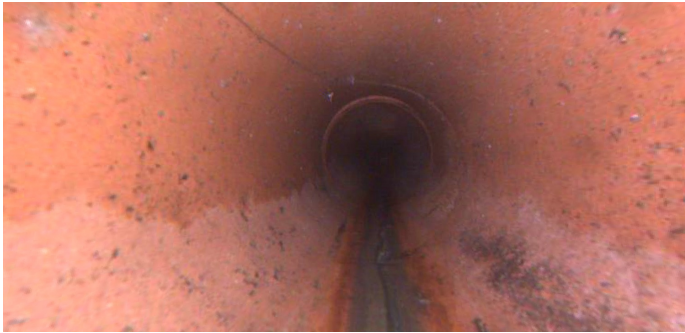
Code:	<b>MWL</b>
Description:	<b>Water Level</b>

Distance (ft):	<b>.0</b>
Structural Grade:	<b>0</b>
O&M Grade:	<b>0</b>
Clock Start/From:	
Clock To:	
1st Value:	
2nd Value:	
Value Percent:	<b>5.000</b>
Continuous Index:	
Within 8" of Joint:	<b>NO</b>
Remarks:

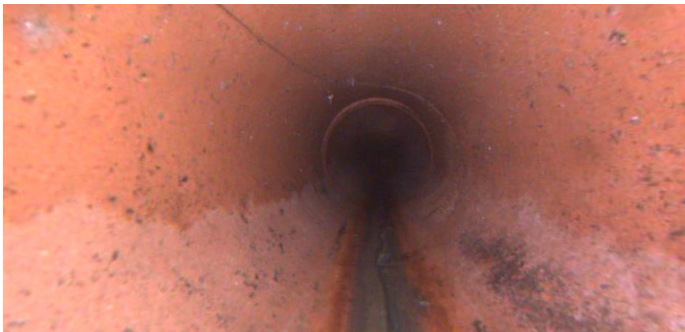
Code:	<b>FL</b>
Description:	<b>Fracture Longitudinal</b>

Distance (ft):	<b>.0</b>
Structural Grade:	<b>3</b>
O&M Grade:	<b>0</b>
Clock Start/From:	<b>10</b>
Clock To:	
1st Value:	
2nd Value:	
Value Percent:	
Continuous Index:	
Within 8" of Joint:	
Remarks:

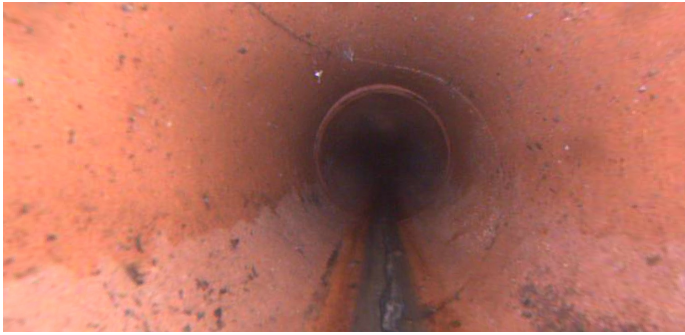
Code: **FS**  
Description: **Fracture Spiral**

Distance (ft): **1.1**  
Structural Grade: **3**  
O&M Grade: **0**  
Clock Start/From: **12**  
Clock To: **6**  
1st Value:  
2nd Value:  
Value Percent:  
Continuous Index:  
Within 8" of Joint:  
Remarks:

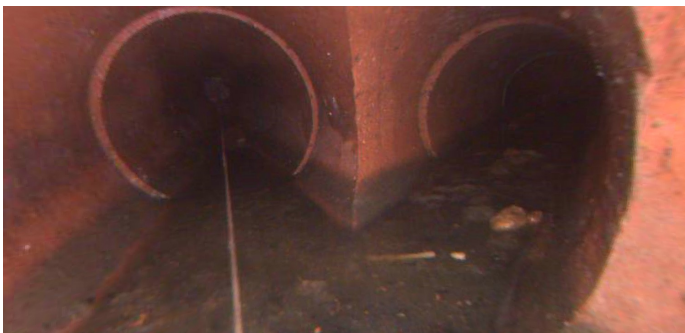
Code: **TFA**  
Description: **Tap Factory Active**

Distance (ft): **9.1**  
Structural Grade: **0**  
O&M Grade: **0**  
Clock Start/From: **9**  
Clock To:  
1st Value: **4.000**  
2nd Value:  
Value Percent:  
Continuous Index:  
Within 8" of Joint:  
Remarks:

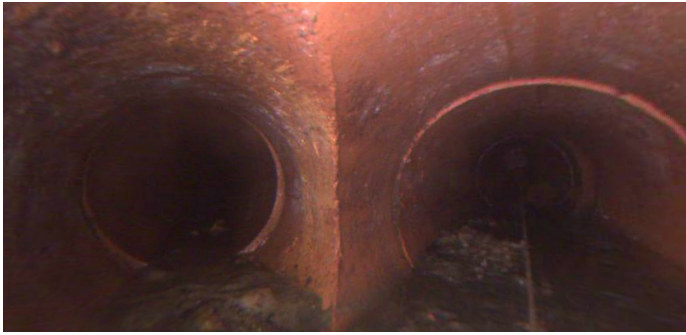
Code: **TFA**  
Description: **Tap Factory Active**

Distance (ft): **10.9**  
Structural Grade: **0**  
O&M Grade: **0**  
Clock Start/From: **3**  
Clock To:  
1st Value: **4.000**  
2nd Value:  
Value Percent:  
Continuous Index:  
Within 8" of Joint:  
Remarks:

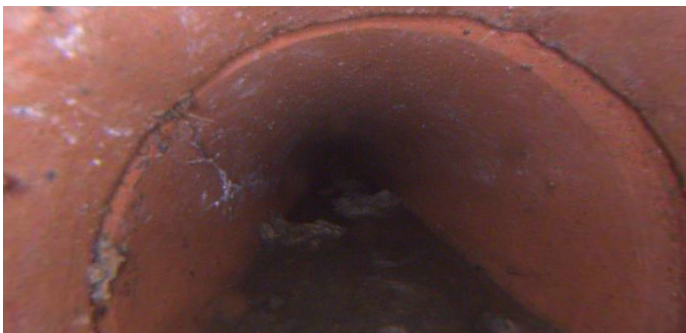
Code: **RFJ**  
Description: **Roots Fine Joint**

Distance (ft): **11.9**  
Structural Grade: **0**  
O&M Grade: **1**  
Clock Start/From: **10**  
Clock To:  
1st Value:  
2nd Value:  
Value Percent:  
Continuous Index:  
Within 8" of Joint: **YES**  
Remarks:

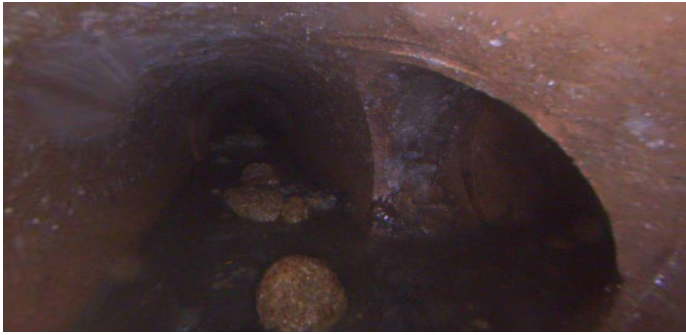
Code: **TFA**  
Description: **Tap Factory Active**

Distance (ft): **17.6**  
Structural Grade: **0**  
O&M Grade: **0**  
Clock Start/From: **3**  
Clock To:  
1st Value: **4.000**  
2nd Value:  
Value Percent:  
Continuous Index:  
Within 8" of Joint:  
Remarks:

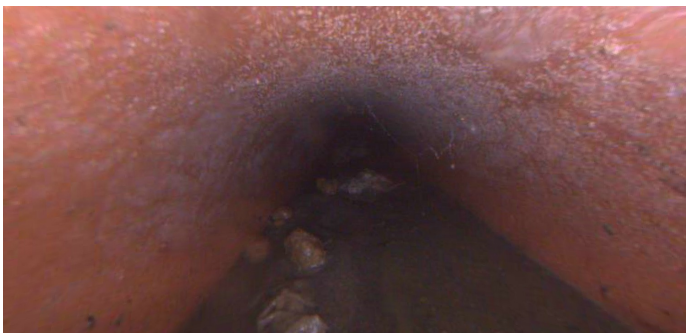
Code: **MSA**  
Description: **Abandoned Survey**

Distance (ft): **24.8**  
Structural Grade: **0**  
O&M Grade: **0**  
Clock Start/From:  
Clock To:  
1st Value:  
2nd Value:  
Value Percent:  
Continuous Index:  
Within 8" of Joint: **NO**  
Remarks: **DEBRIS UNDER WATER**
