Profile/Photo Observation Report

| Street: | Rush Ct. | Flow Control: | Not Controlled |
| City: | Hobart, IN | Year Renewed: | |
| US MH: | M-904-042 | DS MH: | M-904-044 |

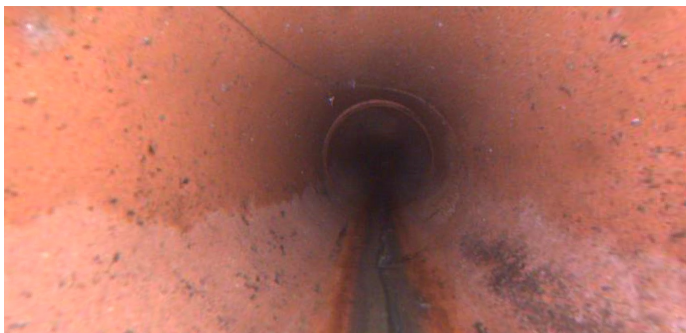
Code: **AMH**
Description: **Manhole**

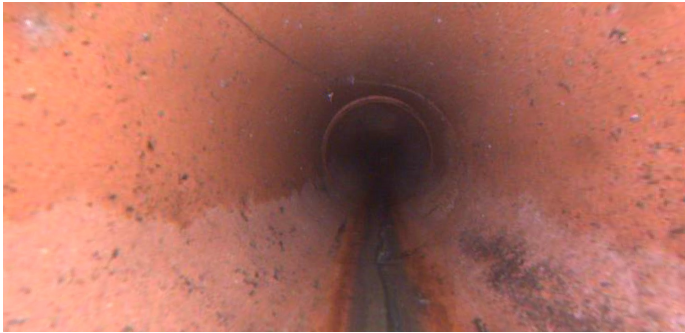
| Code: | MWL |
| Description: | Water Level |

| Value Percent: | 5.000 |

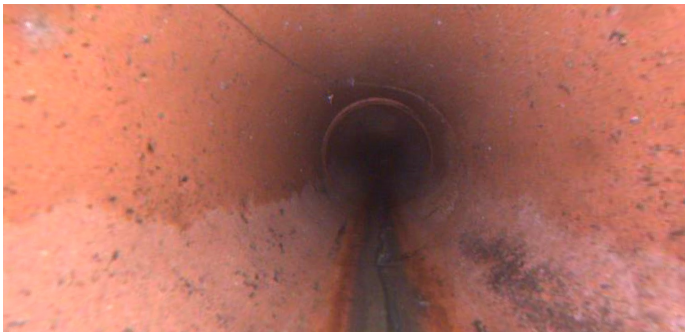
| Position | Code | Observation | Video (sec) | Grade |
|---|---|---|---|---|
| .0 | FL | Fracture Longitudinal | 32 | S 3 |

| Code: | FL |
| Description: | Fracture Longitudinal |

| Distance (ft): | .0 |
| Structural Grade: | 3 |
| Clock Start/From: | 10 |

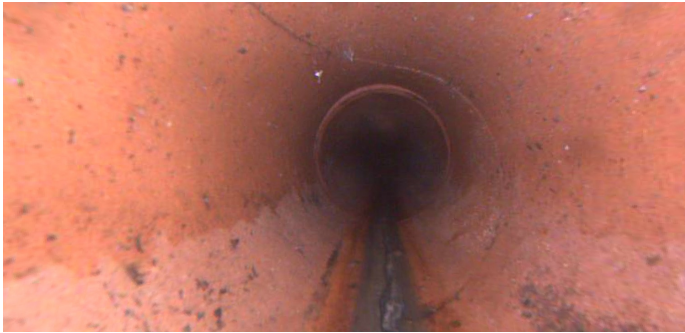
| Position | Code | Observation | Video (sec) | Grade |
|---|---|---|---|---|
| 1.1 | FS | Fracture Spiral | 46 | S 3 |

Code: **FS**
Description: **Fracture Spiral**

Distance (ft): **1.1**
Structural Grade: **3**
O&M Grade: **0**
Clock Start/From: **12**
Clock To: **6**
1st Value:
2nd Value:
Value Percent:
Continuous Index:
Within 8" of Joint:
Remarks:

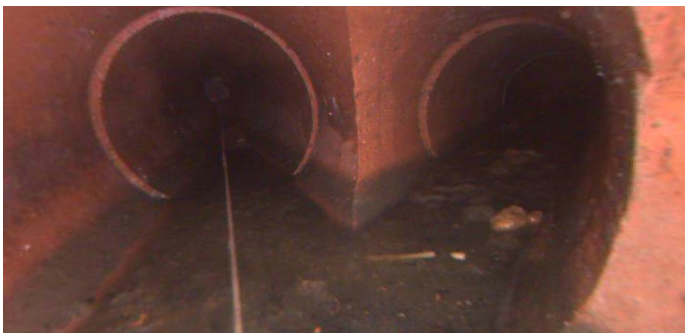
Code: **TFA**
Description: **Tap Factory Active**

Distance (ft): **9.1**
Structural Grade: **0**
O&M Grade: **0**
Clock Start/From: **9**
Clock To:
1st Value: **4.000**
2nd Value:
Value Percent:
Continuous Index:
Within 8" of Joint:
Remarks:

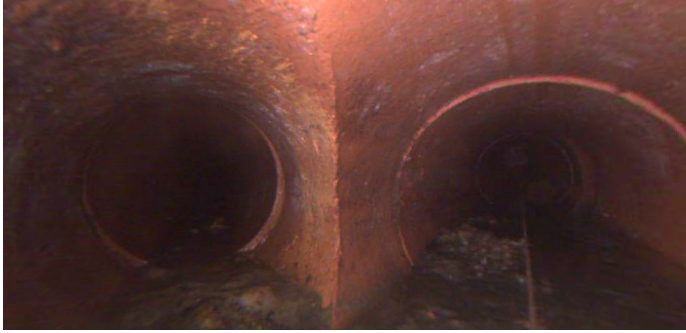
Code: **TFA**
Description: **Tap Factory Active**

Distance (ft): **10.9**
Structural Grade: **0**
O&M Grade: **0**
Clock Start/From: **3**
Clock To:
1st Value: **4.000**
2nd Value:
Value Percent:
Continuous Index:
Within 8" of Joint:
Remarks:

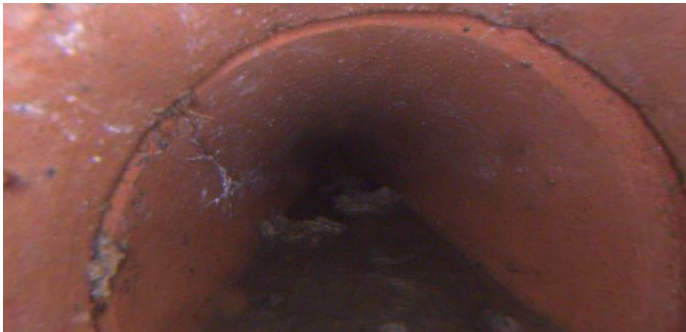
| Position | Code | Observation | Video (sec) | Grade |
|---|---|---|---|---|
| 11.9 | RFJ | Roots Fine Joint | 109 | M 1 |

Code: **RFJ**
Description: **Roots Fine Joint**

Distance (ft): **11.9**
Structural Grade: **0**
O&M Grade: **1**
Clock Start/From: **10**
Clock To:
1st Value:
2nd Value:
Value Percent:
Continuous Index:
Within 8" of Joint: **YES**
Remarks:

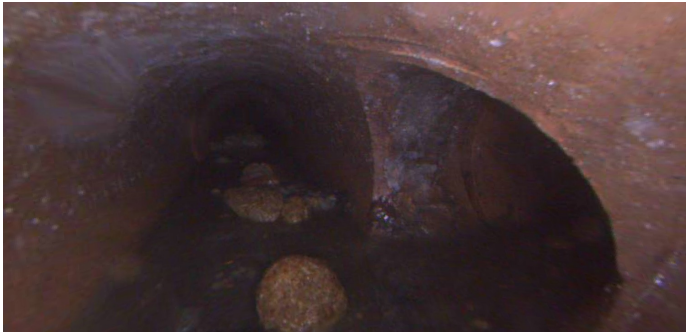
Code: **TFA**
Description: **Tap Factory Active**

Distance (ft): **17.6**
Structural Grade: **0**
O&M Grade: **0**
Clock Start/From: **3**
Clock To:
1st Value: **4.000**
2nd Value:
Value Percent:
Continuous Index:
Within 8" of Joint:
Remarks:

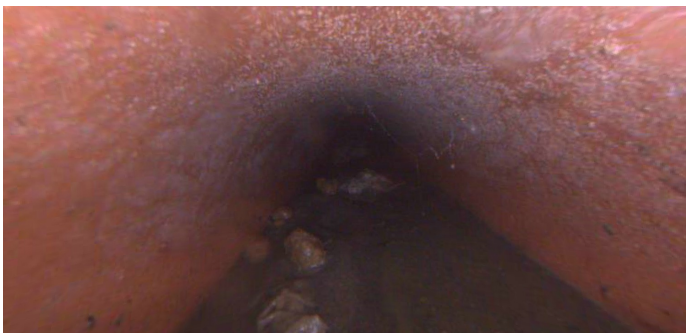
Code: **MSA**
Description: **Abandoned Survey**

Distance (ft): **24.8**
Structural Grade: **0**
O&M Grade: **0**
Clock Start/From:
Clock To:
1st Value:
2nd Value:
Value Percent:
Continuous Index:
Within 8" of Joint: **NO**
Remarks: **DEBRIS UNDER WATER**
