Profile/Photo Observation Report

Street: RUSH CT Flow Control: Not Controlled

US MH: M-904-042 DS MH: M-904-044 Total Length Surveyed (ft): 32.5

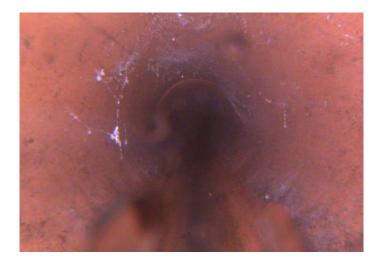
Code:	AMH		
Description:	Manhole		
Distance (ft):	.0		
Structural Grade:	0		
O&M Grade:	0		
Clock Start/From:			
Clock To:			
1st Value:			
2nd Value:			
Value Percent:			
Continuous Index:			
Within 8" of Joint:	NO		
Remarks:	M-904-044

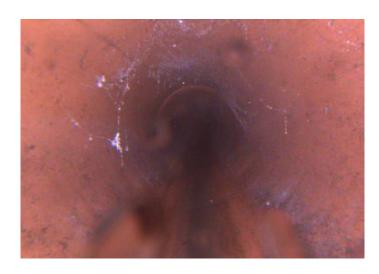
Code: MWL Description: **Water Level**

Distance (ft): .0 Structural Grade: 0 O&M Grade: 0 Clock Start/From:

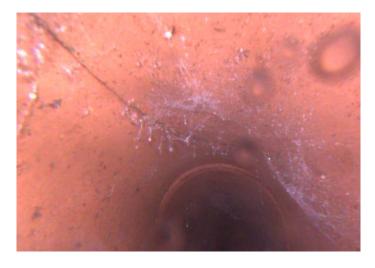
Code: CL

Crack Longitudinal Description:

Distance (ft): 1.5 Structural Grade: 2 O&M Grade: 0 Clock Start/From: 12

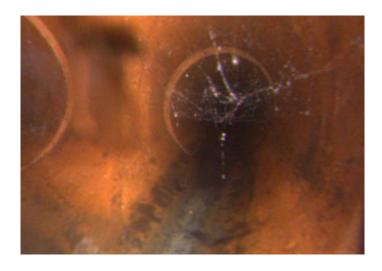
Code: TF
Description: Tap Factory

Distance (ft): 9.0
Structural Grade: 0
O&M Grade: 0
Clock Start/From: 3

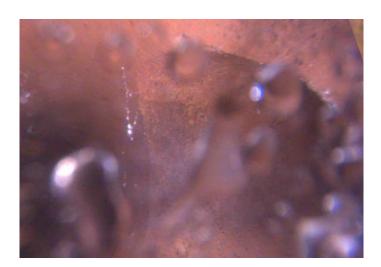
Code: **TF**

Description: Tap Factory

Distance (ft): 10.3
Structural Grade: 0

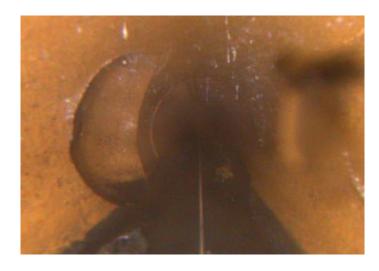
Code: TF
Description: Tap Factory

Distance (ft): 18.7
Structural Grade: 0
O&M Grade: 0
Clock Start/From: 9

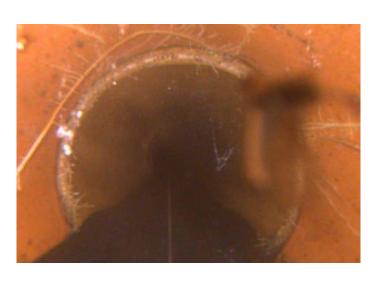
Code: RFJ

Description: Roots Fine Joint

Distance (ft): 19.9 Structural Grade: 0 O&M Grade: 1 Clock Start/From: 8 Clock To: 4 1st Value: 2nd Value: Value Percent: Continuous Index: Within 8" of Joint: YES

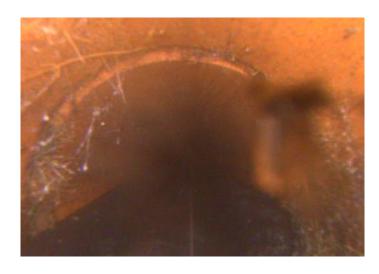
Code: RFJ

Description: Roots Fine Joint

Distance (ft): 30.1
Structural Grade: 0
O&M Grade: 1
Clock Start/From: 8
Clock To: 4
