Profile/Photo Observation Report

Date:	10/05/2018	Weather:		Coding:	PACP 6.0
Pipe Length (ft):	162.4	Owner:	NA	Pre Clean:	Not Known
P.O.#:		Surveyor:	Michael Carlino	PSR:	P-904-044-042
Customer:		Clean Date:	01/01/1900	Shape:	C

Street:	Rush Ct.	Flow Control:	Not Controlled
City:	Hobart, IN	Year Renewed:	
Location:	Light Highway	Tape/Media #:	
Purpose:	Routine Assessment	Dia/Height:	8"
Use:	Sanitary	Material:	VCP
Drain Area:	NA	Lining:	
Category:	NA		
Comment:

Location Details:		Direction of Survey:	Upstream
US MH:	M-904-042	DS MH:	M-904-044
		Total Length Surveyed (ft):	32.5

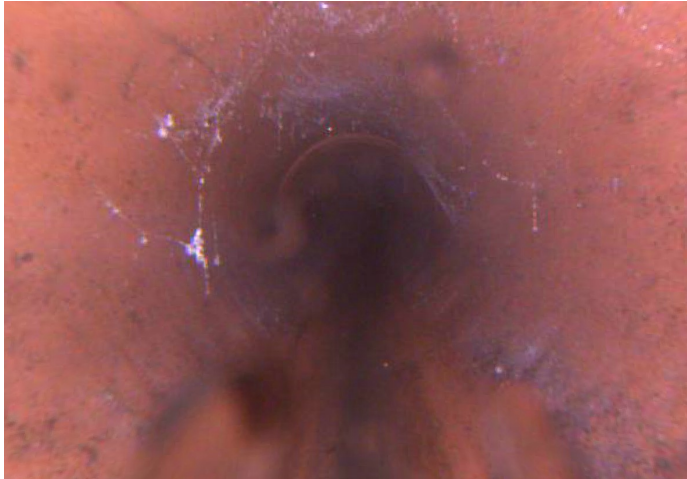
Code: **MWL**
Description: **Water Level**

Distance (ft): **.0**
Structural Grade: **0**
O&M Grade: **0**
Clock Start/From:
Clock To:
1st Value:
2nd Value:
Value Percent: **5.000**
Continuous Index:
Within 8" of Joint: **NO**
Remarks:

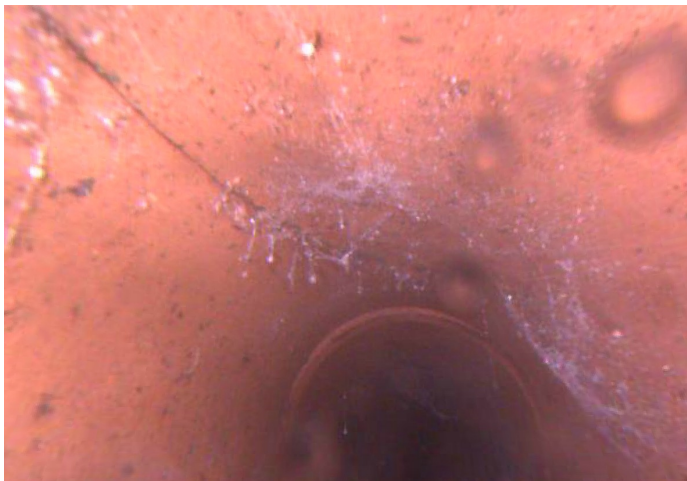
Code: **CL**
Description: **Crack Longitudinal**

Distance (ft): **1.5**
Structural Grade: **2**
O&M Grade: **0**
Clock Start/From: **12**
Clock To:
1st Value:
2nd Value:
Value Percent:
Continuous Index:
Within 8" of Joint:
Remarks:

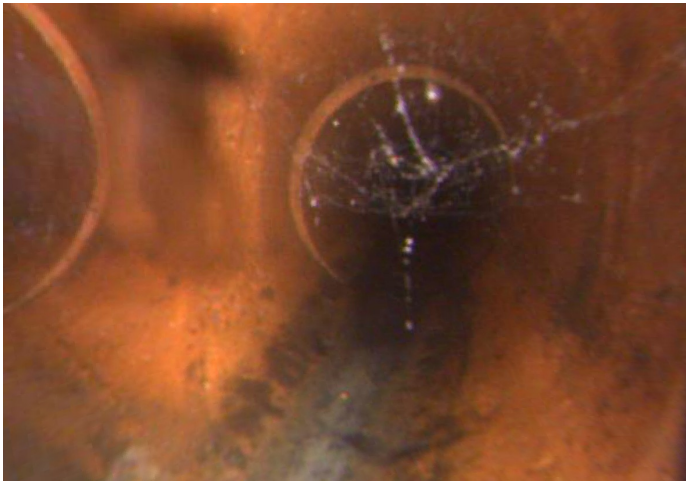
Code: **TF**
Description: **Tap Factory**

Distance (ft): **9.0**
Structural Grade: **0**
O&M Grade: **0**
Clock Start/From: **3**
Clock To:
1st Value: **6.000**
2nd Value:
Value Percent:
Continuous Index:
Within 8" of Joint:
Remarks:

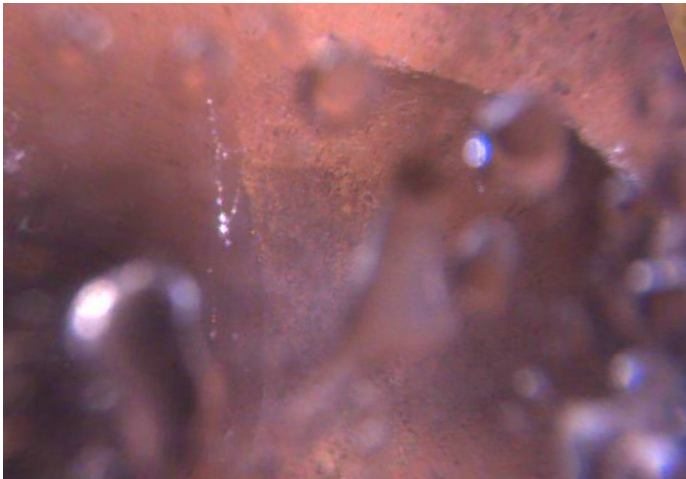
Code: **TF**
Description: **Tap Factory**

Distance (ft): **10.3**
Structural Grade: **0**
O&M Grade: **0**
Clock Start/From: **3**
Clock To:
1st Value: **6.000**
2nd Value:
Value Percent:
Continuous Index:
Within 8" of Joint:
Remarks:

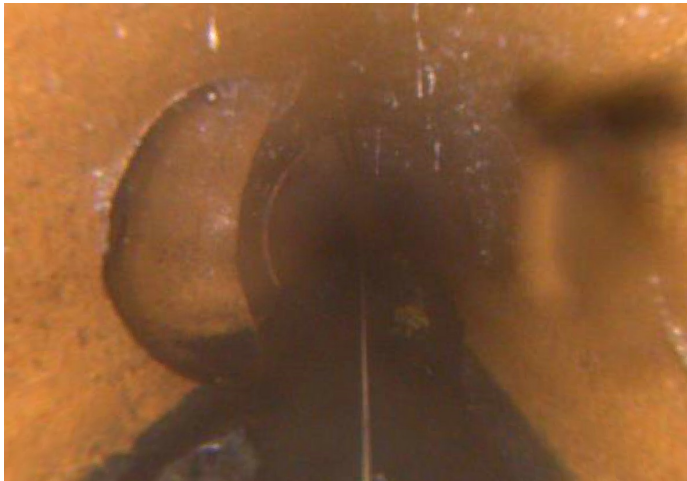
Code: **TF**
Description: **Tap Factory**

Distance (ft): **18.7**
Structural Grade: **0**
O&M Grade: **0**
Clock Start/From: **9**
Clock To:
1st Value: **6.000**
2nd Value:
Value Percent:
Continuous Index:
Within 8" of Joint:
Remarks:

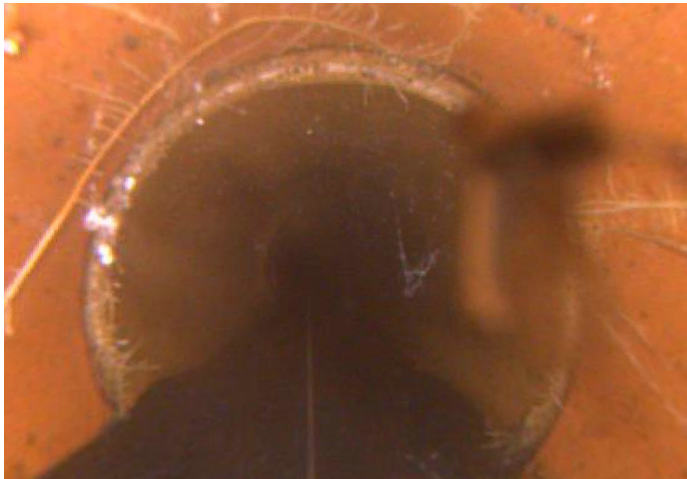
Code: **RFJ**
Description: **Roots Fine Joint**

Distance (ft): **19.9**
Structural Grade: **0**
O&M Grade: **1**
Clock Start/From: **8**
Clock To: **4**
1st Value:
2nd Value:
Value Percent:
Continuous Index:
Within 8" of Joint: **YES**
Remarks:

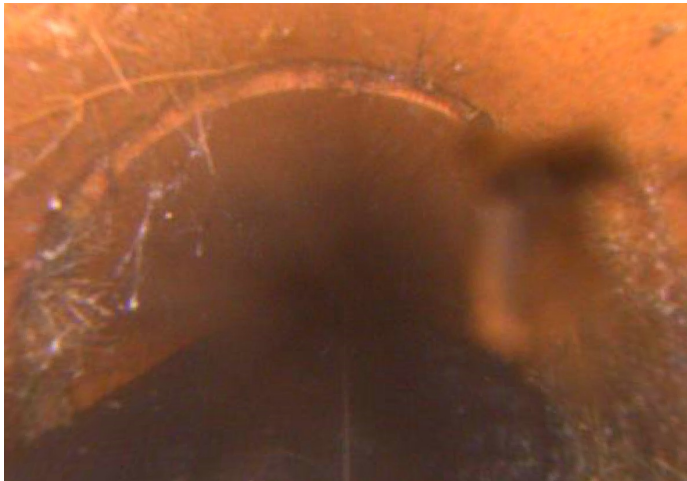
Code: **RFJ**
Description: **Roots Fine Joint**

Distance (ft): **30.1**
Structural Grade: **0**
O&M Grade: **1**
Clock Start/From: **8**
Clock To: **4**
1st Value:
2nd Value:
Value Percent:
Continuous Index:
Within 8" of Joint: **YES**
Remarks:

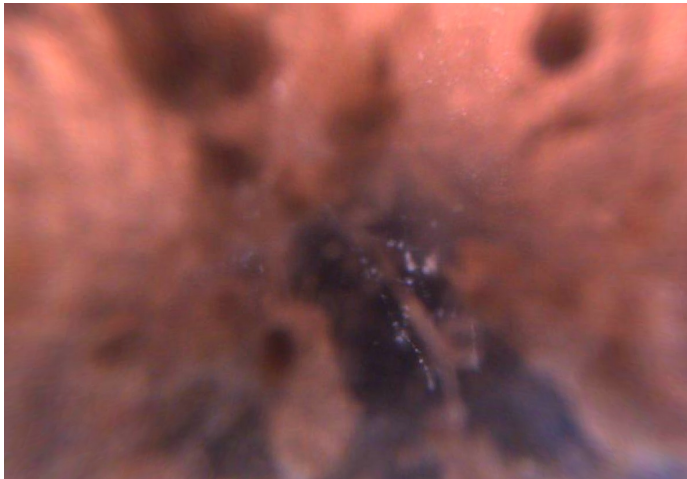
Code: **MSA**
Description: **Abandoned Survey**

Distance (ft): **32.5**
Structural Grade: **0**
O&M Grade: **0**
Clock Start/From:
Clock To:
1st Value:
2nd Value:
Value Percent:
Continuous Index:
Within 8" of Joint: **NO**
Remarks: **Possible Debris**
