## Profile/Photo Observation Report

Date:	<b>04/21/2018</b>	Weather:		Coding:	<b>PACP 4.2</b>
Pipe Length (ft):	<b>313.3</b>	Owner:	<b>City of Hobart</b>	Pre Clean:	<b>No Pre-Cleaning</b>
P.O.#:	<b>2004</b>	Surveyor:	<b>SAN</b>	PSR:	<b>P-904-042-047</b>
Customer:	<b>Red Zone</b>	Clean Date:		Shape:	<b>C</b>

Street:	<b>205 Rush Ct</b>	Flow Control:	<b>Not Controlled</b>
City:	<b>Hobart In</b>	Year Renewed:	
Location:	<b>Light Highway</b>	Tape/Media #:	<b>Deliverable 1</b>
Purpose:	<b>Routine Assessment</b>	Dia/Height:	<b>18"</b>
Use:	<b>Sanitary</b>	Material:	<b>VCP</b>
Drain Area:	<b>Northeast</b>	Lining:	
Category:	<b>NA</b>		
Comment:	<b>425-1</b>		
Location Details:	<b>Grass at edge of street</b>	Direction of Survey:	<b>Downstream</b>
US MH:	<b>M-904-042</b>	DS MH:	<b>M-904-047</b>
		Total Length Surveyed (ft):	<b>313.3</b>

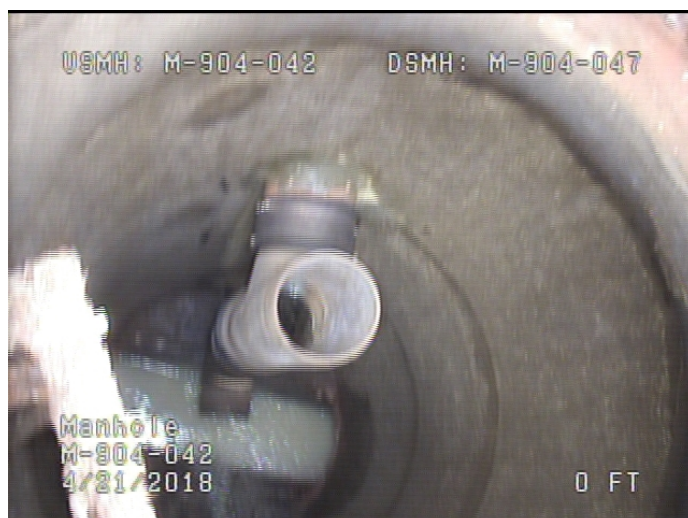
Code: **AMH**  
Description: **Manhole**

Distance (ft): **.0**  
Structural Grade: **0**  
O&M Grade: **0**  
Clock Start/From:  
Clock To:  
1st Value:  
2nd Value:  
Value Percent:  
Continuous Index:  
Within 8" of Joint: **NO**  
Remarks: **M-904-042**

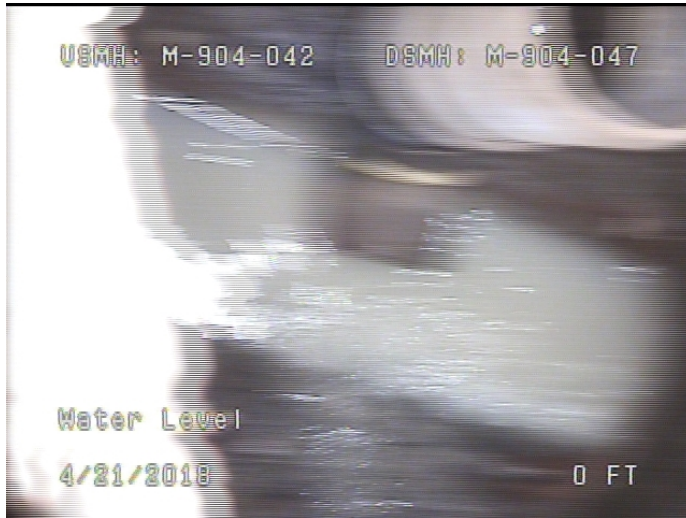
Code: **MWL**  
Description: **Water Level**

Distance (ft): **.0**  
Structural Grade: **0**  
O&M Grade: **0**  
Clock Start/From:  
Clock To:  
1st Value:  
2nd Value:  
Value Percent: **25.000**  
Continuous Index:  
Within 8" of Joint: **NO**  
Remarks:

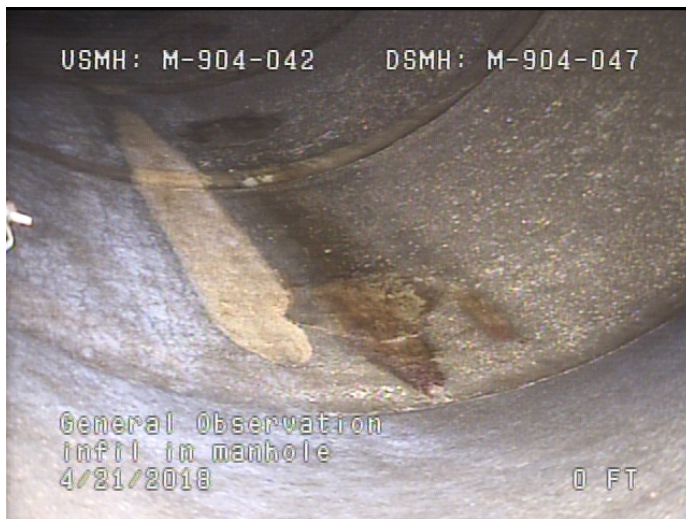
Code: **MGO**  
Description: **General Observation**

Distance (ft): **.0**  
Structural Grade: **0**  
O&M Grade: **0**  
Clock Start/From:  
Clock To:  
1st Value:  
2nd Value:  
Value Percent:  
Continuous Index:  
Within 8" of Joint: **NO**  
Remarks: **infil in manhole**

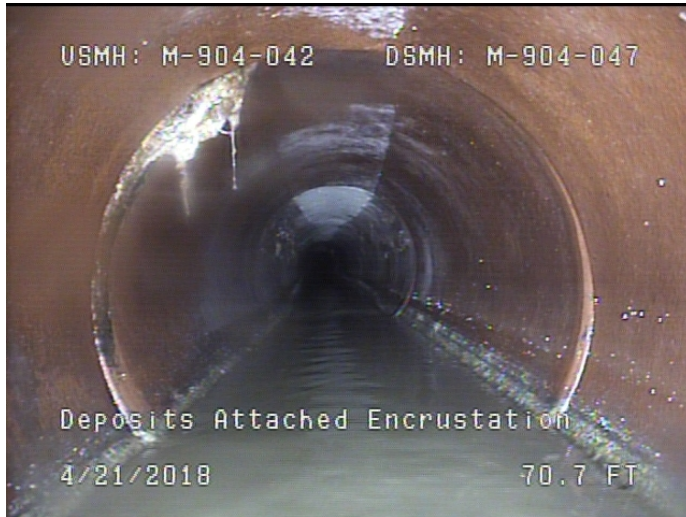
Code:	<b>DAE</b>
Description:	<b>Deposits Attached Encrustation</b>
Distance (ft):	<b>70.7</b>
Structural Grade:	<b>0</b>
O&M Grade:	<b>3</b>
Clock Start/From:	<b>8</b>
Clock To:	<b>11</b>
1st Value:	
2nd Value:	
Value Percent:	<b>15.000</b>
Continuous Index:	
Within 8" of Joint:	<b>YES</b>
Remarks:

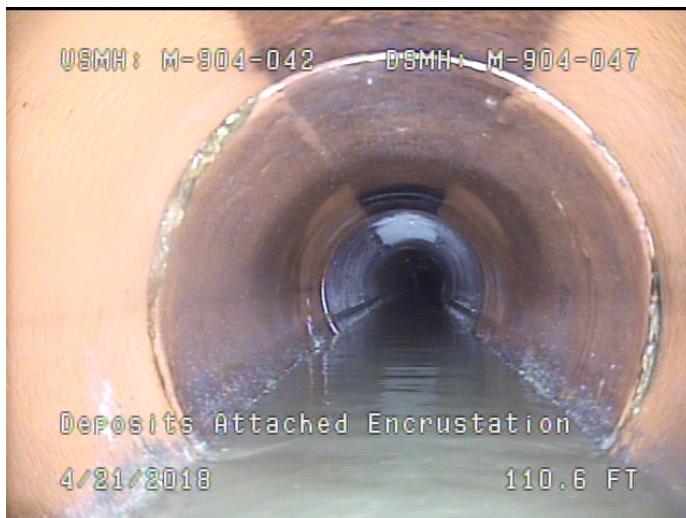
Code:	<b>DAE</b>
Description:	<b>Deposits Attached Encrustation</b>
Distance (ft):	<b>110.6</b>
Structural Grade:	<b>0</b>
O&M Grade:	<b>2</b>
Clock Start/From:	<b>9</b>
Clock To:	<b>10</b>
1st Value:	
2nd Value:	
Value Percent:	<b>5.000</b>
Continuous Index:	
Within 8" of Joint:	<b>YES</b>
Remarks:

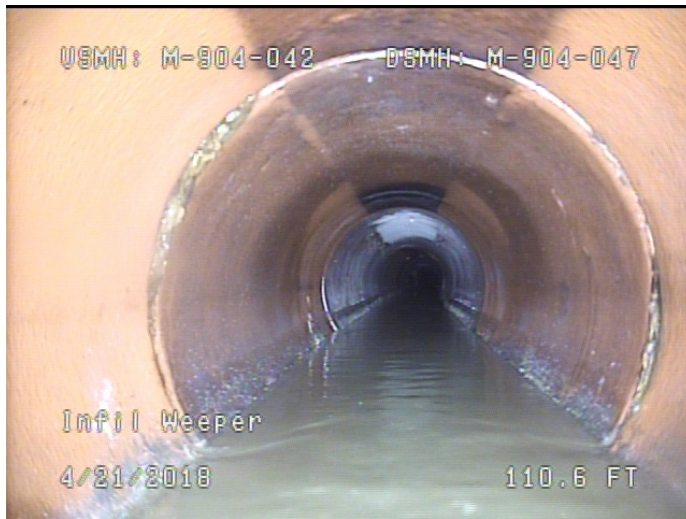
Code: **IW**  
 Description: **Infil Weeper**

Distance (ft): **110.6**  
 Structural Grade: **0**  
 O&M Grade: **2**  
 Clock Start/From: **9**  
 Clock To: **11**  
 1st Value:  
 2nd Value:  
 Value Percent:  
 Continuous Index:  
 Within 8" of Joint: **YES**  
 Remarks:

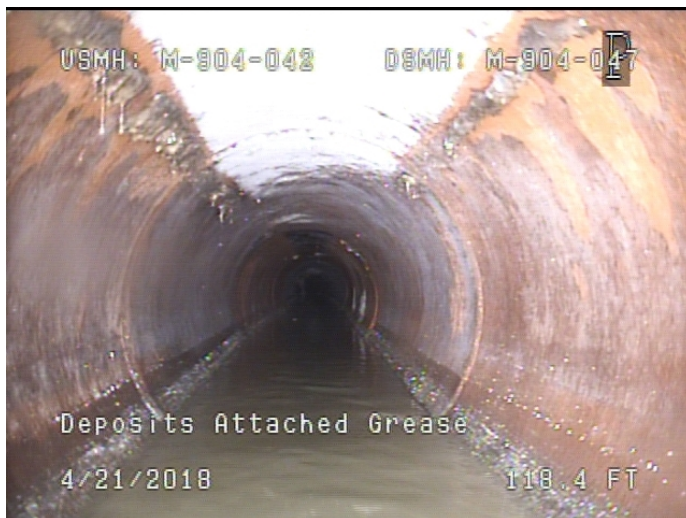
Code: **DAGS**  
 Description: **Deposits Attached Grease**

Distance (ft): **118.4**  
 Structural Grade: **0**  
 O&M Grade: **2**  
 Clock Start/From: **11**  
 Clock To: **1**  
 1st Value:  
 2nd Value:  
 Value Percent: **5.000**  
 Continuous Index:  
 Within 8" of Joint: **YES**  
 Remarks:

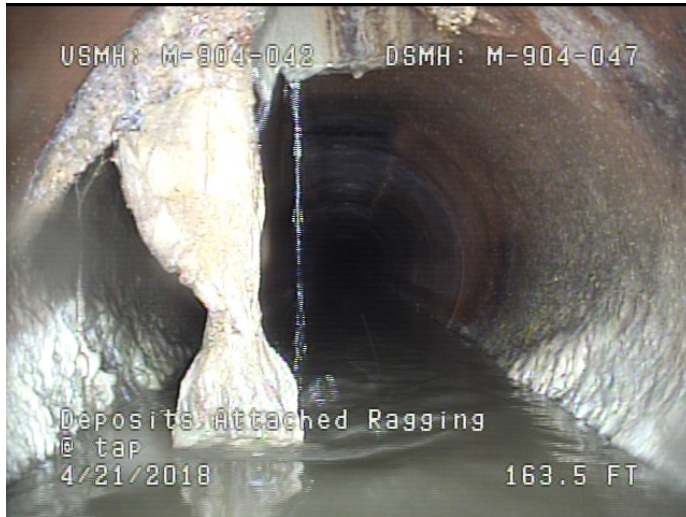
Code:	<b>DAR</b>
Description:	<b>Deposits Attached Ragging</b>
Distance (ft):	<b>163.5</b>
Structural Grade:	<b>0</b>
O&M Grade:	<b>3</b>
Clock Start/From:	<b>7</b>
Clock To:	<b>11</b>
1st Value:	
2nd Value:	
Value Percent:	<b>15.000</b>
Continuous Index:	
Within 8" of Joint:	<b>YES</b>
Remarks:	<b>@ tap</b>

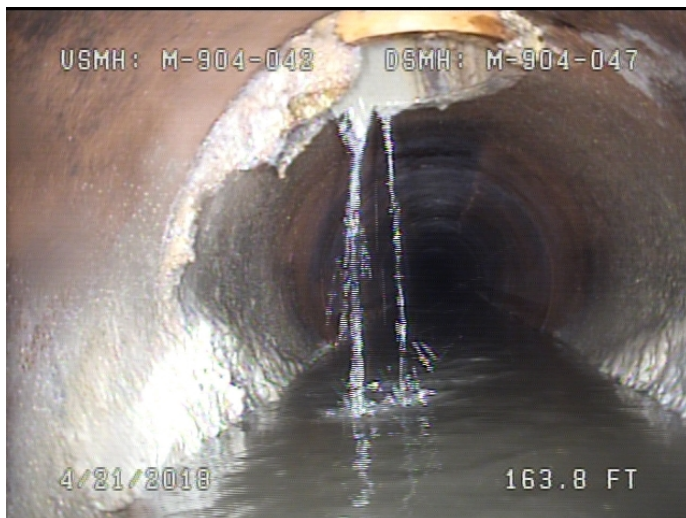
Code:	<b>TBD</b>
Description:	<b>Tap Break-in Defective</b>
Distance (ft):	<b>163.8</b>
Structural Grade:	<b>0</b>
O&M Grade:	<b>3</b>
Clock Start/From:	<b>10</b>
Clock To:	
1st Value:	<b>6.000</b>
2nd Value:	
Value Percent:	
Continuous Index:	
Within 8" of Joint:	<b>NO</b>
Remarks:	<b>infil @ tap</b>

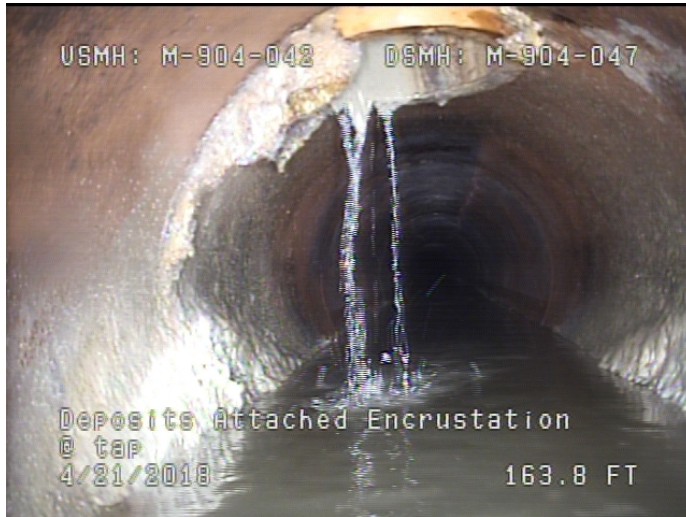
Code:	<b>DAE</b>
Description:	<b>Deposits Attached Encrustation</b>
Distance (ft):	<b>163.8</b>
Structural Grade:	<b>0</b>
O&M Grade:	<b>2</b>
Clock Start/From:	<b>2</b>
Clock To:	<b>9</b>
1st Value:	
2nd Value:	
Value Percent:	<b>10.000</b>
Continuous Index:	
Within 8" of Joint:	<b>NO</b>
Remarks:	<b>@ tap</b>

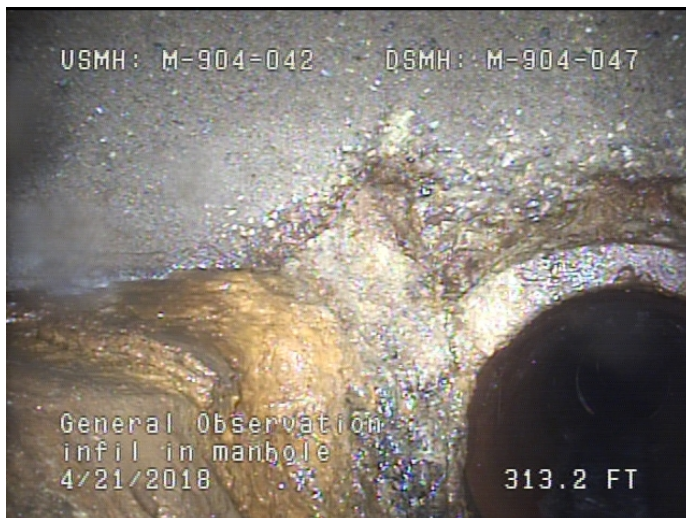
Code:	<b>MGO</b>
Description:	<b>General Observation</b>
Distance (ft):	<b>313.2</b>
Structural Grade:	<b>0</b>
O&M Grade:	<b>0</b>
Clock Start/From:	
Clock To:	
1st Value:	
2nd Value:	
Value Percent:	
Continuous Index:	
Within 8" of Joint:	<b>NO</b>
Remarks:	<b>infil in manhole</b>

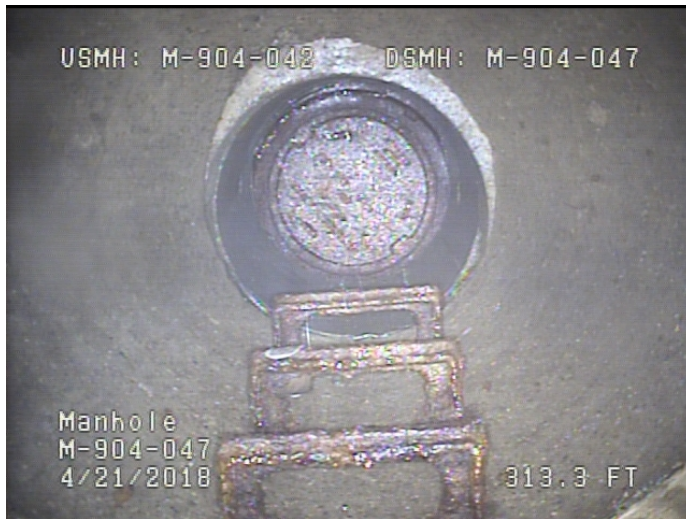
Code:	<b>AMH</b>
Description:	<b>Manhole</b>
Distance (ft):	<b>313.3</b>
Structural Grade:	<b>0</b>
O&M Grade:	<b>0</b>
Clock Start/From:	
Clock To:	
1st Value:	
2nd Value:	
Value Percent:	
Continuous Index:	
Within 8" of Joint:	<b>NO</b>
Remarks:	<b>M-904-047</b>
